RISK ANALYSIS TO ASSESS SOCIAL VULNERABILITY IN THE COUNTRY CLUB LA VILLA, MOQUEGUA-2023

Romina Mae Ripas Lanza^a, Nick Holifield Rivera Manzano^a, Luis Enrique Fernando Rivera Juárez^a, Ronal Alonso Mayta Alberto^a, Paola Julia Parra Ocampo^{b,c*}, Marcos Luis Quispe Pérez^a

^aSchool of Mining Engineering, Engineering Campus, Universidad Nacional de Moquegua, Moquegua, Peru.

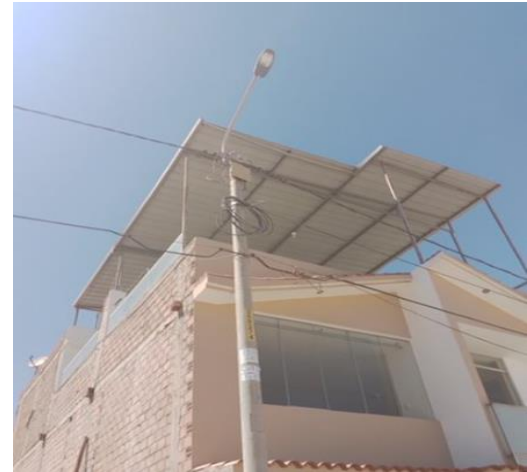
**Figure 8** Type of cover

In the specific context of the study in the Country Club La Villa Urbanization, the type of roof of the buildings is a crucial factor in the evaluation of seismic and geomechanical vulnerability. The range of cover types, from tile roofs and metal sheets to reinforced concrete covers, poses a significant risk during an earthquake or natural disaster. These risks could lead to the crushing of vehicles, harm to people, and damage to the

The type of roof can influence the structural resistance of buildings against seismic events and other geomechanical risks, as well as protection against water seepage and other external elements, as shown in Figure 8 and Figure 9.

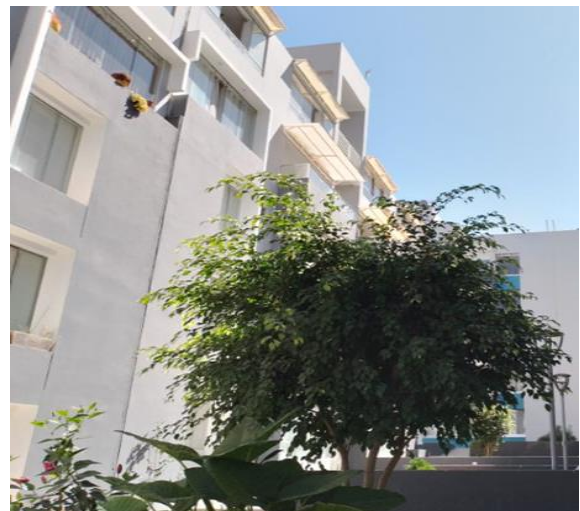
**Figure 9** Non-structural elements

It was found wall coverings, interior finishes, partitions, electrical and sanitary installations, furniture, and non-structural equipment and systems, to a certain extent, tend to deteriorate over time. Likewise, they can be damaged or detached, which represents a risk to the integrity of people and the general stability of the buildings, denoted explicitly to a

large extent by the large windows in the buildings that represent a large part of them as a danger. Therefore, it is necessary to evaluate the quality, design, and installation of these elements, considering their ability to resist dynamic loads and seismic movements, as well as their adequate fixing and anchoring, as shown in Figure 10 and Figure 11.

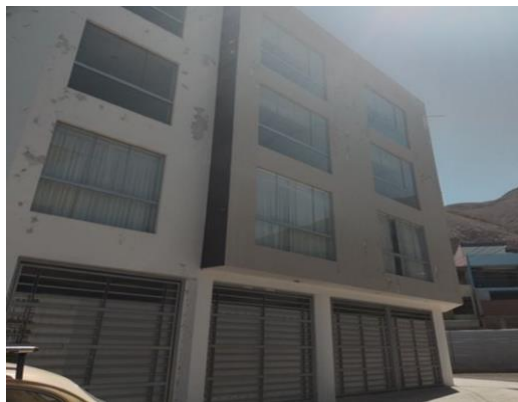
Figure 11 Inadequate windows
