THERMAL-INDUCED DAMAGE ON SOLDER JOINTS OF HIGH-DENSITY ADJACENT BALL GRID ARRAY COMPONENTS DURING THE REWORK PROCESS

Adlil Aizat Ismail^{a,b}, Maria Abu Bakar^{b*}, Abang Annuar Ehsan^b, Zol Effendi Zolkefli^a

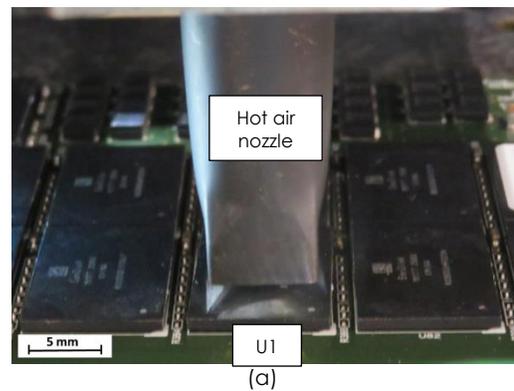
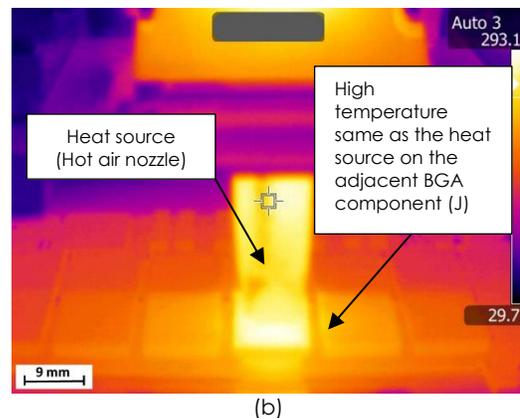
Figure 6 Photograph and infrared thermography image during the rework process: (a) photograph of the BGA components; (b) infrared thermography image

The heat dissipation of the BGA components on the PCBA during rework was confirmed using infrared thermography. Brighter colours indicated warmer temperatures with more heat and infrared radiation emitted, whereas darker colors indicated lower temperatures with less heat and infrared radiation emitted. As a reference for the infrared thermography photos, photographs of the BGA components on the top PCBA side throughout the rework process were shot with a standard camera as shown in Figure 6 (a). Figure 6 (b) shows the bright yellow colour of the heat source, which came from the hot air nozzle indicating a surface temperature of 293.1 °C. The same colour can be observed on the side of adjacent components from the rework location.

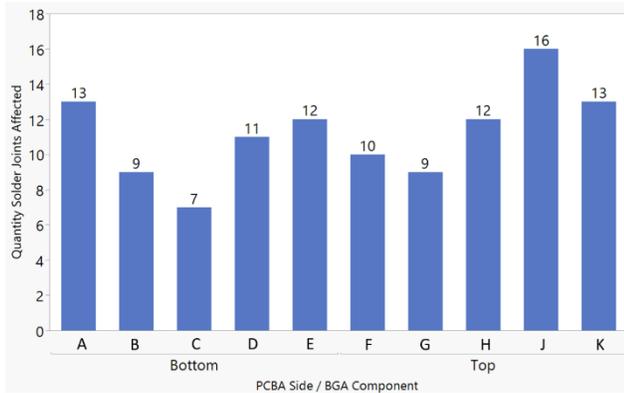
Figure 7 Bar chart on the quantity of solder joints affected by dye penetration due to solder crack

Figure 7 depicts the quantity of solder joints affected by dye penetration on the BGA components for both the top and bottom PCBA sides due to the solder joint crack. The solder joints of the BGA component on the top PCBA side were more impacted than the bottom PCBA side. BGA component J located on the side of the rework component was the most impacted by the solder crack. This is due to the top PCBA side has been exposed to the concentrated heat from the hot air nozzle. Tang *et al.*, (2018) stated that thermal reflows pose a high risk of damaging nearby BGA components' solder joints during rework [22].

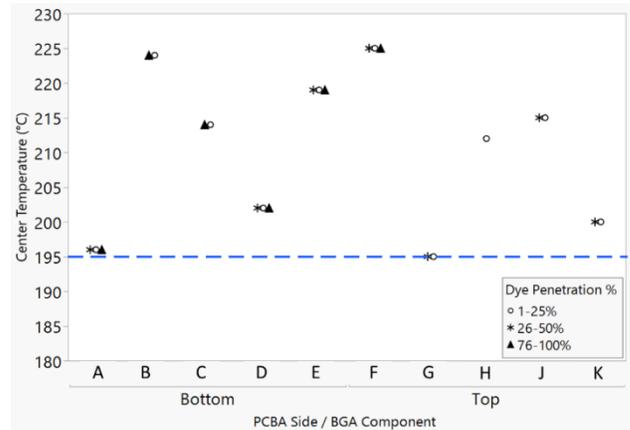
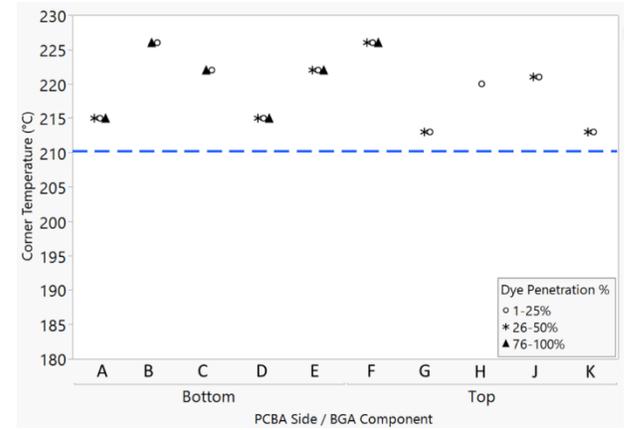
Figure 8 Dye penetration % with the effect of temperature differences at the BGA component area: (a) centre of the BGA components; (b) corner of the BGA components

Figures 8 (a) and (b) show the dye penetration % severity and related to the surrounding component's centre and corner temperatures. Dye penetration of more than 76% mostly occurred on the bottom PCBA side except for the BGA component F on the top PCBA side since it was located on the side of the rework component location.

When the centre temperature of the adjacent components from the rework location exceeded 195 °C, dye penetration of 76 % or higher occurred. Once the corner temperature of the adjacent BGA component reached above 210 °C, similar results were obtained. These findings were also in line with Jiang *et al.*, (2019) who found that temperature load has a substantial impact on solder joint quality and reliability, potentially inducing crack damage [23].

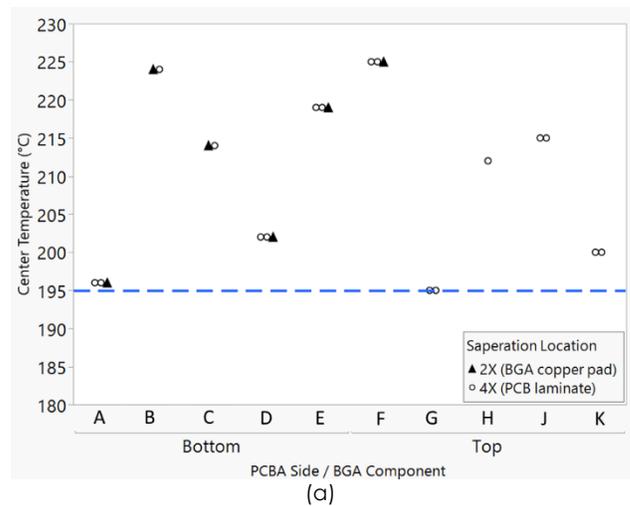
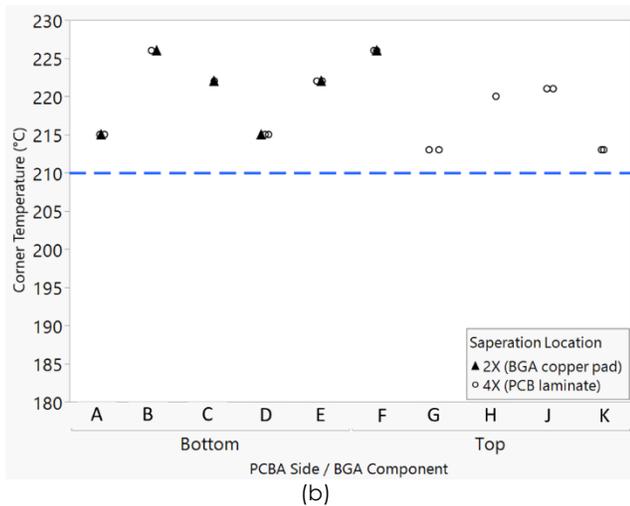
Figure 9 Separation location with the effect of temperature differences at the BGA component area: (a) centre of the BGA components; (b) corner of the BGA components

The interaction between the temperature on the centre and corner of each adjacent BGA component and separation location after the D&P test is shown in Figures 9 (a) and (b). The bottom PCBA side has the largest solder joint separation locations at the copper pad on BGA (2X) except for BGA component F on the top PCBA side. If the adjacent component's centre temperature exceeds 195 °C, separation at 2X was likely to occur. When the corner temperature of each adjacent BGA exceeded 210 °C, an identical observation was made. Xu *et al.*, (2020) reported that due to the thermal exposure, cracks can be found on the solder joints close to the copper pad on BGA [24].

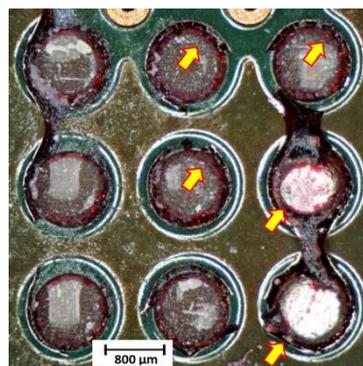
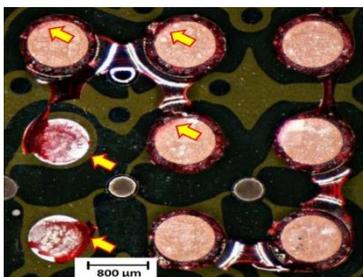
Figure 10 D&P result post hot air rework: (a) PCBA side; (b) BGA component side

Figures 10 (a) and (b) show D&P test results for post hot air rework. The photos were taken from the top corner of the F BGA component section, which was located near the U1 rework component. This section focuses on nine of the 132 solder joints on a BGA component. The dye penetration coverage represented the affected solder joints because of the crack occurrence, according to the observations. Because of the hot air rework, five out of nine BGA solder joints were affected.

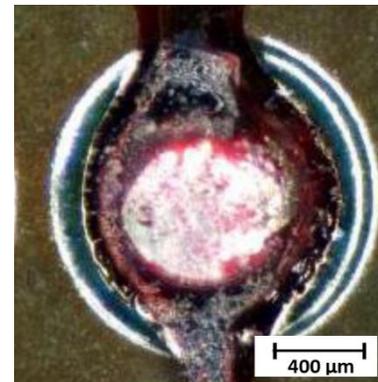
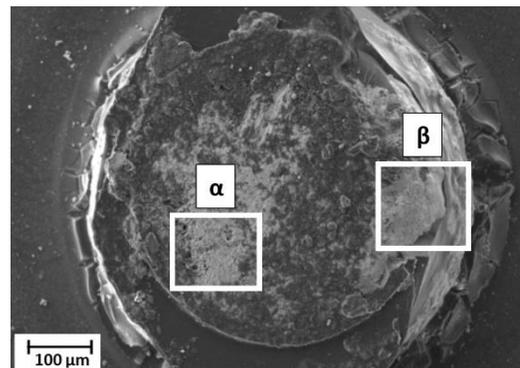
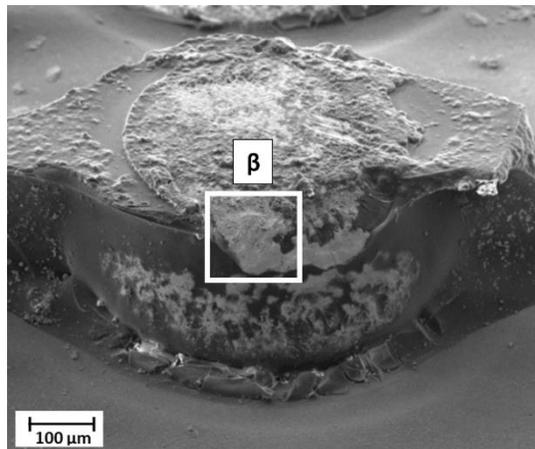
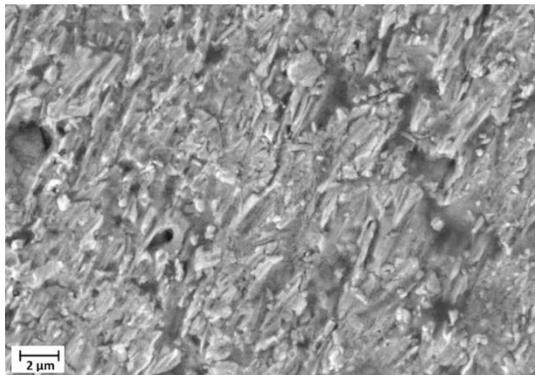
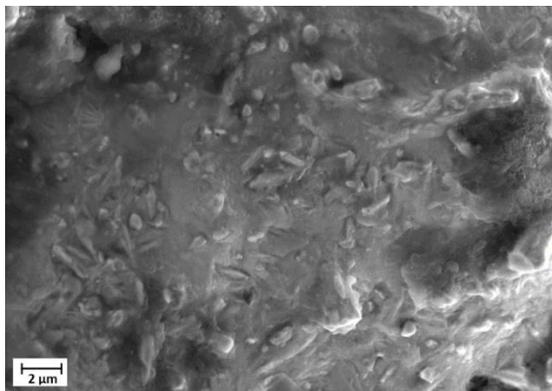
Figure 11 Close up look at PCBA side of dye penetration: (a) optical microscope image; (b) SEM image from top; (c) SEM image from isometric view; (d) elongated surface (a); (e) intergranular surface (β)

Figures 11 (a-c) show solder joint separation locations at the PCBA side along with their SEM image. The rounded surface indicates a separation from the IMC layer (β), whereas the flat surface indicates a separation near the bulk solder (a). The SEM image shows two different surface topographies: an intergranular surface (β) with dye penetration and an elongated surface (a) fracture with no dye penetration as shown in Figures 11 (d) and (e). The image of the intergranular surface shows no signs of severe plastic deformation, indicating a brittle fracture that generates an unstable crack that quickly propagates, allowing the dye to penetrate. The elongated surface has spherical dimples, which are indicative of a ductile fracture. This is consistent with the findings of the Nourani and Spelt (2015) investigation, the brittle fracture surface was flatter and smoother, resulting in a progressive change in the crack route from the bulk solder to the brittle IMC.
