An Experience of Ageing on XLPE Insulation

W. G. Ariastina^{a*}, A. I. Weking^a, I. N. S. Kumara^a, I. A. D. Giriantari^a, I. N. Sugiarta^b

A case study of ageing on XLPE conductor insulation of 20kV primary distribution feeder is presented in this paper. The insulation degradation mainly occurred around conductor tie where the conductor is attached to the post insulator. A section of distribution feeder with defects on the conductor insulation has been examined for this study. Potential losses due to presence of discharges have been investigated by measuring the difference current at locations of the affected conductor. Temperature measurements of the insulation surface have also been carried out. Provisional maintenance procedures were introduced to eliminate the discharges. Measurements of current and surface temperature were repeated nine months after completion of the maintenance work. Results indicated that the discharges have been completely disappeared.

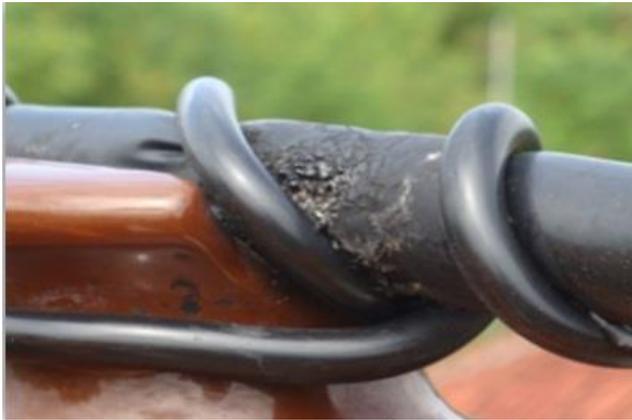
Nevertheless, after a few years of utilisation, problems began to appear on the insulation of the AAAC-S. It was found that the XLPE sheath degrade rapidly, particularly near the insulator tie. Tiny sparks at the degraded sheath section can be observed clearly at night, indicating the occurrence of discharges. Visual observation of the conductor insulation during day time showed burnt sections around the conductor tie. At some sections, the XLPE sheath has been completely disappeared. This situation obviously requires immediate attention and appropriate maintenance measures.

Figure 1 shows a part of degraded insulation of the conductor. The conductor is attached to the top of a post insulator and is tied using a polymer string. It is clear that the XLPE insulation of the conductor has been burnt thus reducing its insulating capability. This condition is as a consequence of the occurrence of discharges on the conductor section.

Figure 1 Sheath degradation of AAAC-S

Following the identification of the insulation damage, a life maintenance procedure was carried out. This work was aimed to prevent further defect on the conductor strand due to high energy discharges. The work includes tie changed and removal of the affected conductor sheath. Consequently there are some parts of the lines became completely bared at the tie points.

During maintenance of the damaged XLPE sheath, different methods were introduced in addition to removal of the burnt insulation. Polymer strings were used to replace the metal strings for conductor tie. The existence of the electric field on the XLPE sheath was reduced by means of intrusive needles tied on both ends of the strings. This removes the potential difference between the conductor and the strings. It should be noted here that the introduced methods are for experimental purpose only. Although these methods have successfully removed the discharges, more proper and standardised methods must be followed.

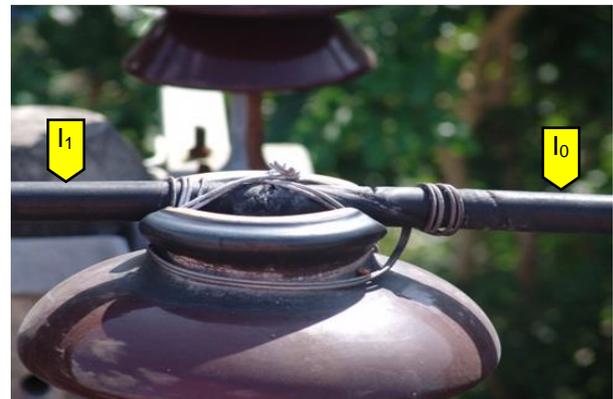
Figure 3 depicts the locations of current measurement near a conductor tie of a section with damaged XLPE sheath. The markers on the picture are for indication only. The exact locations of current measurements were further left and right to accommodate all damaged insulation segments. The clamp meter used to measure I₁ has similar characteristics to that used to measure I₀.

Figure 3 Location of current measurements

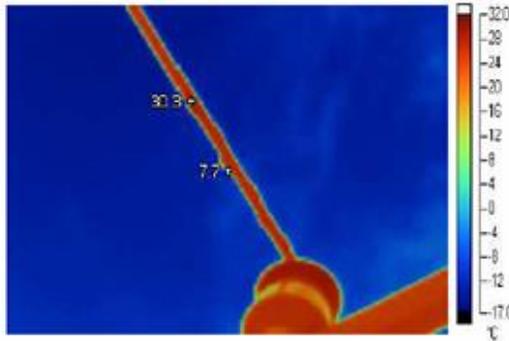
Figure 4 shows a typical image from the utilised thermo vision camera. The camera may identify a temperature variation within the aimed area. The average temperature of the conductor sheath near the discharge locations were recorded for this study.

Figure 4 Typical image from the thermo vision camera

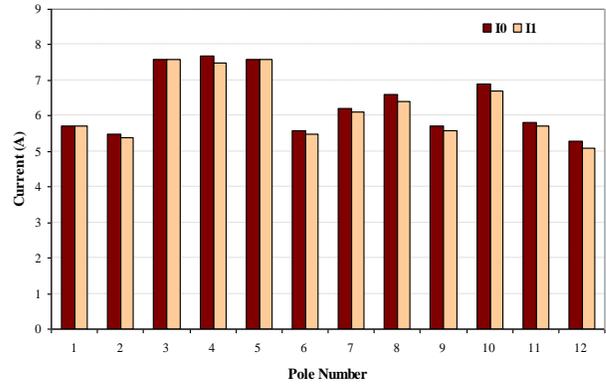
Current measurements were carried out before commencing and after completion of planned maintenance works. The measurements and maintenances were carried out during dry season. The current measurement results of the red, yellow and blue phases for the twelve poles before maintenance are presented in Figure 5 to 7. Bars with darker colour indicate incoming current (I_0), while those with lighter colour indicate outgoing current (I_1). It is clear that the difference current exists which is indicating the potential power loss at most of damaged insulation sections.

Figure 5 Measured current of red phase

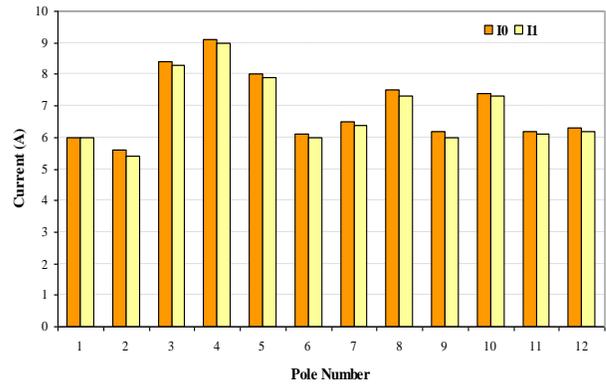
Figure 6 Measured current of yellow phase

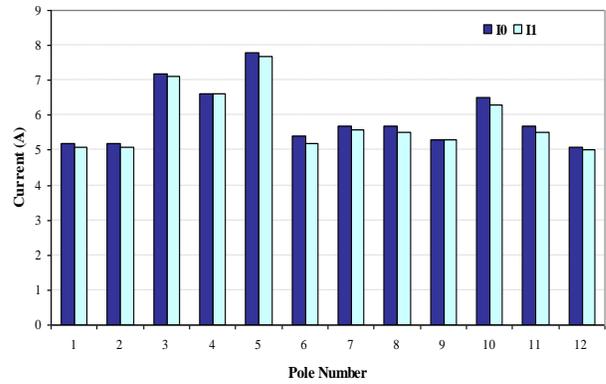
Figure 7 Measured current of blue phase

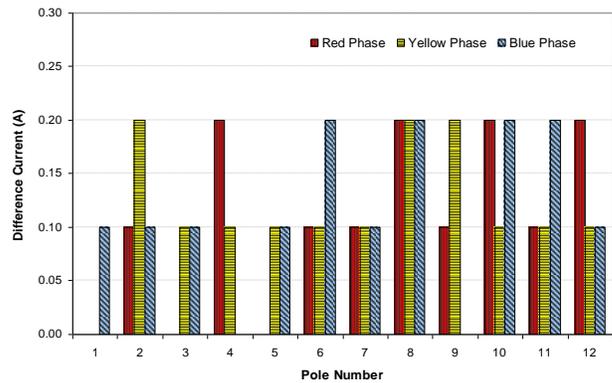
The measured quantity of flowing current on the conductor depends on the load of the remaining part of the feeder at the time of measurement. The magnitude of difference current varies from point to point of measurements, with an average value of 0.108A for the red phase and of 0.117A for the yellow and the blue phases. This evidence is depicted in Figure 8, where less discharge events occurred on the red phase compared to that on the yellow and blue phases.

Figure 8 Difference current measured at the twelve poles

Potential power loss at all phases was identified at seven out of twelve explored poles, while potential power loss at only one phase was discovered for one pole. This fact indicates that the insulation damage occurred around conductor tie at all the investigated twelve poles. The results also designate that at 91% of the total number of poles, the insulation ageing involves two or more phases.

Following the identification of defects on the XLPE insulation, immediate life maintenance works were carried out to prevent further defects on the conductor. Measurements of the flowing current were repeated after completion of the maintenance. There was no indication of difference current during the second measurement.

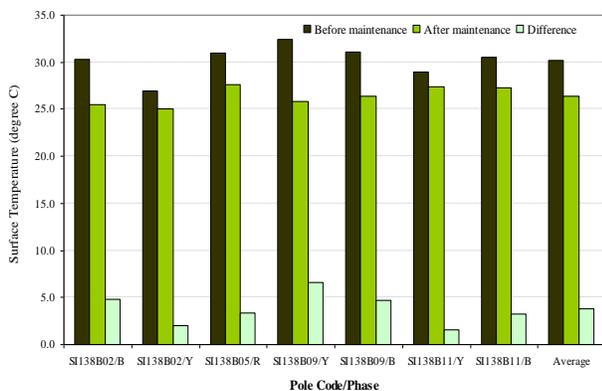
Figure 9 shows the surface temperature of the XLPE sheath before and after maintenance works at a number of investigated poles and particular phases. Note that not all defect points were measured for surface temperature. Measurements were carried out randomly on poles with an identification number of 2, 5, 9 and 11, as shown in the figure. The average temperature of the XLPE sheath surface near defect locations (before maintenance) is slightly above 30°C. In contrast, after completion of the maintenance works, the approximate average XLPE sheath surface temperature became 26.5°C. There was a reduction of about 3.5°C in surface temperature of the XLPE sheath after maintenance process was completed.

Figure 9 Surface temperature of the XLPE sheath
