An Experience of Ageing on XLPE Insulation

A case study of ageing on XLPE conductor insulation of 20kV primary distribution feeder is presented in this paper. The insulation degradation mainly occurred around conductor tie where the conductor is attached to the post insulator. A section of distribution feeder with defects on the conductor insulation has been examined for this study. Potential losses due to presence of discharges have been investigated by measuring the difference current at locations of the affected conductor. Temperature measurements of the insulation surface have also been carried out. Provisional maintenance procedures were introduced to eliminate the discharges. Measurements of current and surface temperature were repeated nine months after completion of the maintenance work. Results indicated that the discharges have been completely disappeared.

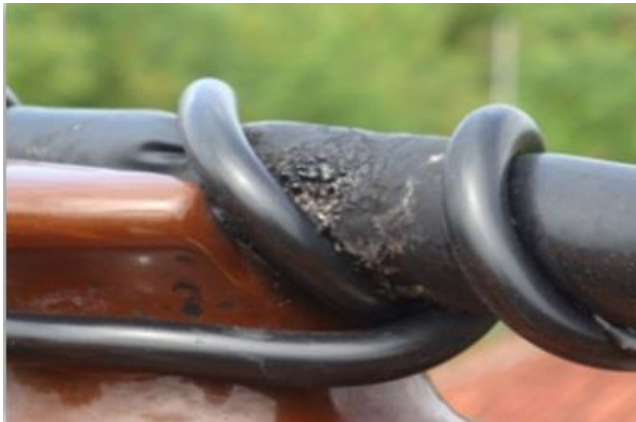
XLPE sheath degrade rapidly, particularly near the insulator tie. Tiny sparks at the degraded sheath section can be observed clearly at night, indicating the occurrence of discharges. Visual observation of the conductor insulation during day time showed burnt sections around the conductor tie. At some sections, the XLPE sheath has been completely disappeared. This situation obviously requires immediate attention and appropriate maintenance measures.

Figure 1 shows a part of degraded insulation of the conductor. The conductor is attached to the top of a post insulator and is tied using a polymer string. It is clear that the XLPE insulation of the conductor has been burnt thus reducing its insulating capability. This condition is as a consequence of the occurrence of discharges on the conductor section.

Figure 1 Sheath degradation of AAAC-S

Following the identification of the insulation damage, a life maintenance procedure was carried out. This work was aimed to prevent further defect on the conductor strand due to high energy discharges. The work includes tie changed and removal of the affected conductor sheath. Consequently there are some parts of the lines became completely bared at the tie points.

During maintenance of the damaged XLPE sheath, different methods were introduced in addition to removal of the burnt insulation. Polymer strings were used to replace the metal strings for conductor tie. The existence of the electric field on the XLPE sheath was reduced by means of intrusive needles tied on both ends of the strings. This removes the potential difference between the conductor and the strings. It should be noted here that the introduced methods are for experimental purpose only. Although these methods have successfully removed the discharges, more proper and standardised methods must be followed.

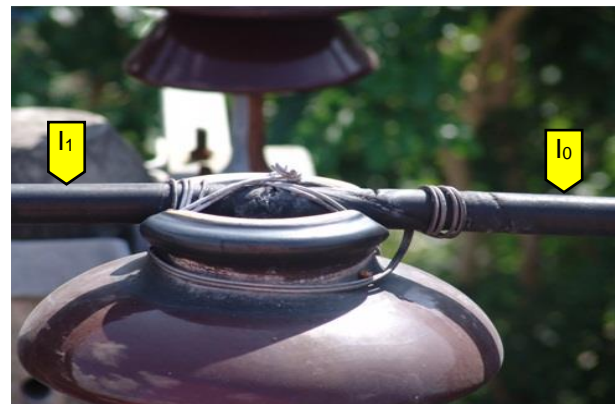
Figure 3 depicts the locations of current measurement near a conductor tie of a section with damaged XLPE sheath. The markers on the picture are for indication only. The exact locations of current measurements were further left and right to accommodate all damaged insulation segments. The clamp meter used to measure I₁ has similar characteristics to that used to measure I₀.

Figure 3 Location of current measurements

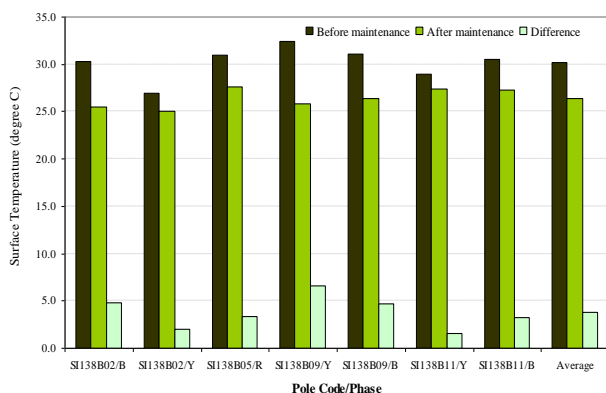
Figure 9 shows the surface temperature of the XLPE sheath before and after maintenance works at a number of investigated poles and particular phases. Note that not all defect points were measured for surface temperature. Measurements were carried out randomly on poles with an identification number of 2, 5, 9 and 11, as shown in the figure. The average temperature of the XLPE sheath surface near defect locations (before maintenance) is slightly above 30°C. In contrast, after completion of the maintenance works, the approximate average XLPE sheath surface temperature became 26.5°C. There was a reduction of about 3.5°C in surface temperature of the XLPE sheath after maintenance process was completed.

Figure 9 Surface temperature of the XLPE sheath
