## APPRAISAL OF MOISTURE PROBLEM OF INHERITANCE BUILDING ENVELOPE ASSEMBLIES VIA VISIBLE AND INFRARED THERMOGRAPHY METHODS

Ting Siew Jing<sup>a</sup>, Md Azree Othuman Mydin<sup>a\*</sup>, Nangkula Utaberta<sup>b</sup>

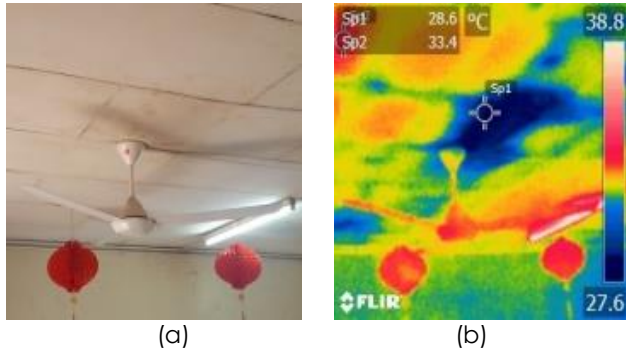
During the day of inspection, a pail of water was accidentally poured on the floor in the room above. The water seeped through the ceiling and leave water stain on the ceiling, which can hardly be seen in Figure 2a.

**Figure 2** Ceiling at the ground floor main hall: (a) visible; (b) infrared thermal image

It is possible that there are cracks on the ceiling, but exact position of the cracks cannot be identified. In the thermal image, signs of moisture, which are indicated in dark blue colour, can be clearly seen in Figure 1b. The application of infrared thermal imaging camera helps the researcher to identify the location of leakage on the ceiling.

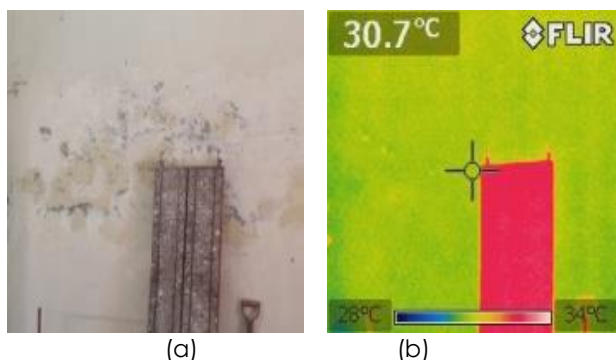
In Figure 3a, peeled-off paint on the wall can be clearly observed. It will usually be suspected that moisture is only present at the defected area. However, in the infrared thermal image, it shows that the particular area have similar temperature as the rest of the wall (Figure 3b). Moisture spots are present in the whole wall, indicated by the blue spots covering all over the wall. The application of infrared thermal imaging camera helps the research to determine the defect more accurately

**Figure 3** Right wall at the courtyard: (a) visible; (b) infrared thermal image

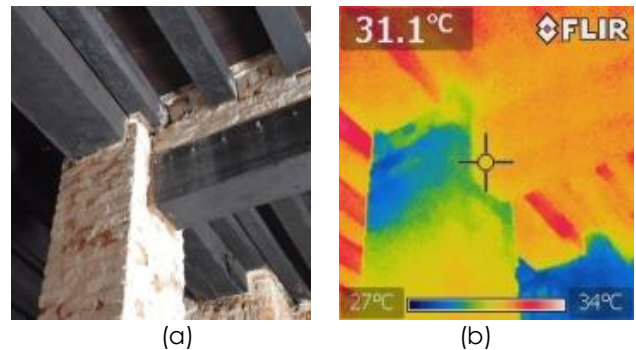
In Figure 4a, the researcher could not detect any sign of moisture intrusion on the column through

observation. When it was further inspected using infrared thermal camera, a clear image of area with lower temperature was shown (Figure 4b). Sign of moisture was detected at the upper part of the column. This indicates the presence of defected insulation in the column as the beams which are in contact with the column shows no sign of moisture. The lowest and highest temperatures detected on the column are 28.7°C and 31.2°C respectively, recorded a difference of 2.5°C.

**Figure 4** Column in the room at ground floor: (a) visible; (b) infrared thermal image

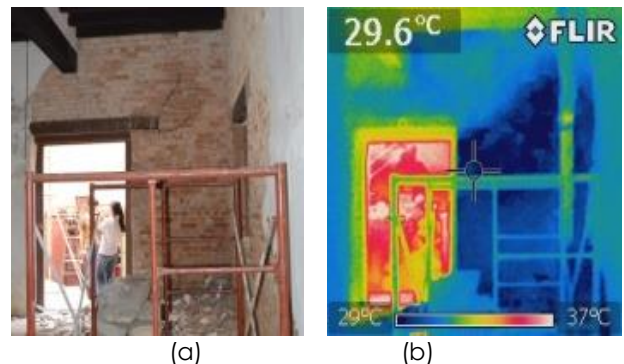
Similar to the aforementioned images, no sign of moisture was observed on the wall in the room, as shown in Figure 5a. With inspection using infrared thermal imaging camera, it shows that moisture presents at the floor-wall joint as well as the middle of the wall (Figure 5b). This may imply the missing of insulation at the particular area and penetration of ground water from the floor. The lowest and highest temperatures detected on the wall are 28.8°C and 32.4°C respectively, recorded a difference of 3.6°C.

**Figure 5** Left wall of the room at ground floor: (a) visible; (b) infrared thermal image

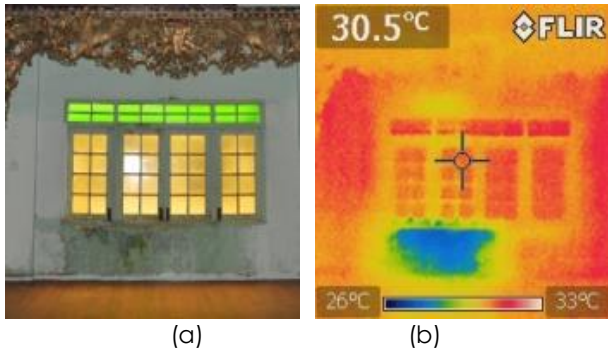
Peeled-off paint was clearly observed on the wall, as shown in Figure 6a. It can be suspected that moisture intrusion appears in the façade. Inspection through infrared thermography method shows that, only a small part of the wall faces moisture problem. Lower temperature can also be detected at the window

pane, which implies that the affected area is caused by seepage of water from the window pane. Generally, the wall has the same colour tone, which is red in colour; however the area around the defected area shows yellowish tone, which depicts that temperature reduces gradually while getting closer to the defected area (Figure 6b). This helps the researcher to identify potential areas where moisture problem may present. The lowest and highest temperatures detected on the wall are 27.9°C and 30.8°C correspondingly, recorded a difference of 2.9°C.

**Figure 6** A wall at the front hall at first floor: (a) visible; (b) infrared thermal image

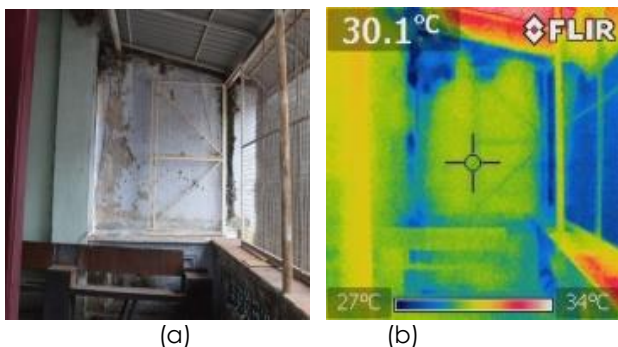
Figure 7a was taken at the balcony at the first floor of the assessed building. Fungus stain was discovered at the corner of the wall which was in contact with the roof. The infrared thermal image (Figure 7b) shows the heat flow in the wall. The temperatures at the corners and sides area are relatively low as compared to the middle of the wall. It can be implied that those areas are consistently exposed to water. Water flows down the roof, gradually penetrates through the building façade. Although the metal sheet roof was exposed under sunlight, signs of moisture could still be detected at the corner of the roof. The lowest and highest temperatures detected on the wall are 27.7°C and 30.5°C respectively, recorded a difference of 2.8°C.

**Figure 7** Left wall at the balcony at first floor: (a) visible; (b) infrared thermal image

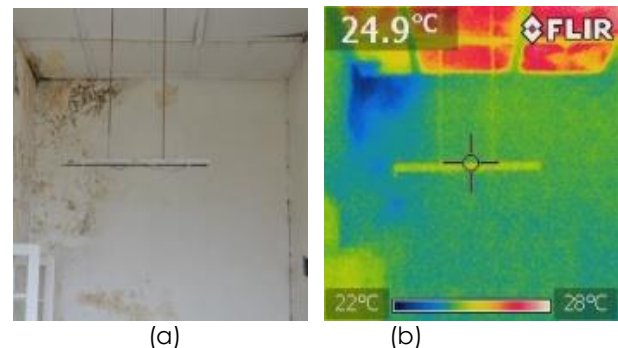
Fungus and water stain at the corner of the wall can be clearly seen in Figure 8a. It is logical to suspect that there are cracks at the ceiling where water flows into the building through the gaps. In Figure 8b, the assumption is confirmed as lower temperature is detected at the connection area between the wall and ceiling. Water vapour is trapped at the corner of the wall and gradually spread to other parts with lower moisture content.

**Figure 8** A wall in the left room at ground floor: (a) visible; (b) infrared thermal image

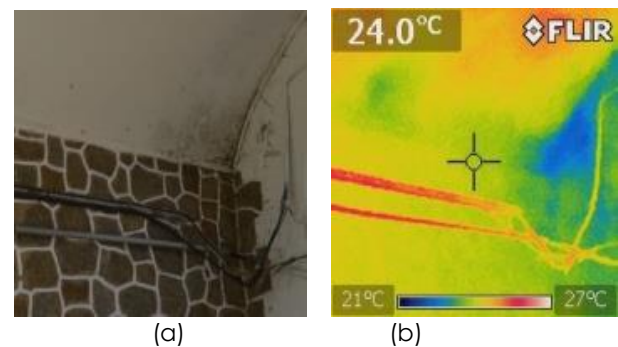
Similar to the aforementioned figure, fungus stain can also be seen at the arch of the main entrance (Figure 9a). External façade has higher potential to be intruded with moisture as it exposes to external environmental conditions more than the internal façade. With the help of infrared thermal imaging camera, the exact location of leakage of water can be determined as can be seen from Figure 9b. The darkest area indicates the lowest temperature detected, which is most probably the location of cracks that causes seepage of water.

**Figure 9** Arch at the main entrance of gatehouse: (a) visible; (b) infrared thermal image
