STUDY OF RISING DAMPNES PROBLEM IN HOUSING AREA IN KLANG VALLEY, MALAYSIA

Muhamad Hanif Hassan^a, Md Azree Othuman Mydin^{a*}, Nangkula Utaberta^b

^aSchool of Housing, Building and Planning, Universiti Sains Malaysia, 11800, Penang, Malaysia

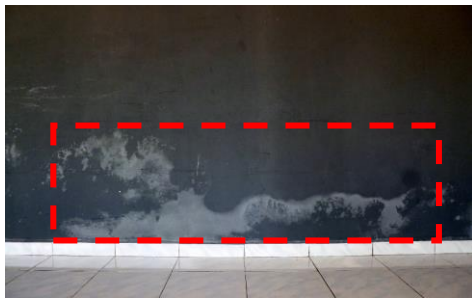
(a) Rising damp clearly seen at the base of the wall

Figure 2 Sign of rising dampness problems

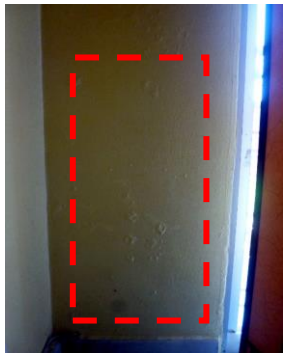
(b) Blistering of paint cause by rising damp

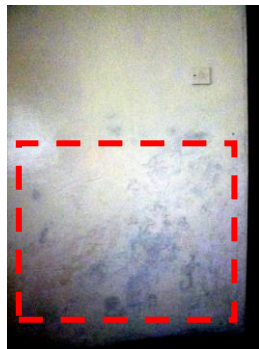
(c) Rising damp affect the internal wall surface

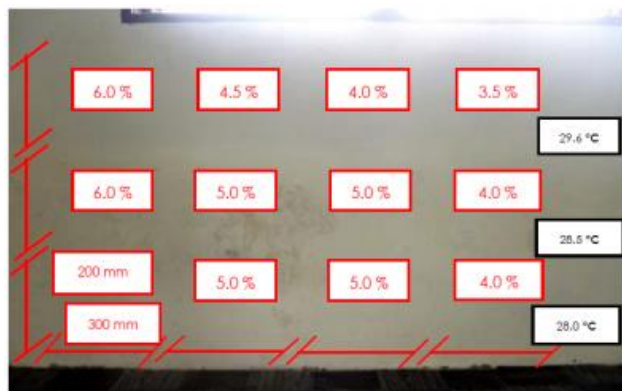
The results were based on the collected data in all the inspected houses. The dampness data was collected by using 200 mm x 300 mm of grid around the affected area with the usage of moisture meter in order to determine the H₂O % concrete and infrared thermometer to determine the temperature of the defect area. Figure 4 shows an example of rising damp data which was obtained using the moisture meter and thermometer.

**Figure 4** Example of rising damp data was obtained using moisture meter and thermometer

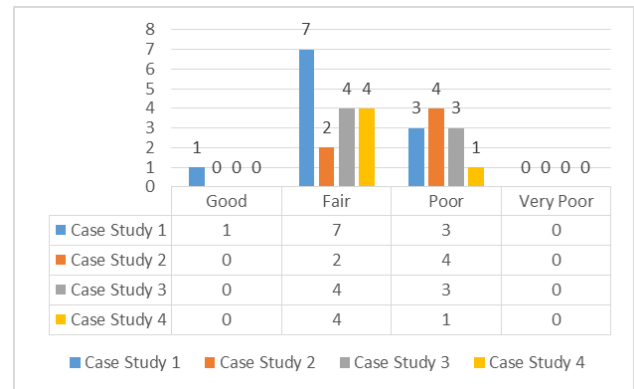
Figure 5 shows the comparison of case study area with dampness rating. A total of 29 rising dampness problem were identified throughout the inspection of all the case study area in Klang Valley. It shows that case study one area have the most number of problems with fair rating. But case study area shows that the most cases of rising damp problem were in poor rating. Most of the fair rating dampness are wall that have stain mark, blistering paint, peeling paint and mould. But the poor rating dampness mostly are wet base wall with "tide mark" or effects from water from the ground that affected by capillary action of

ground water, inadequate ventilation and very humid space.

Figure 5 Comparisons of case study area with dampness rating
