# ASSESSMENT OF BUILDING DEFECTS OF TRADITIONAL TIMBER HOUSES IN PENANG, MALAYSIA

Dayang Sufeane Shuib\*, Faizal Baharum

School of Housing, Building and Planning, Universiti Sains  
Malaysia, 11800, Penang, Malaysia

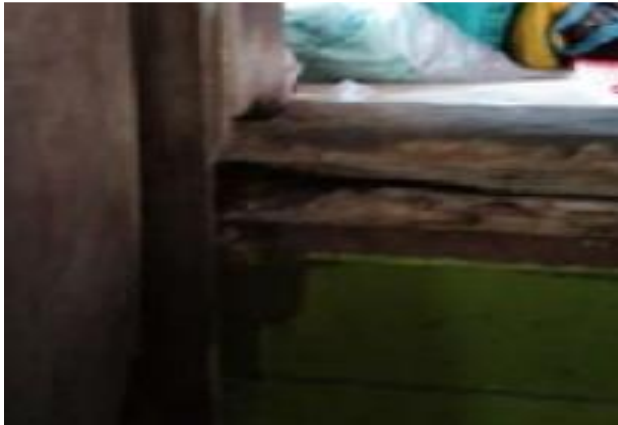
Figures 1 and 2 show deterioration of timber window frame and timber underneath floor slab. There is no excess moisture detect from the laser

moisture. The moisture location 1 (Figure 1) is 7.8 while moisture content for location 2 (Figure 2) is 10.4.

**Figure 1** Deterioration of timber window frame

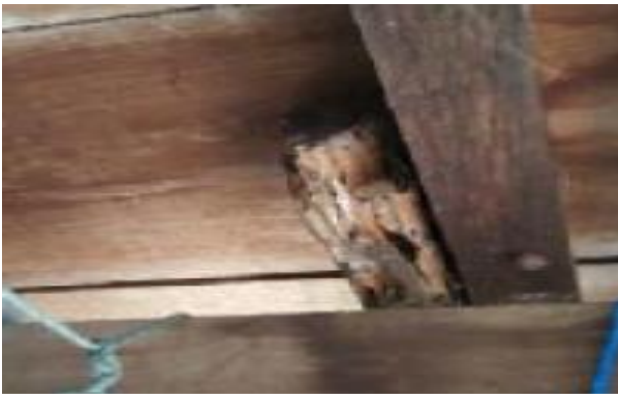
**Figure 2** Decay of timber underneath floor slab

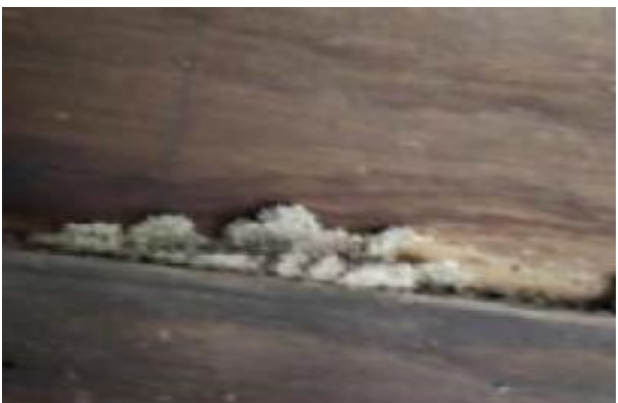
**Figure 3** Termites attack on beams at 1<sup>st</sup> floor

Figure 3 shows termite's effect all over the beam on the first floor. Figure 4 shows insect attack from beetles on timber roof section. All the four examples are out of twelve defects found in the timber house. The result from BARIS, it is specify the timber house one is in FAIR condition with total score 5. No serious defect is found. Only cosmetic defect and minor defects are required repaired works

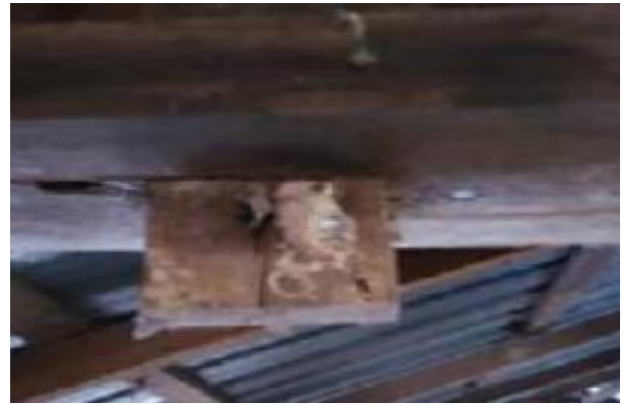
**Figure 4** Insect attack from beetles on timber roof section

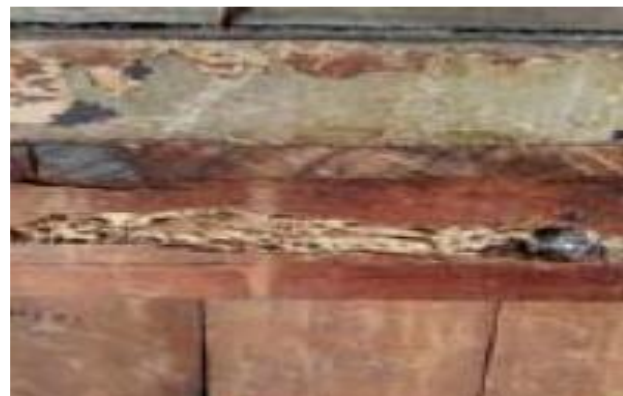
**Figure 5** Deterioration of timber

Figure 5 shows deterioration of timber. It has low presence of moisture content with 10.1. Figure 6 shows scaling of painting at the column. This picture is taken outside of the house. Last but not least, Figure 7 shows discoloration on timber. The colour of the timber is fading and uneven. The total defects found in this traditional timber house two is eighteen. There is one serious defect should be taken urgent repair work. Overall condition for this house is FAIR with total score of 6.

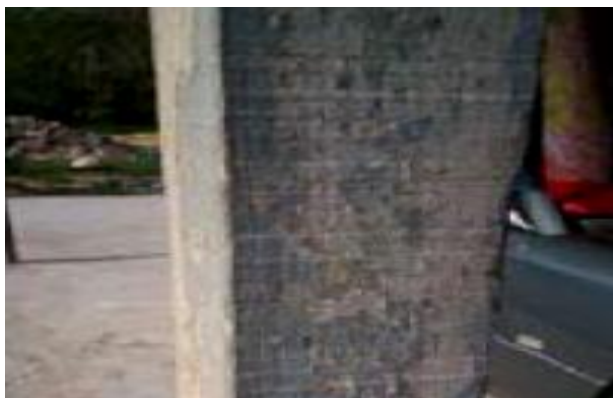
**Figure 6** Scaling of painting at column area

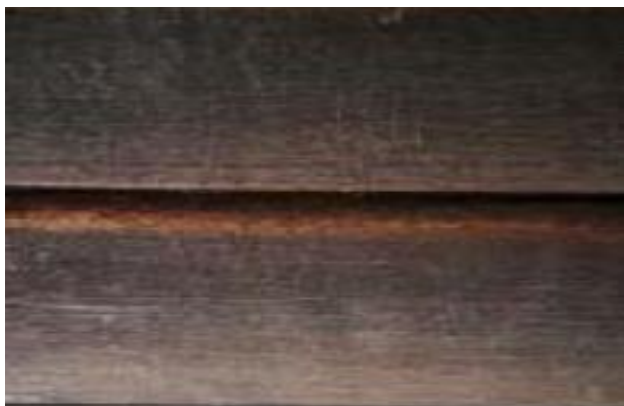
**Figure 7** Discolouration of timber

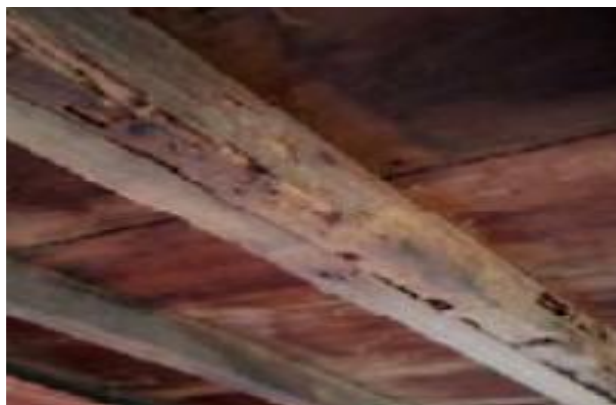
**Figure 8** Deterioration of timber beam

Figure 8 shows deterioration of timber beam inside the house. The defect located at the hall of the house. Most of the hall's beams are decaying. The moisture test shows the moisture presence for is 11.4. Figure 9 shows termites nest which was found on the column area. Figure 10 shows discoloration of timber wall. The picture is taken outside of the house. While Figure 11 shows warping of timber partition which also taken outside of the house. The four examples of defect shown above are out of fifteen defects all together that can be traced in traditional timber house three. The overall condition of the house is FAIR which need some maintenance services. The total score for the house is 6.

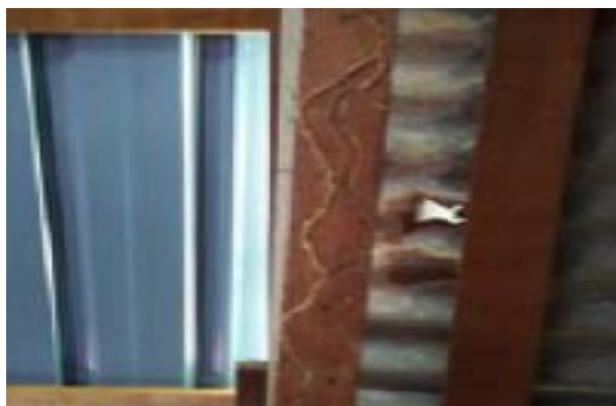
**Figure 9** Termites nest on the column area

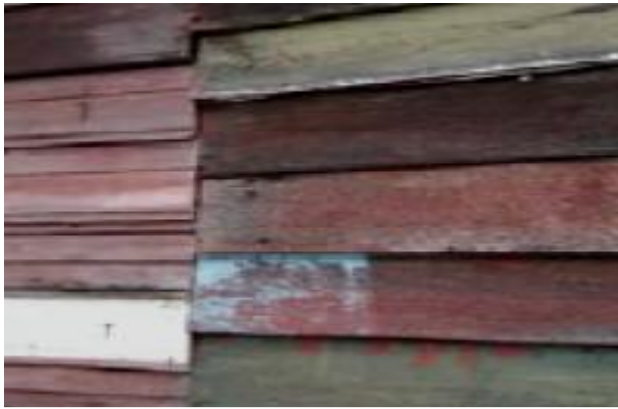
Figure 10 Discoloration of timber wall

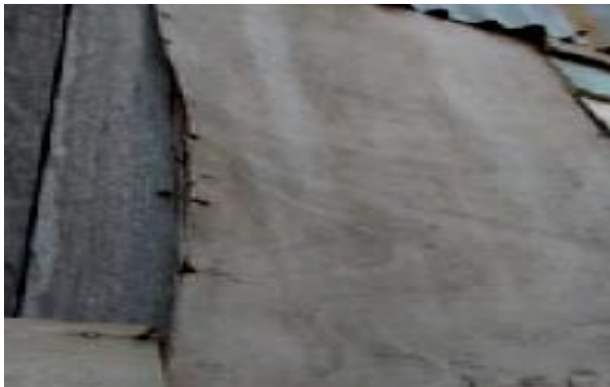
Figure 11 Warping of timber partition
