COMMON BUILDING DEFECTS IN NEW TERRACE HOUSES

Keywords: Building defect, housing, condition assessment, new house, visual inspection

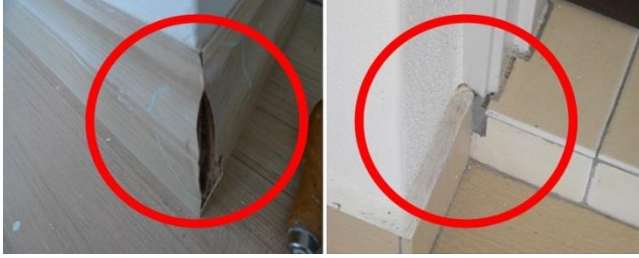
Figure 5 Defects at the wall skirting

The defects at the wall skirting (left) and at the connection between the wall skirting and the door frame (right) can be observed visually without the use of inspection tools. The photograph on the left indicates that the edges of the wall skirting are not aligned. Furthermore, an opening was detected at the joint of the edges. This defect may have been caused by poor workmanship quality and the use of poor building/adhesive materials. The photograph on the right suggests that the connection of the tiles at the joint is uneven and that this defect is the result of poor workmanship quality. Both defects were rated as dilapidated by the matrix assessment (five marks). The defects were also considered to be in need of urgent action (three marks) because they are unacceptable in new houses. Therefore, the defects are classified as dilapidated overall (15 marks).

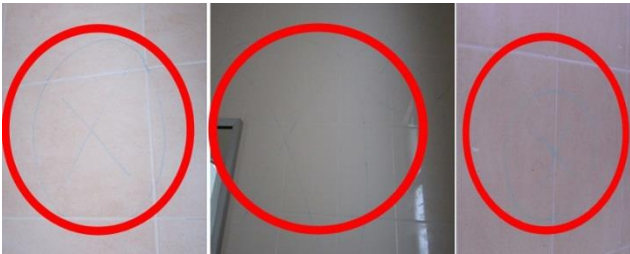
Figure 6 Hollowness in the wall tiles.

Figure 6 depicts the building defects on the walls through photographs. These defects were classified under hollowness; they were not observed visually and could be identified only by tapping a steel rod on the defective areas to produce a hollow sound (a sound different from the norm). This defect is attributed to poor workmanship quality, such as the inaccurate ratio of cement and sand mixture, uneven internal walls, and entrapped air. These defects were rated as dilapidated by the condition assessment (five marks) of a new house. Thus, urgent action (three marks) must be taken. Overall, the defects were classified as dilapidated (15 marks).

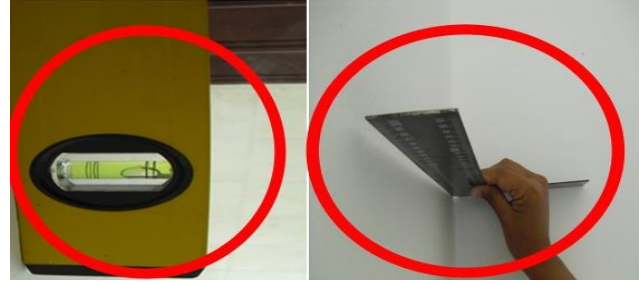
Figure 7 Walls angled incorrectly

Figure 7 displays the wall defects as identified by a spirit level (left) and an L-square (right). The photograph on the left presents a slanting wall that is not at a 90° angle from the floor. The photograph on the right indicates that the angle between the two depicted walls is not 90°, as it should have been, because the wall surfaces are uneven. This unevenness is ascribed to the improper alignment of the brick wall. Both defects were the result of the poor workmanship of the contractor. Although the defects are not harmful to building tenants, the quality is not commensurate with the price paid by the homebuyers, who expect to receive houses that meet the specifications. Therefore, these defects were rated as dilapidated (12 marks). Moreover, the unit is in very poor condition (four marks) and requires urgent action (three marks).

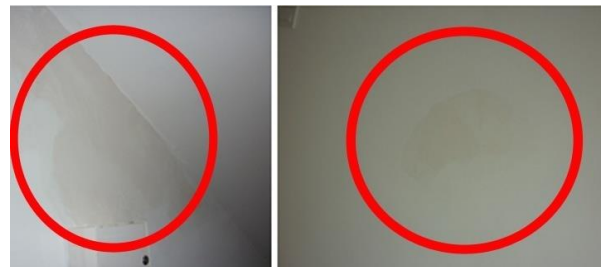
Figure 8 Unevenly applied wall paint.

Figure 8 displays the unevenly applied paint on the walls, which is considered a cosmetic defect. This defect can be observed visually without the use of any tools and may have been caused by poor workmanship quality, including unfinished construction and worker negligence. Although this defect is only cosmetic, it cannot be tolerated as an acceptable standard for new houses. Thus, it requires urgent action (three marks). Moreover, the defect condition was rated as very poor (four marks). Therefore, serious effort must be made to improve the building condition (12 marks).

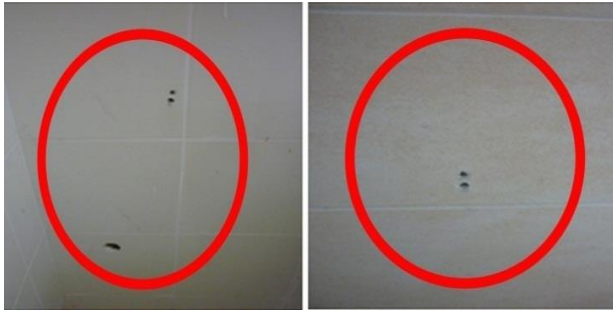
Figure 9 Holes in the wall tiles

Figure 9 exhibits the cosmetic defects in the wall. These types of defects are observed visually and may be caused by installation errors (location) or the carelessness of workers. Furthermore, they are considered serious defects for new houses, which are expected to be defect-free.

The wall tiles are damaged (five marks) and are unacceptable under the current standard (three marks). These defects are therefore rated as dilapidated (15 marks) although they are only cosmetic and cannot result in fatality or injury.

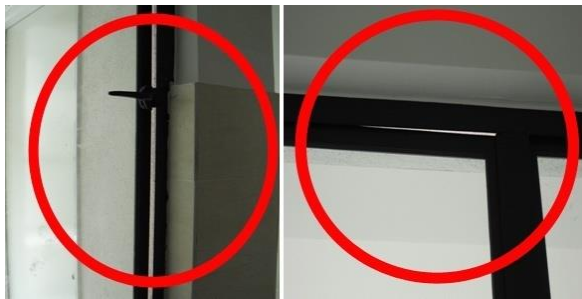
Figure 10 Unacceptable windows

Windows area wall component that connects the internal and external environments. Figure 10 shows the defects detected on the windows; the photograph on the left depicts a window that is difficult to open and close. Although the window remains functional, its functionality is unacceptable at the current standard for new houses; hence, the window is considered defective. The photograph on the right displays the window leaf that cannot be closed tightly. Thus, it displayed a gap. The condition of this window was considered defective because the window failed to function properly. This defect may have been caused by the poor-quality windows supplied by manufacturers. Damage may also have been initiated during installation. Both defects are rated as dilapidated (12 marks) and in very poor condition (four marks). Thus, they require urgent repair or replacement (three marks).

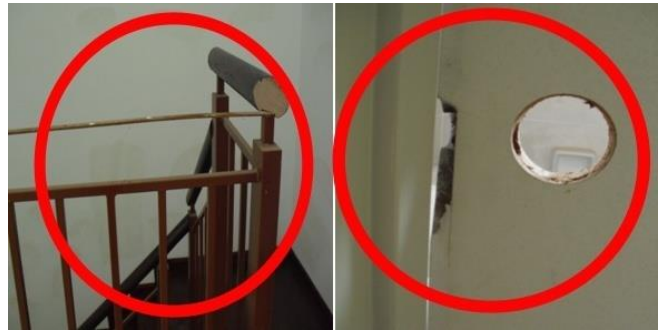
Figure 11 Incomplete construction

Figure 11 displays incomplete construction, which is definitely classified as a defect. The photograph on the left shows that the staircase has no handrails because of incomplete installation. The photograph on the right depicts a door without a knob as a result of the unfinished installation of door accessories. This construction error was caused by employer and worker negligence, and both defects were categorized as dilapidated (15 marks). The matrix assessment rates them as dilapidated (five marks) in condition and regards them as defects in need of urgent replacement (three marks).

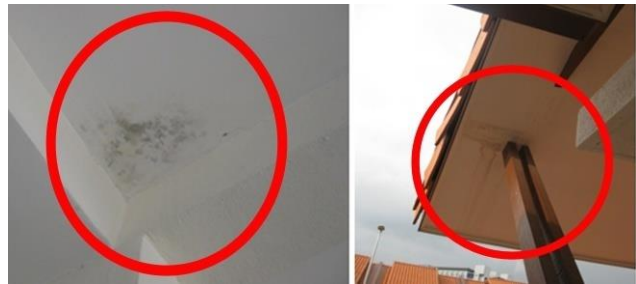
Figure 12 Moisture problem

Figure 12 displays the internal (left) and external (right) dampness to the houses. These defects were attributed to the leakage at the upper component, which exposed the defective components to moisture. The condition may have been induced by either improper installation (roof tiles) or poor material quality, although the main cause is poor workmanship quality. The condition of the defects is very poor (four marks), and the components in question do not function at the acceptable standard (three marks). The defects require serious attention (12 marks).
