ROCK SLOPE ASSESSMENT USING KINEMATIC AND NUMERICAL ANALYSES

This paper presents stability assessment of rock slopes at Jalan Kuari, Cheras, Kuala Lumpur. The site is a disused quarry slope where a low cost residential area of Pangsapuri Intan was built very close to it, frequent instability at the rock slope have been reported. A detailed discontinuity assessment was carried at the site, then, the kinematic and numerical analyses were performed in order to determine the stability of the rock slope. The kinematic analysis was carried out using DIPS 5.0 software and the results showed that about 19% is the percentage of the wedge failure that is encountered for the rock slope. Meanwhile, the finite element method of analysis in Phase² showed that the slope is in stable condition, with the Strength Reduction Factor (SRF) of 2.0. The difference between the results of the kinematic and the finite element analyses is because, the kinematic analysis considered the discontinuities volume and orientations with regards to the slope face, while the finite element, analysed the slope with respect to strength properties. Since the slope is a disused quarry, where previous blasting work had pr

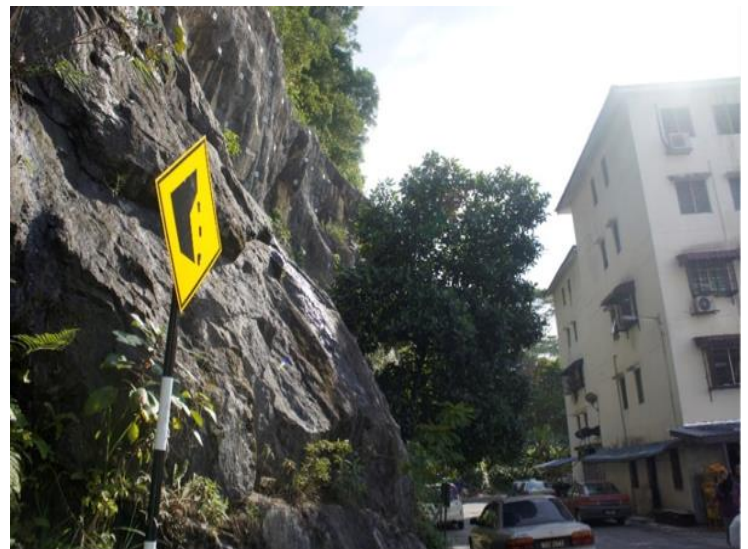
Figure 3 Pangsapuri Intan was built close to the unstable rock slope. (note: the rockfall signboard)

Table 2 summarises the kinematic analysis results, it was found that there is no possibility for planar and toppling failures to occur. The highest risk is due to wedge failure, with 19%. It indicates that there are 62 critical intersections out of a total of 325 mean set plane intersections. However, wedges do not necessarily slide along the line of intersection of two joint planes. Wedges can slide on a single joint plane, if one plane has a more favourable direction for sliding than the line of intersection. In this case, the second joint plane acts as a release plane rather than a sliding plane. This can occur in either the primary or the secondary critical region. As can be seen, there are possible wedge failures on the slope face as well (Figures 3 and 4).

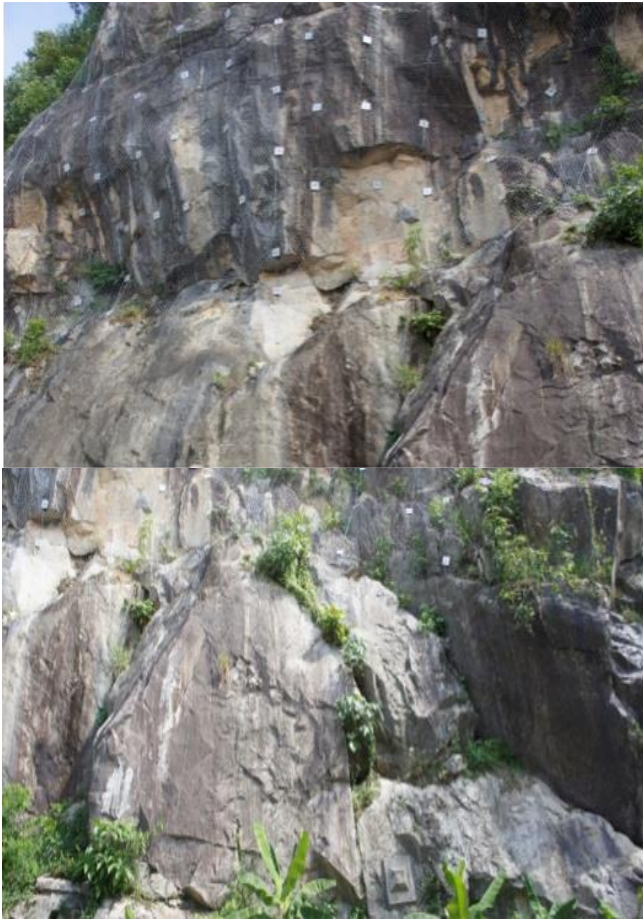
The surrounding rock mass of the slope was investigated carefully. It can be seen, that wiremesh and rock bolt have been installed at certain places on the slope (Figure 4), showing that remedial measure has been carried out at the slope face.

Figure 4 Wire mesh and rock bolt installed on site

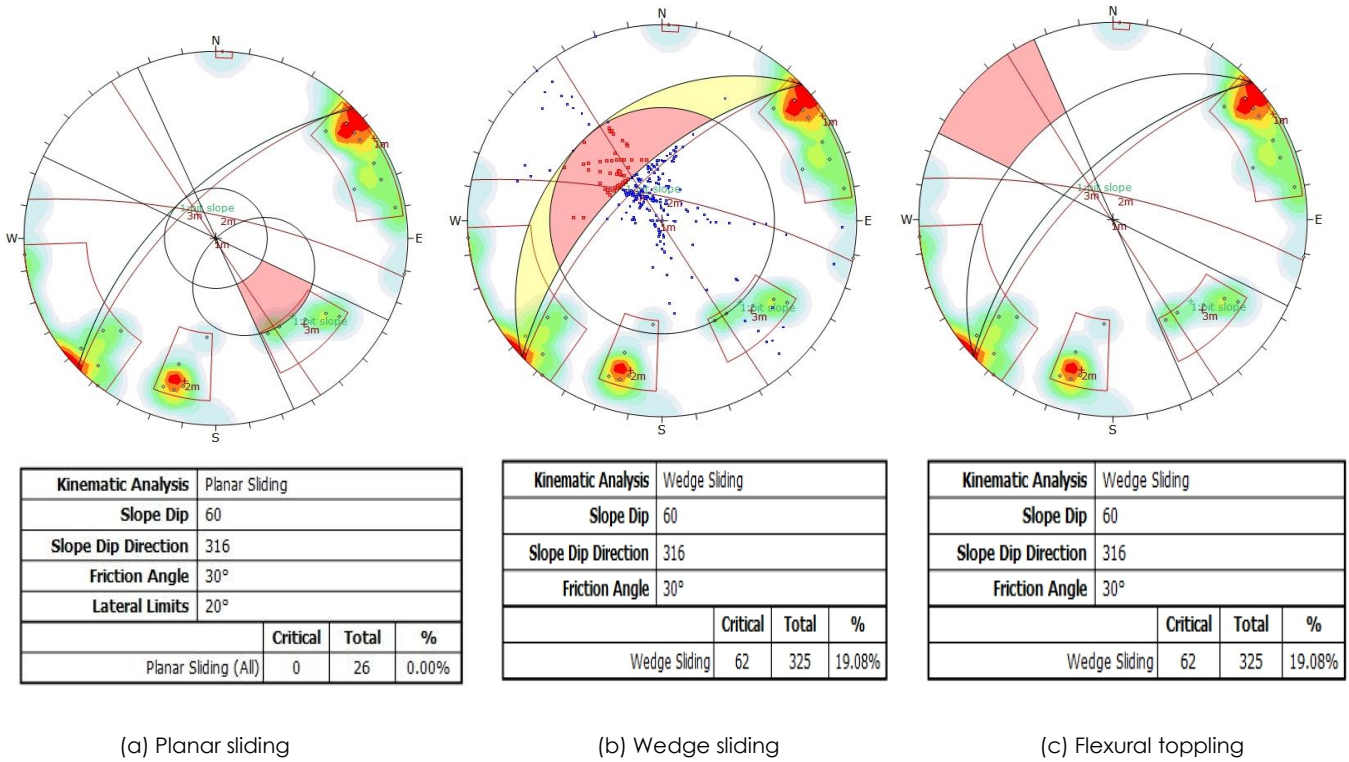
Figure 6 Results of kinematic analyses

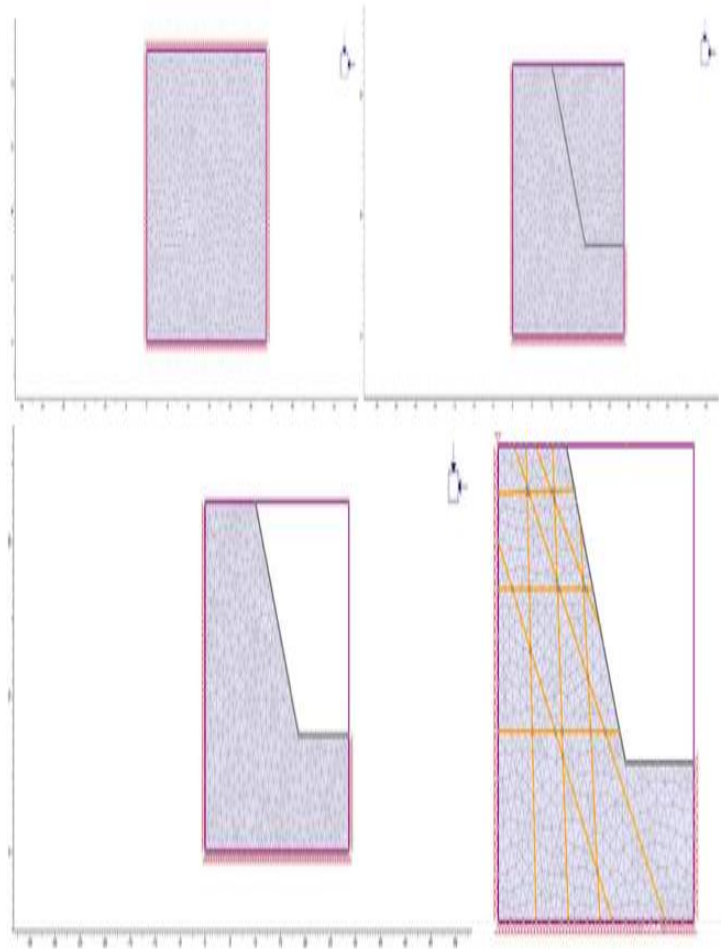
Figure 9 The modelling of the rock slope

| Type of Output | Description | Graphic |
|--|---|---|
| 1.The critical SRF | The critical strength reduction factor (SRF) equals to 2.0 which indicates that the slope is stable. | |
