DEGRADATION ASSESSMENT OF NUCLEAR POWER PLANT EXTRACTION STEAM PIPING AFTER LONG TERM SERVICE

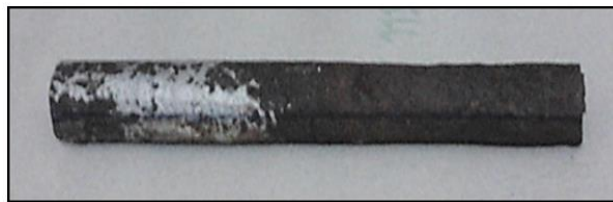
Visual examination shows no disturbance in the uniformity of as received pipe (Figure 2). Whereas, aged pipe shows marked surface corrosion (Figure 3), confirming the long term service in sea shore environment. Corrosion has the potential to reduce a product's design life by premature degradation [23]. Examination of corroded surface under metallurgical microscope (Figure 4) revealed formation of 0.07 mm deep corrosion pits.

Figure 3 SA 106-B Seamless Pipe (Aged)

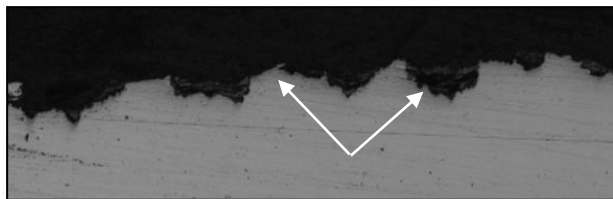
Figure 4 Diamond Polished External Surface of Aged Pipe Sample Showing Corrosion Pits (arrows), 100X

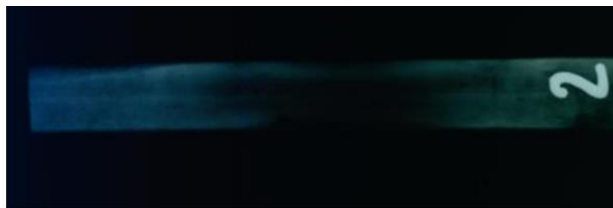
Section of an as-received pipe was subjected to radiographic testing (RT) which revealed no material degradation (figure 5). Radiographic examination of aged pipe revealed the material removal on the internal pipe surface (figure 6). This has occurred due to mechanical rubbing of steam [25] which was being supplied from middle stage extraction of high pressure turbine to deaerator at 0.1 MPa pressure and 250 °F temperature.

Figure 6 Radiograph of Aged Pipe

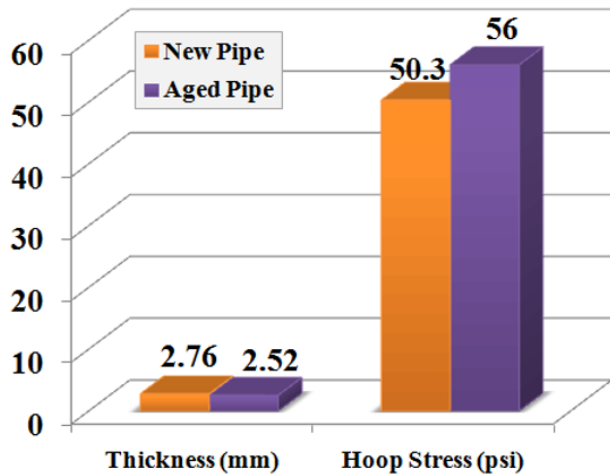
Impinging of high pressure steam causes the material removal from internal pipe surface [25]. Ultrasonic testing has been performed to determine the intensity of erosion; results have been summarised in

figure 7. On average; 8.7% reduction in thickness has taken place from 2.76 mm to 2.52 mm after 12 years of service.

Figure 7 Reduction in Thickness and Increase in Hoop Stress

The hoop stress which acts in tangential direction to the axis of pipe because of the pressure inside the pipe depends upon thickness of pipe [25]. As the pipe degrades and thickness reduces, the probability of pipe failure increases due to increase in hoop stress [25]. Reduction of 8.7% in thickness has increased 11.3% hoop stress upto 0.39MPa, which is very lower than the yield strength of SA 106B (240 MPa) [24] and can not cause any significant deformation.

Piping used in high temperature pressure application degrades with time, so is the case with nuclear power plant's extraction steam piping. Corrosive environment formed 0.07 mm deep pits, whereas mechanical rubbing and impinging of hot and pressurized steam has scratched the internal surface. Reduction of 8.7% in thickness has also occurred due to erosion. This deterioration due to erosion and corrosion can be minimised by using Chrome-Molybdenum-Copper steel pipe with protective coating.

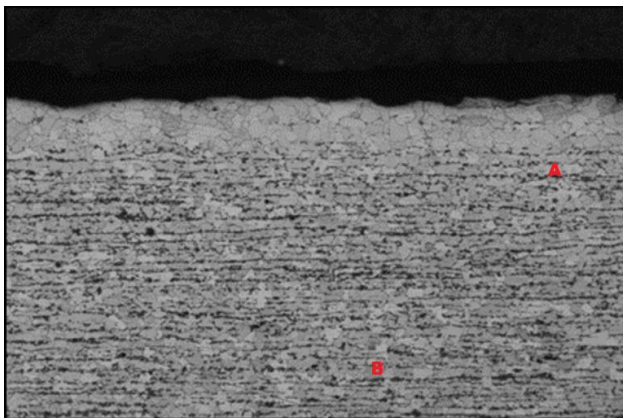
Microstructure of new carbon steel pipe exhibits bands of pearlite and ferrite (see Figure 8); which is typical of the extruded material [27]. Inner surface layer of new pipe is showing decarburized layer up to 0.1 mm occurred during cooling of steel to room temperature after hot extrusion [28]. This anisotropic structure shows poor resistance to impact load.

Figure 8 Nital Etched Microstructure of New Seamless SA 106B Pipe, 100X (A= Pearlite, B= Ferrite)

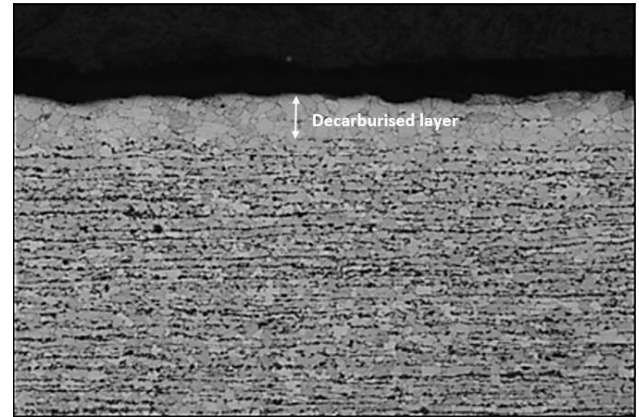
Abrasive action of steam has removed the inner decarburized layer in aged carbon steel pipe (see Figure 9). Prolong exposure to high temperature has distributed pearlite uniformly throughout the matrix and no bands of pearlite and ferrite are present now. Mixture of ferrite and pearlite is more resistant to impact load.

Figure 9 Nital Etched Microstructure of Aged Seamless SA 106B Pipe, 100X

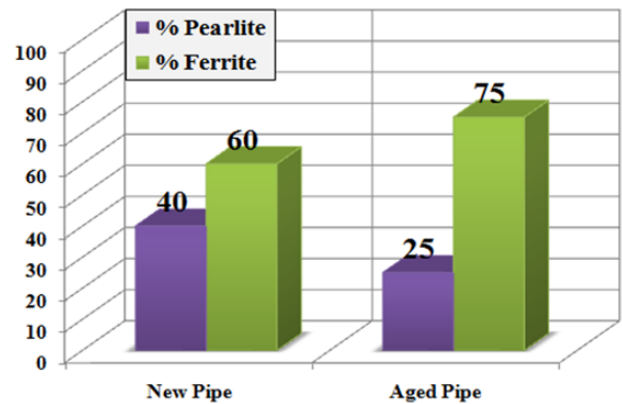
Amount of pearlite and ferrite was 40% and 60% respectively in new carbon steel, which has changed to 25% pearlite and 75% ferrite (Figure 10). Softness is induced with increment of ferrite content, which eventually leads to failure.

Figure 10 Change in Amount of Pearlite and Ferrite Phase after Prolong Service

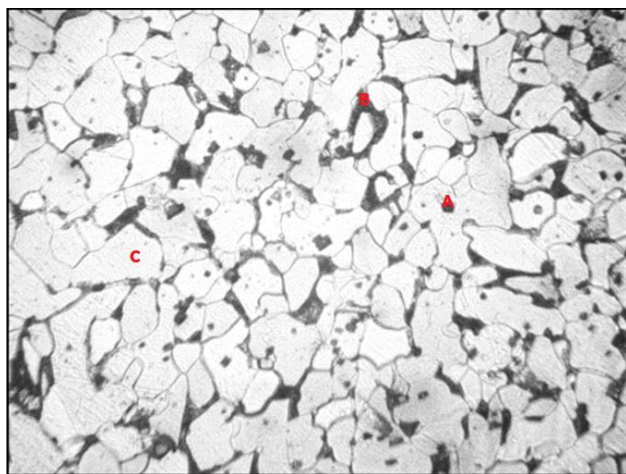
Reduction in pearlite has occurred due to the formation of graphite nodules (see Figure 11) and it is more near inner layer of the pipe, as it has been in direct contact with steam for 12 years. Decrease in amount of pearlite decreases strength and hardness of steel.

Figure 11 Nitral Etched Microstructure of Aged Seamless SA 106B Pipe, 400X (A=Graphite nodules, B=Pearlite, C=Ferrite)

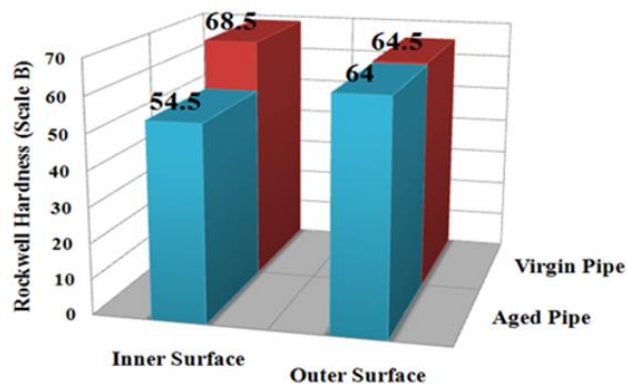
Hardness of the pipe samples has been measured on inner and outer surfaces. Results have been shown in Figure 12. Reduction in hardness of inner pipe surface has found 20%. But on outer surface, it has found 0.7% only. Reduction in hardness is more on inner layer of pipe material because this layer has been directly exposed to hot and pressurized steam.

Figure 12 Difference in Hardness of Virgin and Aged Pipe on Inner and Outer Surface
