CORROSION PROCESSES ON WEATHERING STEEL RAILWAY BRIDGE IN PRAGUE

Viktor Urban*, Vit Krivy, Vojtech Buchta

VSB – Technical University of Ostrava, Faculty of Civil Engineering, Department of Building Structures, 17. listopadu 15/2172, Ostrava Poruba 708 33, Czech Republic

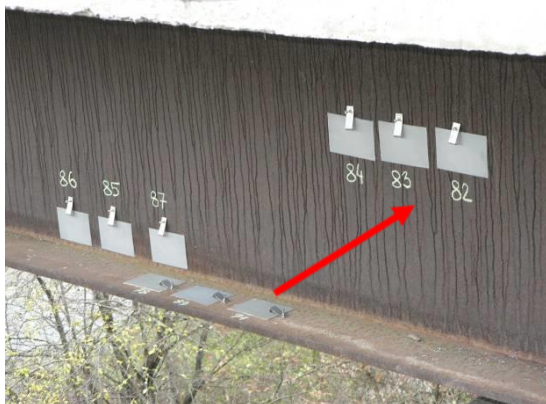
The first three specimens of surface S1 are installed on the external web of the external (northern) main girder close to the western abutment, see Figure 3. This surface is not affected by leaking from drainage system even by the proximity of upper or bottom flanges. The patina development is typical for the whole surface - compact, uniform and visually favourable.

Figure 3 Northern external main girder (external web)

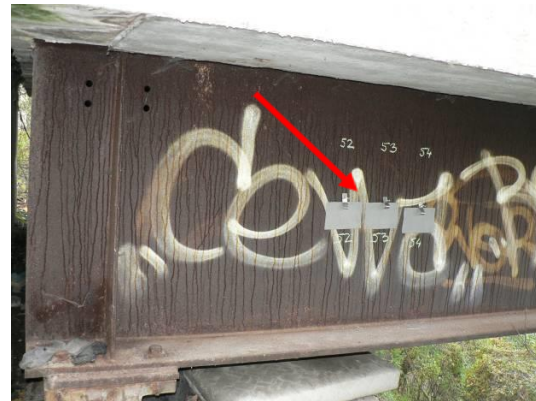
The specimens of surface S2 are installed on the external web of external (southern) main girder close to the western abutment. This surface is not affected by leaking from drainage system even by the proximity of upper or bottom flange, see Figure 4.

Figure 4 Southern external main girder (external web)

The surface is typical for the whole length of the main girder. Patina layer is uniform, compact and visually favourable. The strips resulting from flowing water on the specimen surface (see Figure 5) demonstrate that the methodology truly reflects corrosion processes on the examined structural members.

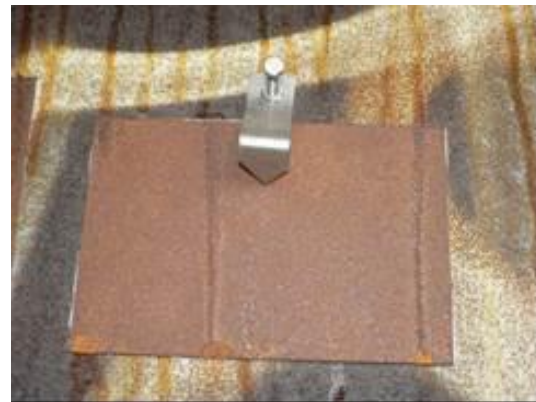
Figure 5 Specimens after one year exposure

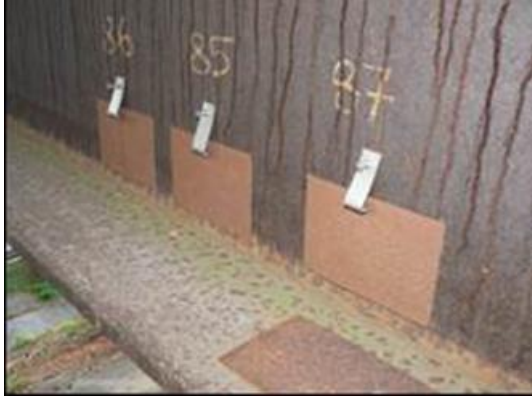
The specimens of selected surface S3 are installed on the external web of external (northern) main girder about 50 mm above the bottom flange. The surface is not affected by water leaking. Visual appearance of patina is typical for given surface, i.e. well-developed thicker and darker patina layer, see Figure 6.

Figure 6 Darker patina layer about 50 mm above the bottom flange on external web of northern main girder

The highest corrosion losses were observed on upper surfaces of lower flanges. The corrosion loss on the external flange is significantly higher than that on the inner flange (the external flanges are generally more influenced by environmental effects). Darker strip of corrosion products on the web close to the bottom flange, see Fig. 6, is only a visual defect and it does not influence the corrosion resistance. The effect of surface orientation (northward vs. southward) is negligible. The results demonstrably show the expected correlation dependence between the measured corrosion losses and the thicknesses of corrosion products, see Figure 7. The correlation factor between both magnitudes is $\rho = 0.98$. The measurement of patina thickness after one-year exposure may serve as a utility for realistic estimation of corrosion rates. The same dependence with high overall correlation factor $\rho = 0.91$ was observed in results from corrosion tests on the road bridge in Ostrava [11] and over the Ostravice River in Frýdek-Místek [12].

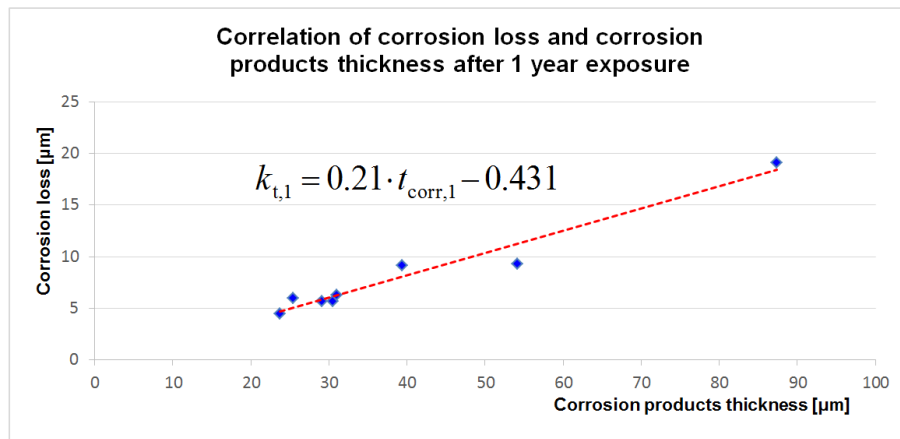
Surface ID	thickness of corrosion products / μm	thickness loss / μm
S1	25,4	6.01
S2	30,5	5.71
S3	29,1	5.67
S4	39,4	9.14
S5	87,4	19.11
S6	31,0	6.25
S7	23,7	4.50
S8	54,1	9.33

**Figure 7** Graphic relationship between the measured corrosion losses and corrosion products thickness
