## **EROSIVE WEAR OF NATURAL GAS PIPES DUE TO HIGH VELOCITY JET IMPACT: PHYSICAL EXAMINATION AND EXPERIMENTAL STUDY**

**Abstract.** A sequential failure of API 5L X42 (NPS8) carbon steel and SDR 17 medium density polyethylene (MDPE) pipes towards the high pressure water pipe was studied. Pipe's failed specimen was physically examined and experimental testing was conducted by using high speed water jetting facility towards a similar NPS8 pipe specimen. High pressure water jet impact from leaked water pipe forms highly erosive water-soil slurry, causing severely damaged on NPS8 carbon steel pipe surface. Thus, it causing substantial losses of pipe coating materials and subsequent rapid thinning of pipe body occurred. Furthermore, weaker ground support causes instability to the MDPE pipe and leads to vertical descend towards high speed gas jet region exerted from failed NPS8 pipe. High impact gas jet physically hit the MDPE pipe at its opposite direction causing its rapid erosion.

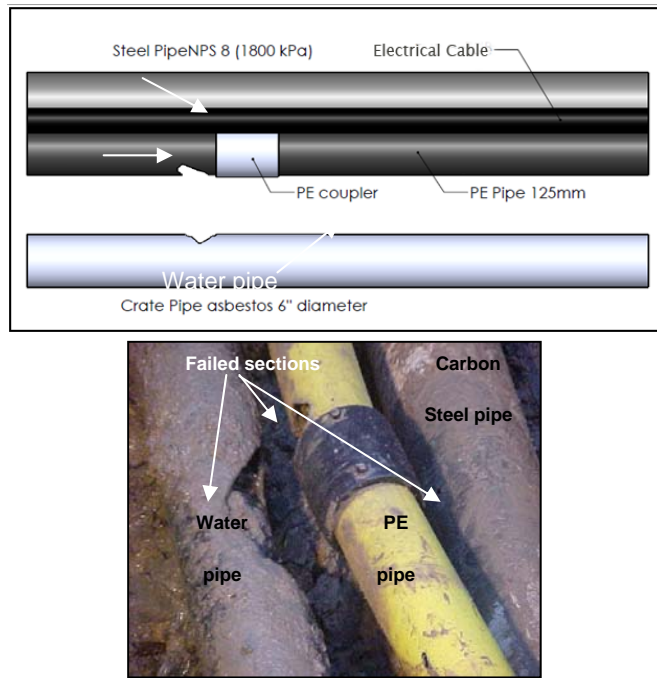
The 8" gas pipe was made of carbon steel, manufactured with stringent specification of NPS8. It was placed around 1.3 m below the ground about 175 mm laterally from the underground water pipe while the water pipe at around 1.2 meter below the surface. The MDPE natural gas pipe is located in parallel with steel and asbestos pipes at a higher position. Comparative positions of the pipes after the excavation and prior (repositioned) to the failure are shown in Figure 2 and 3, respectively.

**Figure 2** Relative positions of steel NPS8, asbestos and MDPE pipes after the excavation

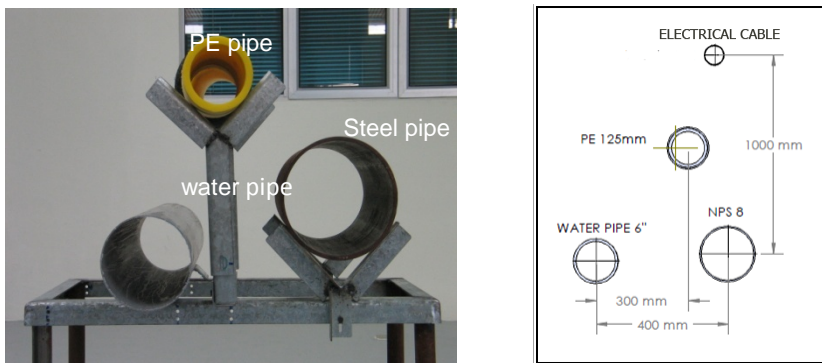
**Figure 3** Reconstruction of relative pipe positions in the laboratory

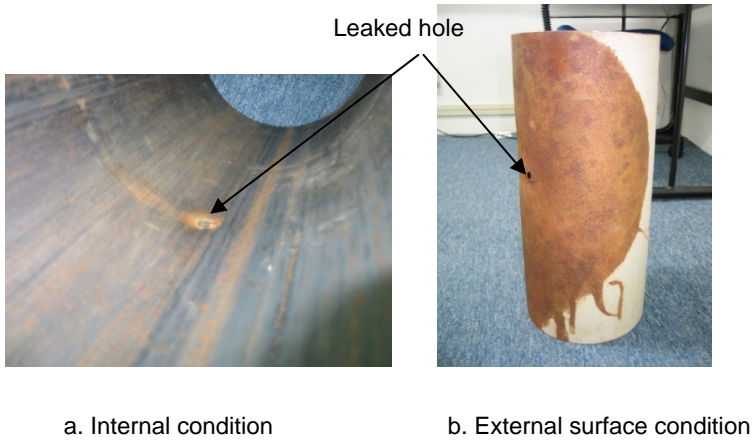
Visual inspections were carried out on both, the photographic evidence and two pipes as shown in Figures 4 and 5. The exposed part of the steel pipe (with the coatings eroded) was heavily oxidized (Figures 4b and 5a). The original condition of the exposed part (Figure 6b) was found free from coating material with clean smooth and shining condition after the incident. However the presence of an erosion marks on the pipe surface in a ripple liked shape (Figure 7a) is similar to the report by Hasan *et al.* [31]. No exhibit of scale or deposit was observed on the inside surface of the pipe thus dismay any indication of internal corrosion.

**Figure 4** Failed specimen of NPS8 gas pipe

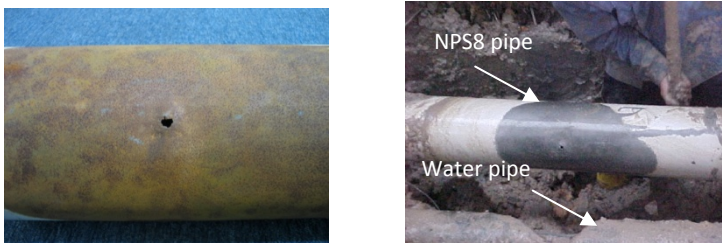
a. Oxidized NPS8 carbon steel pipe indicating leak section      b. NPS8 carbon steel pipe at incident site

**Figure 6** Surface condition of failed NPS8 carbon steel pipe

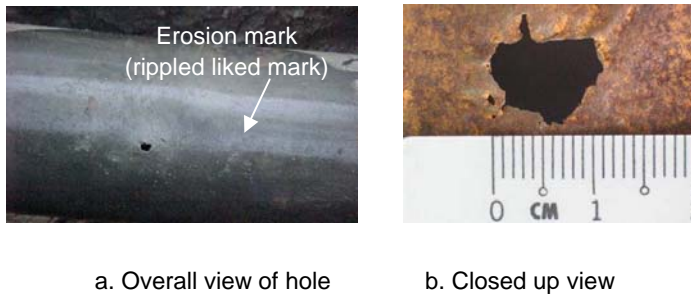
**Figure 7** A 10 mm diameter hole on NPS8 gas pipe wall

A hole with an average diameter of 10 mm was evident in the middle of the eroded part of the carbon steel pipe section (Figure 7a). The eroded part was found to be smooth and free from rust. The size of the eroded section was measured around 50 cm by 30 cm (Figure 7b). The absence of scratch marks or dents in the vicinity of the eroded part seems to support the statement that no third party work was involved within the vicinity of incident location.

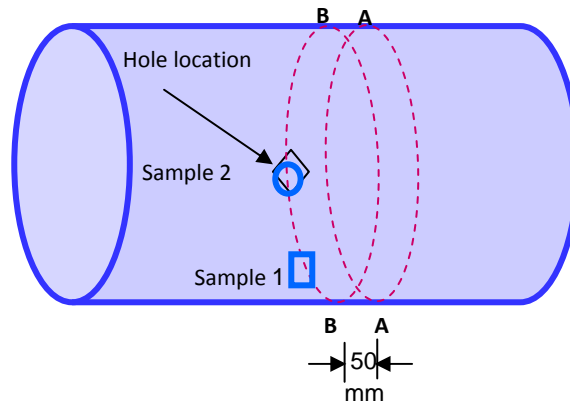
Surface profilometry was conducted using two specimens (A and B) which were obtained from two locations around failure section at about 50 mm apart, schematically shown in Figure 8. Results obtained indicated that the thickness of the metal decreased substantially against the identified leak point as illustrated in Figure 9a for specimen A and Figure 9b for specimen B. Continuous metal losses surrounding the impact area of water jetting had initiating a serious crack growth (pinhole) caused by drastic erosion process. Figure 10 indicates jetting direction and its dispersion against NPS8 pipe wall that had caused erosive wear on pipe wall.

**Figure 8** Thickness mapping areas and specimen locations of NPS8 gas pipe

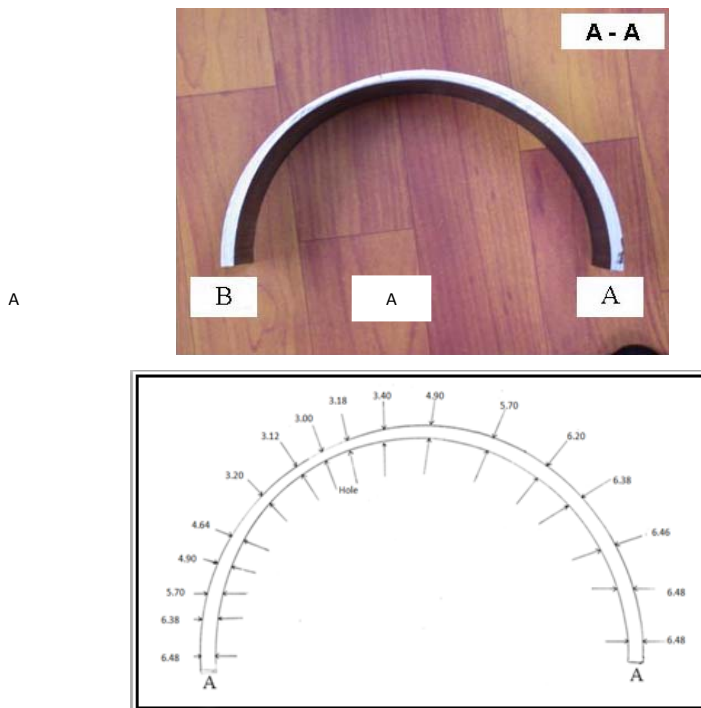
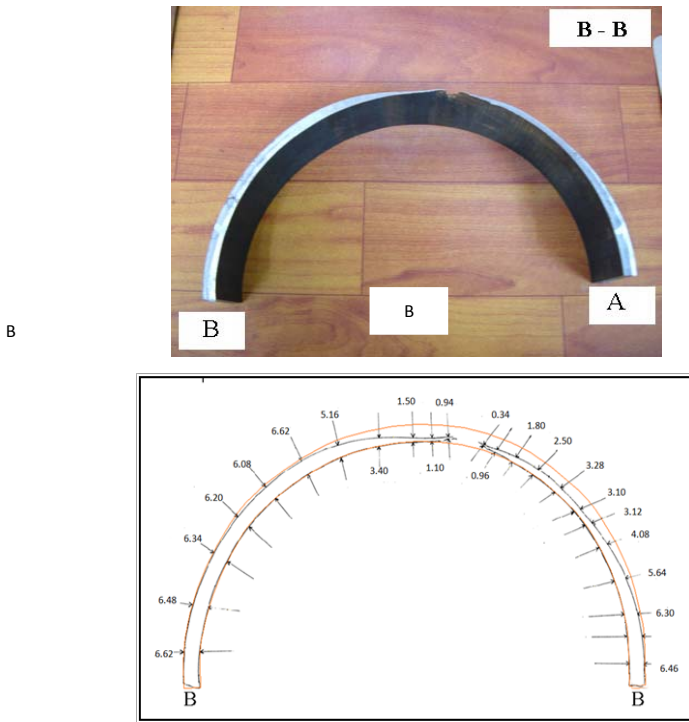
a. Thickness mapping for section A - A (50 mm away from hole)

b. Thickness mapping for section B - B (half way through the hole)

**Figure 9** Thickness mapping of NPS8 gas pipe

Assessment of this results revealed that the thickness of the pipe decreased substantially only at area against to the jetting orifice position. Pipe metal loss has occurred on the area facing directly to the water pipe orifice jet resulting in a hole which increased in its dimensional size with severed metal losses (Figures 2 and 6b). This indicates that the hole was caused by drastic erosion from the failed water pipe buried in the vicinity of the gas pipe. This phenomenon is further explained in Figure 11. By considering the estimated jetting of  $20^\circ$ , it is found that the jetting direction is directly hit the area that had severely experiencing the thickness reduction. The surface pattern was similar with the finding made by H. McL. Clark [12] on cylindrical specimen using slurry pot erosion tester as shown in Figure 12 [32]. There are two peculiar areas that had experienced two different types of wear mechanism. The centre part which is directly hit by the water jetting at high angle where the water is the dominant erosive medium will erode according the deformation wear mechanism. The surrounding areas in the other will erode following cutting wear mechanism. These two types of wear mechanism was proposed by Finnie [13-14], Bitter [15-16], and Neilson *et al.* [33].

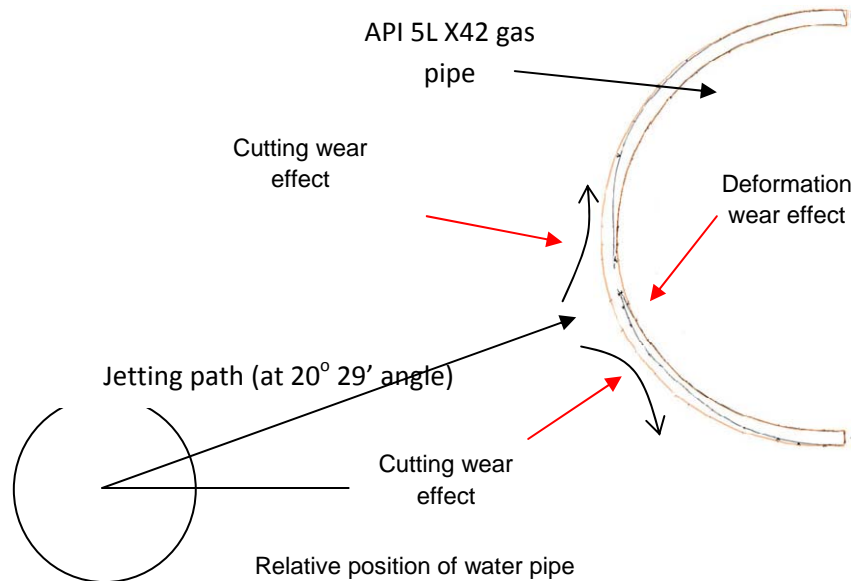
**Figure 11** Rearrangement of pipe surface shows rapid thinning of pipe surface facing toward water jetting

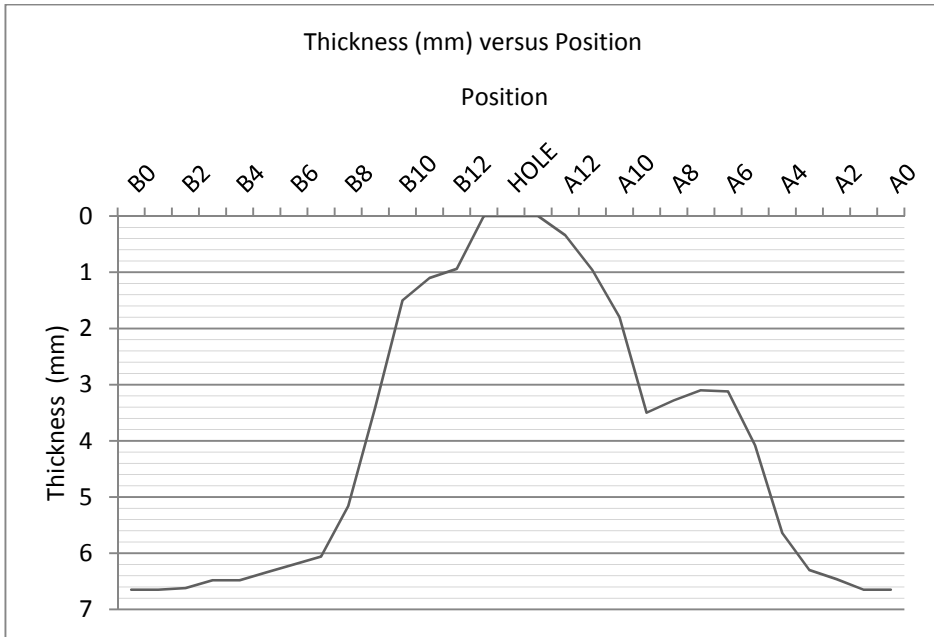
Rapid thickness reduction is also clearly illustrated in Figure 13. Thickness reduction show significant reduction toward the leaked hole. The reduction pattern found to be similar with the wear depth reported by Clark *et al.* [34-35]. As the pipe behaved as a ductile material, it will be eroded through cutting wear mechanism. The estimated jetting angle of  $20^\circ$  which is at low angle just suitable to performed that type of mechanism. This finding is in agreement with study reported by Neilson *et al.* [33].

**Figure 13** A Plot of thickness reduction

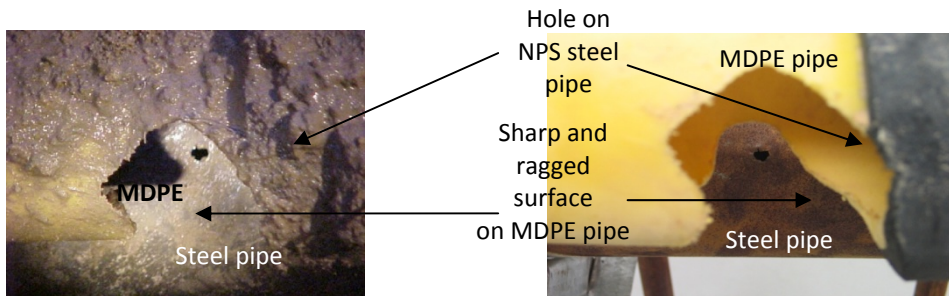
High pressure water jetting from leaked water pipe had earlier caused the substantial displacement of the supporting soil materials underneath the MDPE, shifting downwards. When the steel gas pipe leaked, MDPE pipe was pushed further down until it was low enough to be *‘in the line of fire’* from the high pressure gas jet (Figures 14 and 15).

Visual inspection of the photographic evidence of the incident and the damaged pipe specimens had led to initial conclusion that the most probable cause of MDPE pipe failure was due to high pressure gas jet from NPS8 steel leakage. The continuous gas jet swept the water and suspended sand and silt onto the surface of MDPE pipe causing a '*wet sand blasting*' phenomenon. Similar case was also reported by Hasan *et al.* [31]. This is most evident from the final location of the MDPE pipe relative to the NPS8 pipe leak and the erosion pattern found on the MDPE pipe damaged area shown by Figures 5, 14 and 15. The sharp and ragged surface condition is an evident of high pressure sandblasting effect of gas jet from the leaked NPS8 pipe onto MDPE pipe wall.

**Figure 14** In-situ MDPE pipe relative position directly '*in the line of fire*' NPS8 gas jet

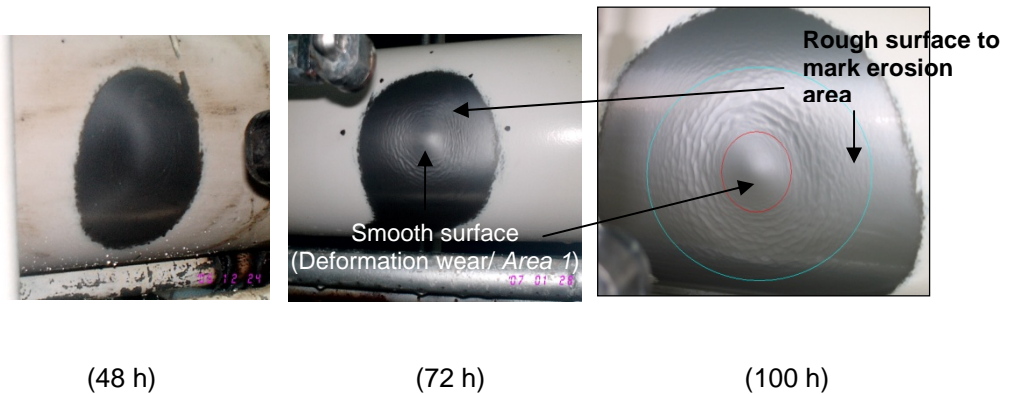
Physical examination of the impacted surface showed that orifice jetting produced significant marking impact on the pipe specimen resembling a rounded shape. One thing peculiar about the impacted surface is that the roughness of the impacted surface is not evenly scattered. This is indicated by the existence of two distinct areas on the specimen's surface, with one being smooth while the other being very rough having rippled like marks. These marks show great similarity with the marks found on the failed pipe section (Figure 7a). Similar marks were found by Hasan *et al.* [31] in his work of consequential rupture of gas pipeline. Figure 18 below depicted a specimen surface after an exposure of 48, 72 and 100 hours respectively to erosive jet impact.

**Figure 18** Specimen surface after impact

Evidence of sand particles mixing with the water jet stream can be seen through the identification of the rough surface (ripple like) on the impact area. Characteristics of the jet reflected by round-shape on the specimen's surface were due to its relative rounded jet outer orifice. Thus, it is concluded that the smooth surface in the middle stream impact area is represented by a smooth rounded area being a result of a horizontal tunneling. The impacted surface confirmed the hypothetic statement of zero sand particles at the point of impact. An impression of a hollow like structure formation from the orifice outlet which resembles a tunnel could be seen clearly in Figure 18. This is

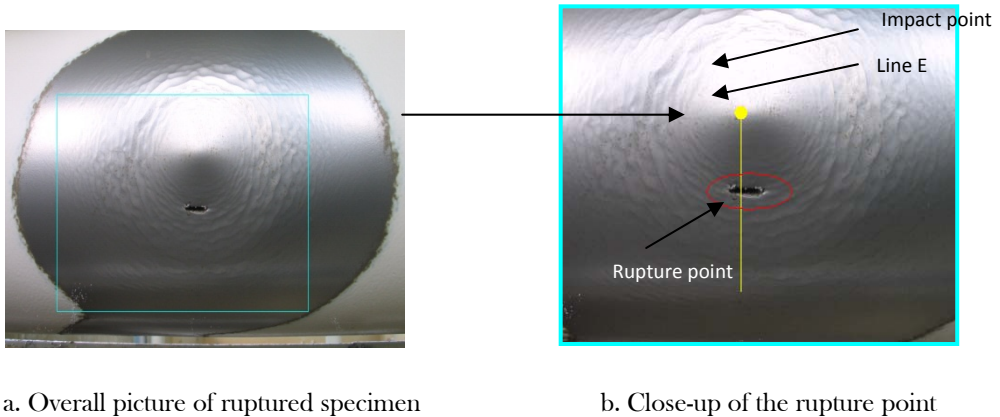
exactly the weakest point of the pipe that initially started a pinch which later becomes evident shown in Figures 4, 6 and 7. This also agreed upon the final ruptured specimen from the experiment shown in Figure 20.

**Figure 20** Picture of ruptured specimen from the experiment
