## **EROSIVE WEAR OF NATURAL GAS PIPES DUE TO HIGH VELOCITY JET IMPACT: COMPUTER SIMULATION STUDY**

**Abstract.** A sequential failures of underground API 5L X42 carbon steel and the SDR 17, 125 mm polyethylene pipes placed side-by-side to a water pipe was studied. Previous study shown that high pressure water jet from leaked water pipe that had mixed with surrounding soil formed water soil slurry with high erosive properties had severely impacted on the pipe surface causing the loss of pipe coating materials. This phenomenon eventually causes rapid thinning of the steel pipe body which later led to its failure. In this study Computational Fluid Dynamics (CFD) and structural analysis were performed to simulate numerically the chronological event of pipeline failure, in comparison with the findings made in the previous study. The structural and CFD simulation results proved that the location, rate and the extent of erosion failures on the pipe surfaces can be well predicted, as compared with actual instances.

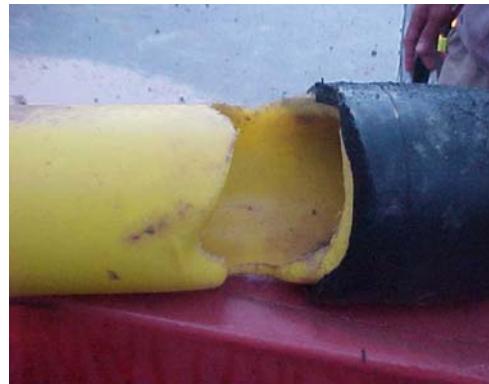
Gas flow leak from PE pipe will not be studied as it was concluded that the PE pipe failed due to gas jet impingement from the steel pipe. Furthermore, due to the very high NPS8 gas jet pressure, the PE was expected to rupture very fast. The failure of the PE pipe should not affect other pipes. Jet flow produced by the PE pipe is considered weak due to the large failure outlet as shown in Figure 2.

**Figure 2** Failed specimen of PE pipe

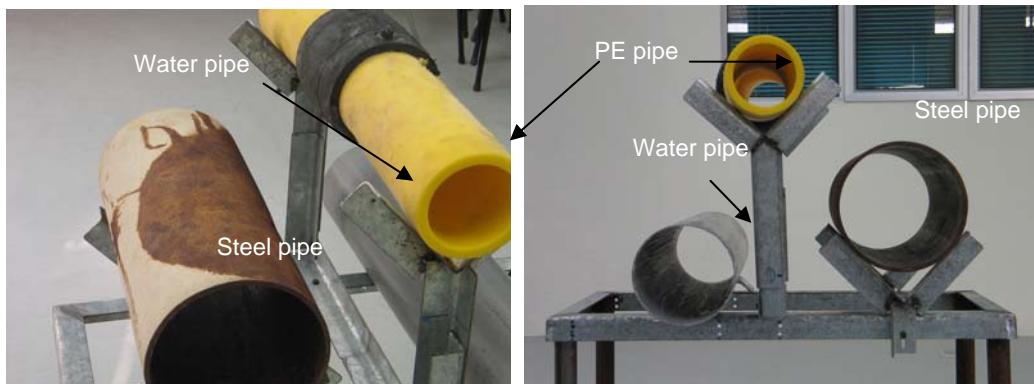
As the water pipe made of asbestos material, its brittle characteristic would cause the pipe to fail instantly. There will be no significant physical outlook left on the failed edge region. However, it was noticed from the photo taken from the site showing the upper part of the asbestos pipe seems experienced more failure than the lower part;

Figure 4 seems to support the hypothesis that the water jet direction is around  $20^\circ$  from the horizontal axis. The exact angle of  $20^\circ 29'$  of jet flow direction is determined through ideal geometrical approach by assuming the jet flow direction is normal to the surface of the outlet (normal impaction) as shown in Figure 5.

**Figure 4** Reconstruction of relative pipe positions (original) for visual inspection

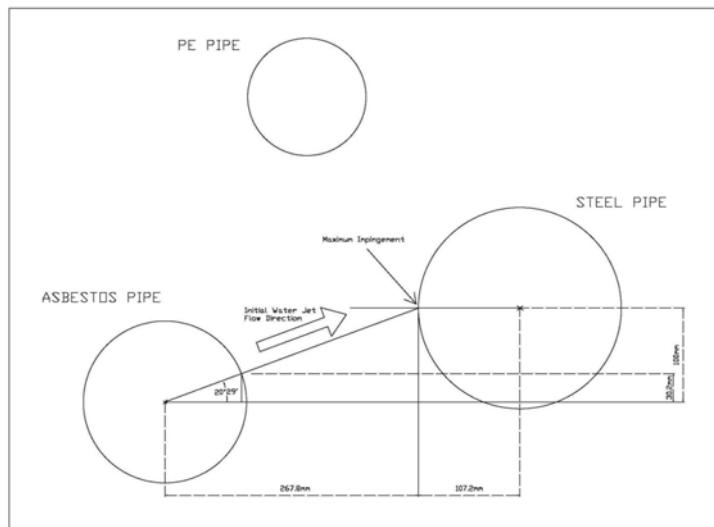
**Figure 5** Water jet leak angle estimation

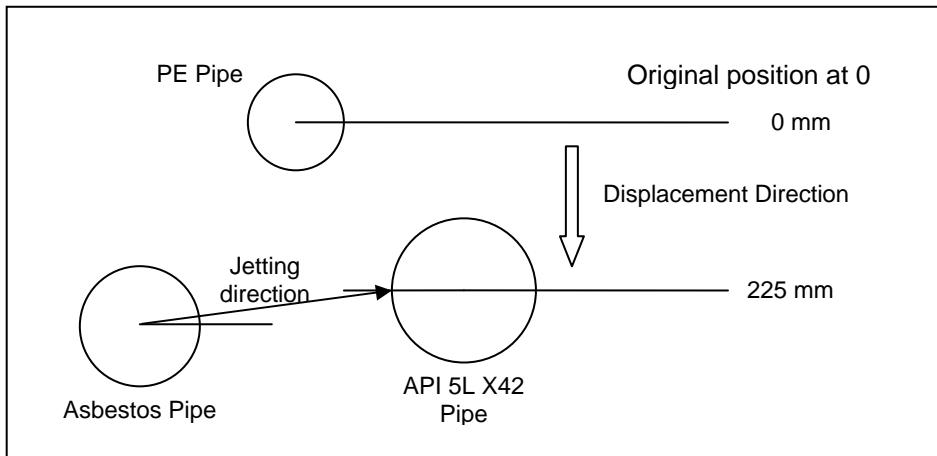
- i. PE pipe vertical position tends to be lowered (moving downward) due to the lack of tangential support.
- ii. As the medium is moving due to the jet flow from water pipe and steel pipe, PE pipe began to drop due the gravitational force and soil weight act on the PE pipe as shown in Figure 6.

**Figure 6** Schematic of PE pipeline displacement

- iii. Water pipe (asbestos) and natural gas pipe (steel) is assumed not displaced due to its physical stiffness.
- iv. Once the PE pipe began to displace, in-equilibrium force acting on the PE pipe will occur.
- v. Expected operating strength of the PE pipe will reduce.
- vi. From the existing design specification and sample of PE pipe, it was expected that the PE pipe would displace vertically around 225 mm away from the original position.

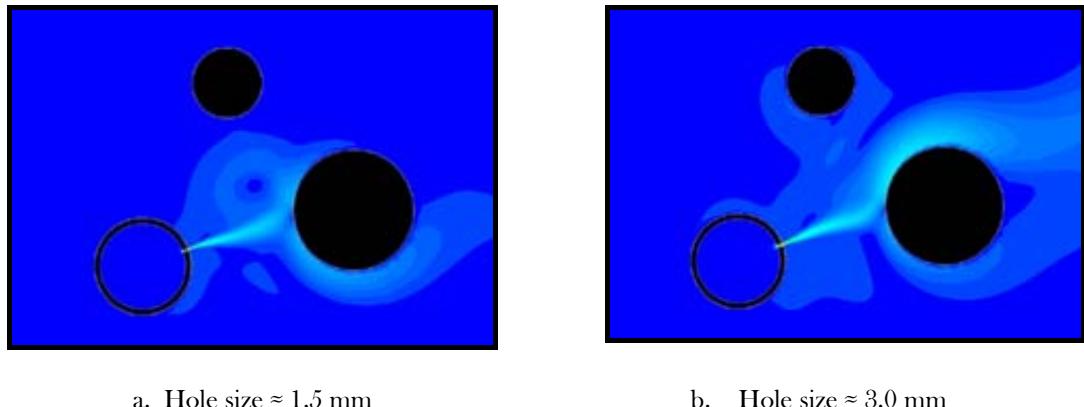
i. Initially, the failure of the asbestos pipe would not create a big sized hole. Failure started as a small crack, possibly longitudinal in direction. The simulation was begun when the crack size has an effective diameter of 1.5 mm. The flow trajectory of the jet is as shown in Figures 7a and 8a.

**Figure 7** Result of water jet simulation (2D velocity profile)

ii. As the effective diameter increased to 3.0 mm, it was shown that the force of the jet impacting on the steel pipe surface is getting much more significant (Figures 7b and 8b). It is believed the water

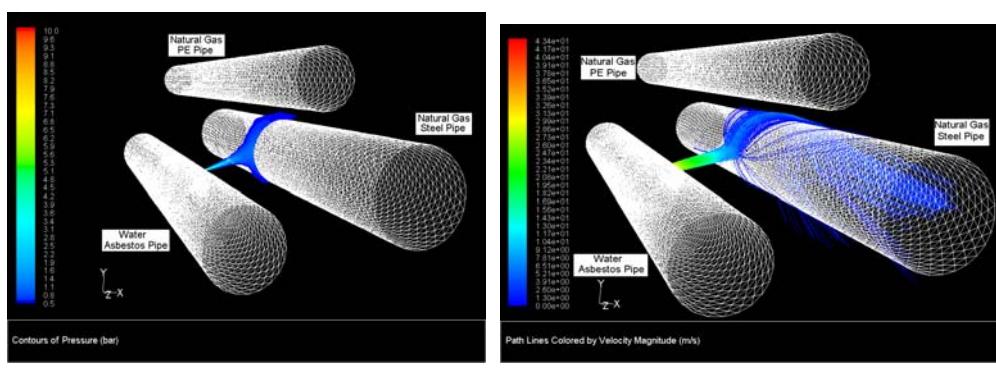
**Figure 8** Result of water jet simulation (3D velocity profile)

soil slurry is strong enough to cause coating losses on the steel pipe surface.

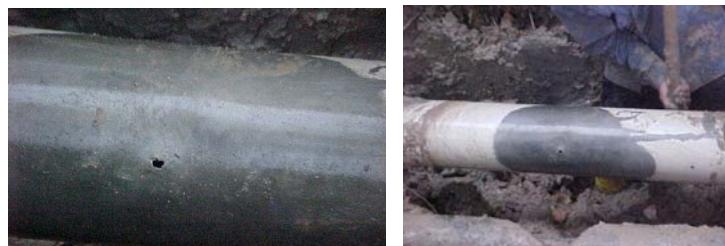
- iii. The flow trajectory was also shown to mostly move along the upper surface of the steel pipe. This fact supports the finding of the surface profilometry study which shows a faster thinning process took place on the upper part of the pipe (previous study). This phenomenon totally agreed with the study conducted on cylindrical specimen using slurry pot erosion tester by H. McI. Clark [18]. This study reported that thinning behavior at centre and its surrounding of impaction for cylindrical ductile material is characterised by the cutting wear and deformation wear, respectively.
- iv. The simulation results seem to agree with the observed conditions of the pipe surface conditions as shown in Figure 9.

**Figure 9** Surface condition of API 5LX42 pipe

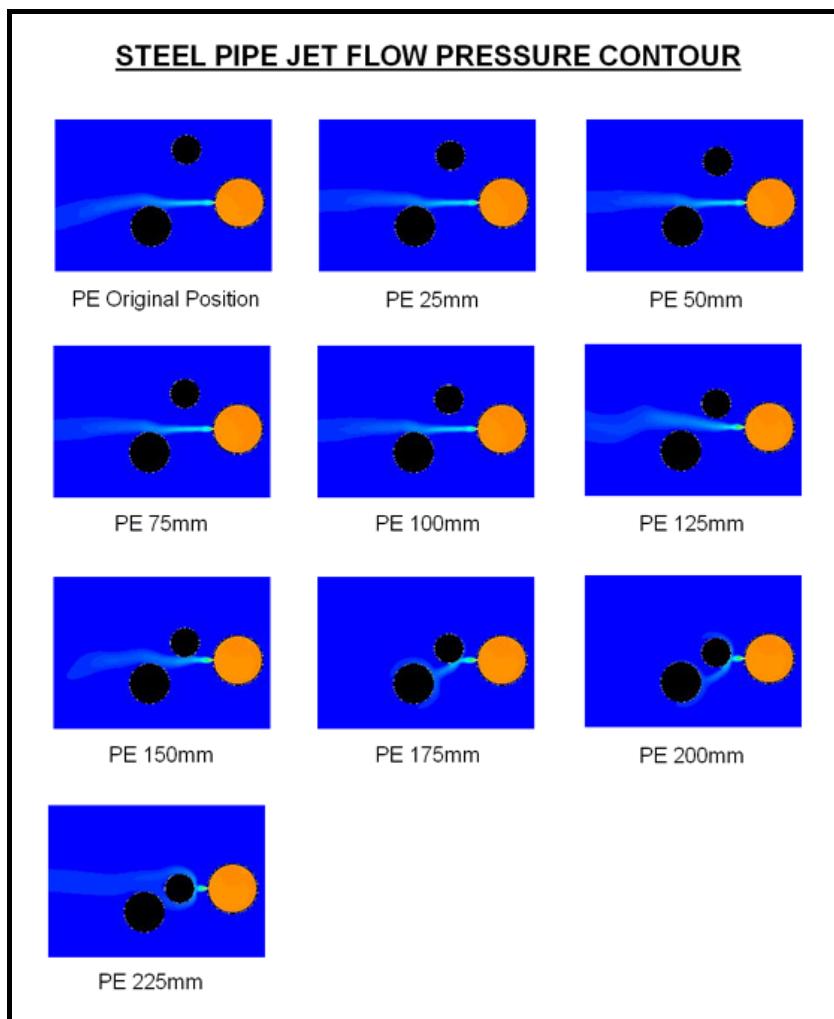
At 0 mm, 25 mm, 50 mm, 75 mm and 100 mm vertical displacement, the pressure contour shows that the pressure behaviour is not affected by the downward movement of the PE pipe. The velocity contour shows no significant difference. The jet flow from the steel pipe tends to flow and diffuse as expected.

**Figure 10** Gas pressure contours for the API 5L X42 pipe leak

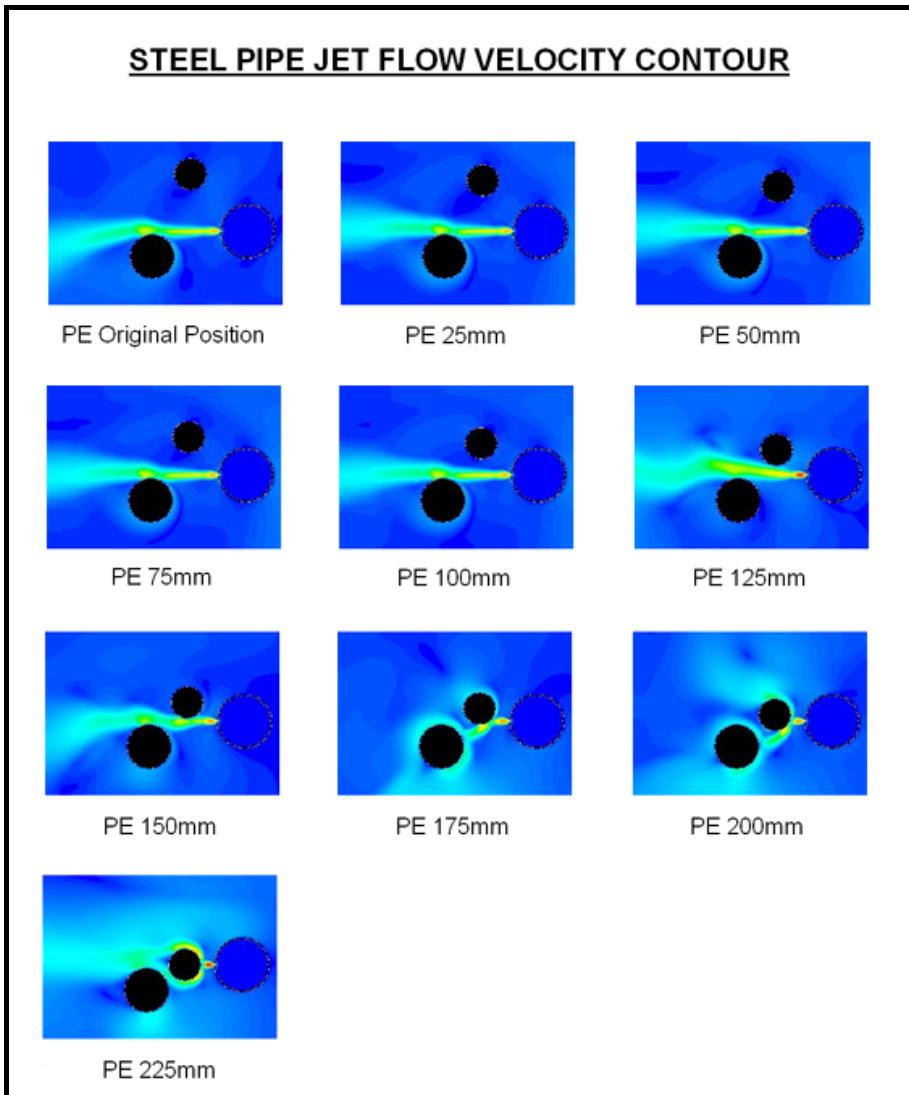
**Figure 11** Gas flow velocity contours for the API 5L pipe leak

As the PE pipe was displaced around 125 mm, it was noticed that the pressure flow tend to change direction. This is due to the existing PE pipe near the flow region that cause external aerodynamic to occur. The upper side of the jet flow tends to move slower relative to the bottom side. Vorticity of flow will develop (Figure 12) due to the velocity difference between the two sides.

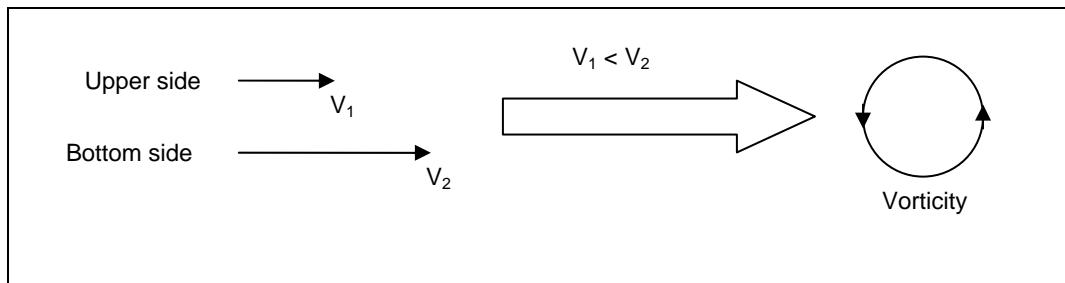
**Figure 12** Vorticity flow development

This is due to the external shear force that was created at the upper side of the jet. The created shear force is due to the different media contact phenomenon. In fact, gravitational forces from the water also contribute to the situation. After certain distance, it was noticed that the flow began to move upward due to the lower natural gas specific gravity.

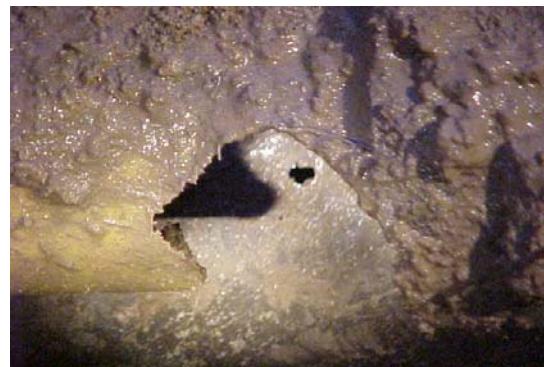
As the PE pipe dropped 150 mm, the gas jet hit the PE pipe. The PE pipe would start to shear by the gas jet flow. The pressure at this stage is around 1.7 bars and the flow velocity about  $400 \text{ ms}^{-1}$ . According to Figure 13, it is believed that the failure of PE pipe happened very fast.

**Figure 13** On-site condition of damaged PE due to gas jet from API 5L X42 pipe

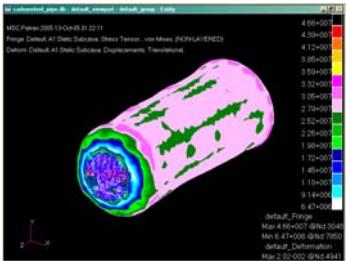
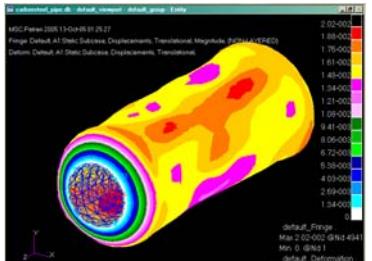
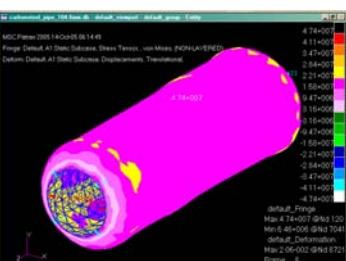
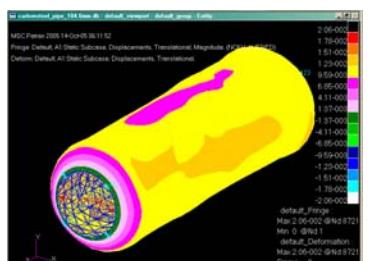
**Figure 15** Stress profile on API 5L X42 pipe

Figure 15 shows the finite element simulation results. The summary of the results are tabulated in Table 1. The results show that as the punch depth gets deeper, the critical pressure due to the surface thickness reduction will increase. The critical element displacement also increased as the wall thickness is reduced. The pipe wall stress and displacement increase as a thickness of pipe reduce.

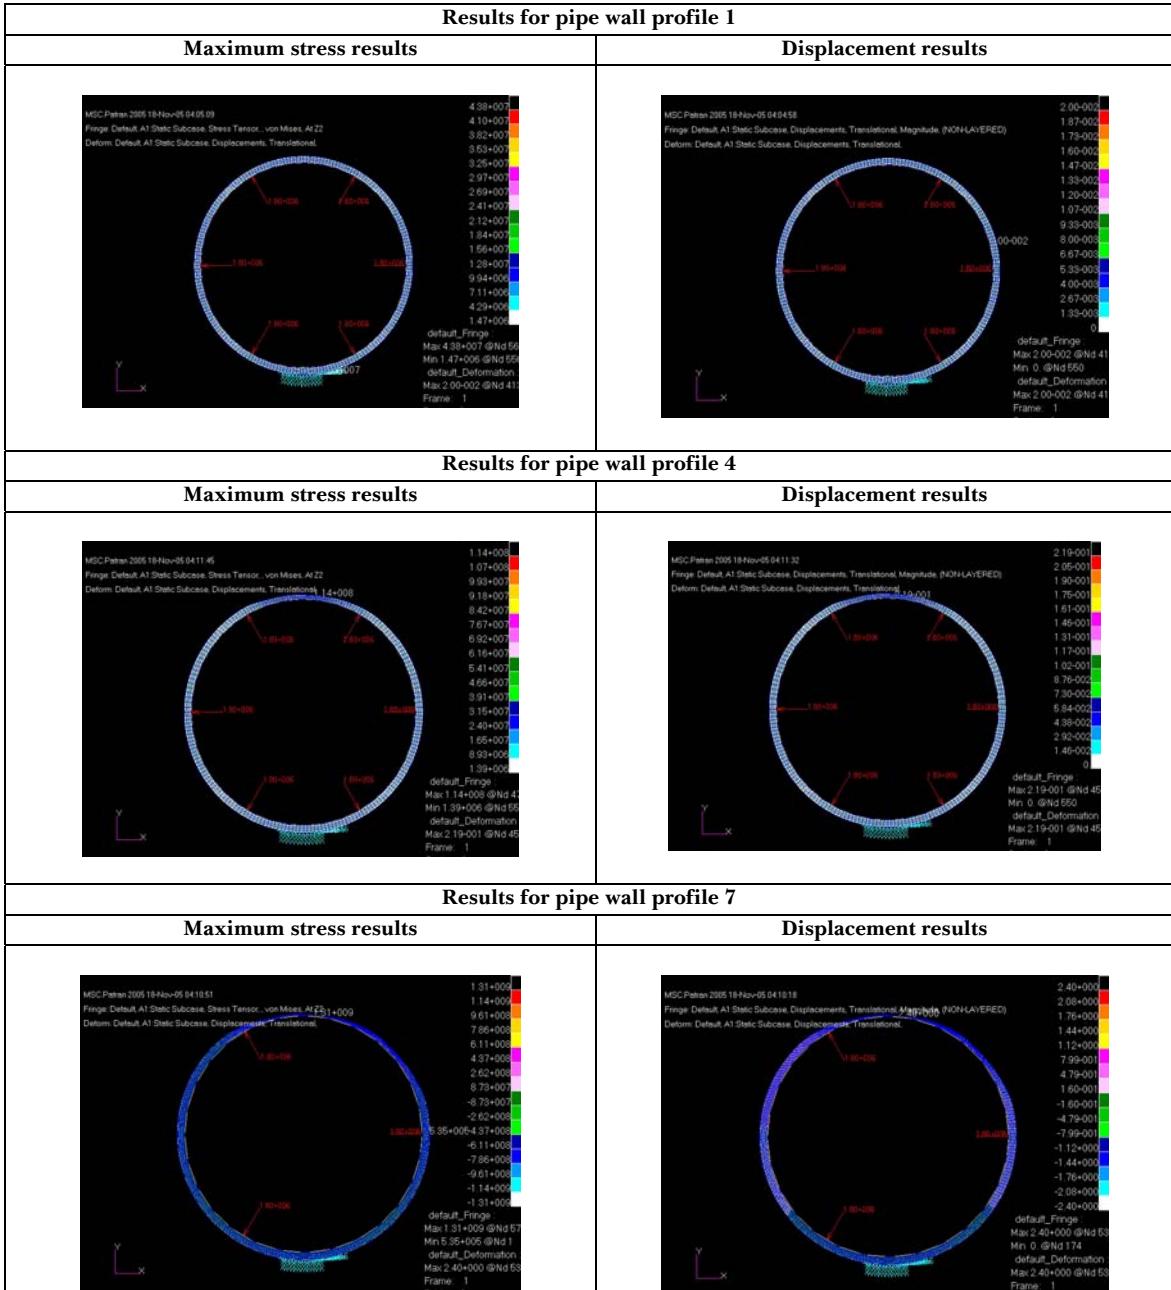
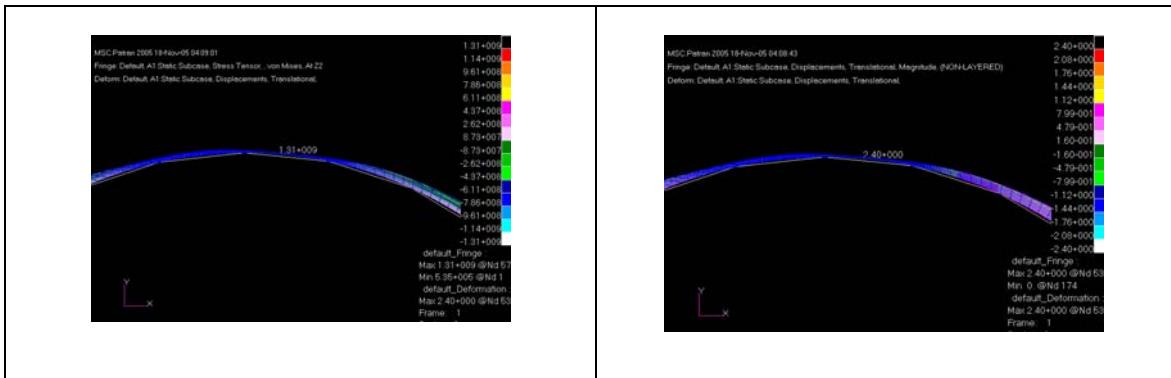
The simulation results of 2D wall thickness reduction study are shown in Figure 17. The graphical representation of these results in term of graph of

**Figure 17** Max stress and displacement results at pipe wall

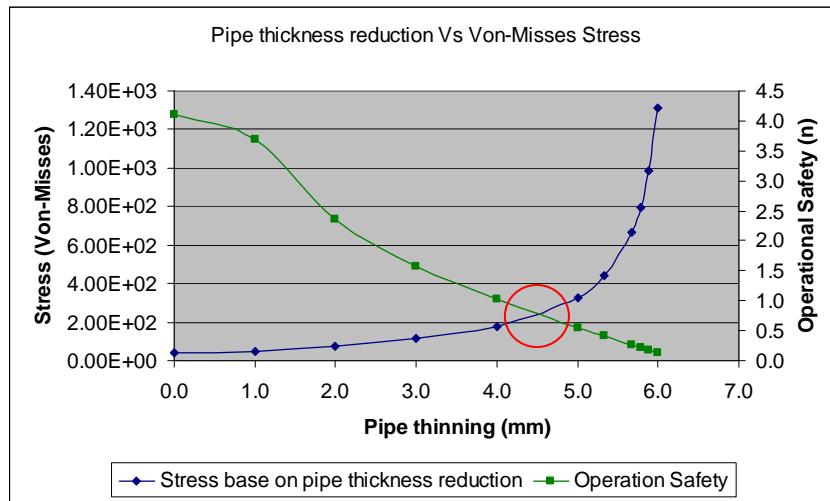
After 4 mm (profile 5) surface thickness reduction the load (von-misses) exceed the permissible stress and lead to failure as indicated by  $n < 1$ . These results also indicated that if the wall thickness is lower than 1.5mm, the strength of the wall pipe is getting weaker and the minimum thickness before failure is lower than 1.25 mm.

**Figure 20** Combination results of carbon steel pipe thinning behaviour

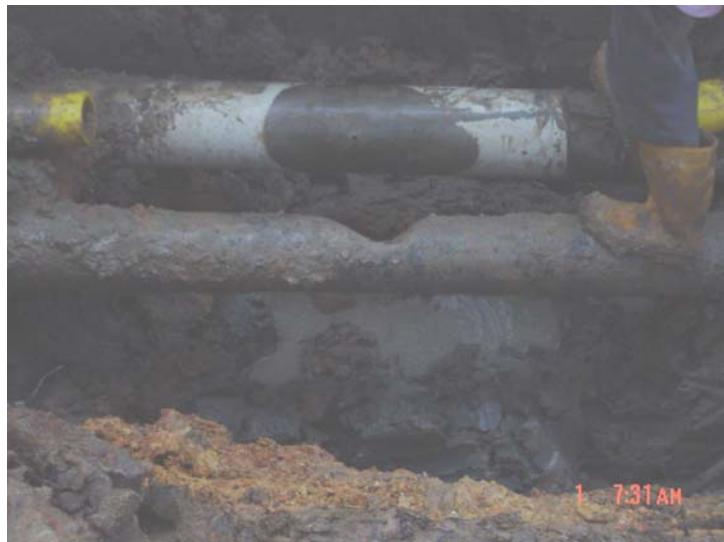
The suggestion that the steel pipe developed the first leak and caused the damage of the water pipe can easily be refuted. Photo evidence (refer to Figure 21) the repositioning of the pipes showed that the steel pipe leak position is not directly facing the water pipe but rather towards the top. The opening of the water pipe that is directly facing the eroded part of the steel pipe.

**Figure 21** Relative positions of the 8 inch water pipe to the NPS 8

The high pressure jet of leaked water from the 8 inch water pipe had earlier caused the displacement of the supporting soil materials underneath the PE 125 causing it to move downwards. When the steel gas pipe leaked, more materials was displaced causing the PE pipe to drop even further until it was low enough to be '*in the line of fire*' from the high pressure gas jet. It was estimated that the PE pipe dropped some 200 mm from its original position
