EFFECT OF GEOLOGICAL STRUCTURE AND BLASTING PRACTICE IN FLY ROCK ACCIDENT AT JOHOR, MALAYSIA

Abstract

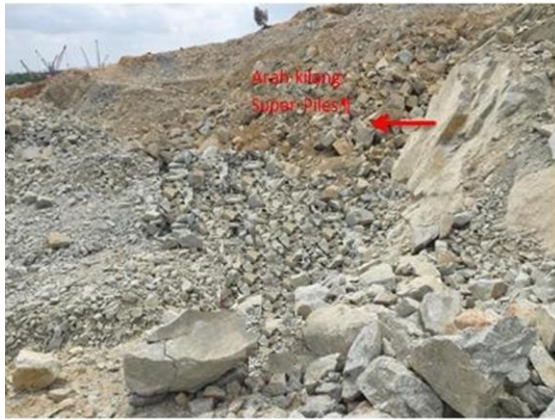
Figure 8 Inspection carried out on site. Red arrow indicates the direction of joint dominance (to the west)

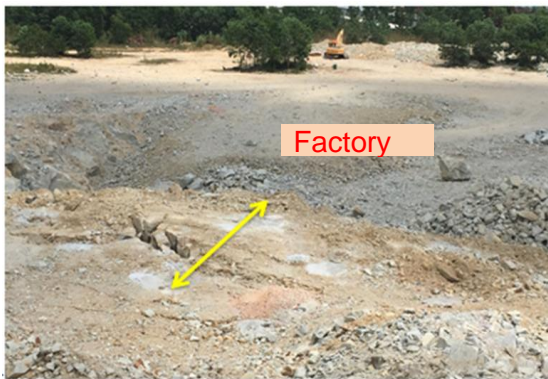
With observations on site and the information supplied by the contractor, the estimated volume of blasted rock mass is 3,000 m³, while the amount of explosive used was 1 tonne. Powder factor used in the blast was 0.33 kg/m³. It takes into account the 21 drill holes which identified the cause of the accident. Also identified from the inspection site, the source of this fly rock was from the line of drill holes in the front line. It was also observed the throw factor from second and third rows did not move far (Figures 9 to 11).

Figure 9 Status of rows of holes 2 and 3 after blast (not moved far)

- i. Initial drilling of holes based on blast design
- ii. Inspecting holes on the day of blasting and limiting charge for holes having less burden or having geological discontinuity
- iii. Selecting proper sequence of initiation of holes. From Figures 9 and 10, it can observed that row 2 and 3 did not move. This could

have been due to cut off of holes due to less time to move front row.

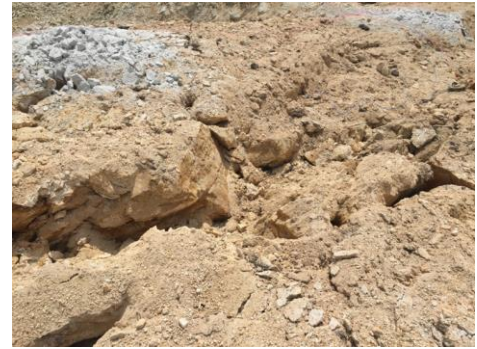
Figure 10 The rock split in lines 2 and 3 and not moved far

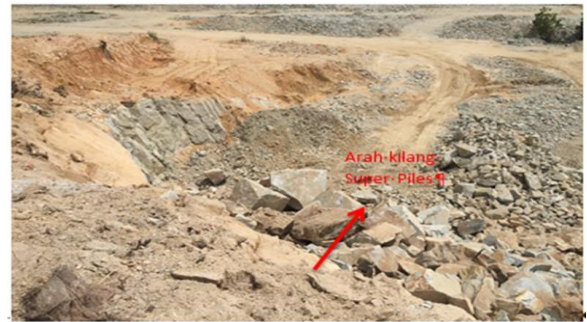
Figure 11 Share of first hole that destroyed – believed to cause fly rock

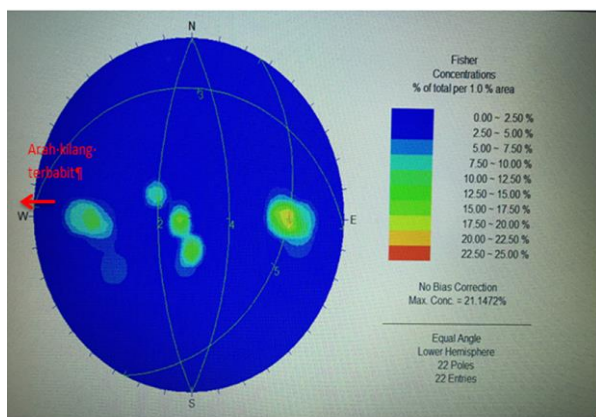
A total of 4 sets of fractures have been identified to exist at the blast site. This discontinuity occurred naturally and there are also new cracks as a result of the work of previous explosions. However, the joint set to the west is the most significant (dominant). As a result of the field measurement on traces of structures, a stereonet was drawn as shown in Figure 12.

Figure 12 Analysis of discontinuity indicating instability direction towards the factory

Local geology plays an important role. Orientation of joint, extended cracks and unfavourable orientation could posed danger. Explosive loading should be modified to suit the compensate changes in geology.
