SEISMIC VULNERABILITY ASSESSMENT OF MEDICAL FACILITIES: A GIS BASED APPLICATION FOR CHITTAGONG, BANGLADESH

Ram Krishna Mazumder*, Mohammad Tais Uddin Utsob & M. A. Rahman Bhuiyan

Institute of Earthquake Engineering Research, Chittagong University of Engineering and Technology, Chittagong 4349, Bangladesh

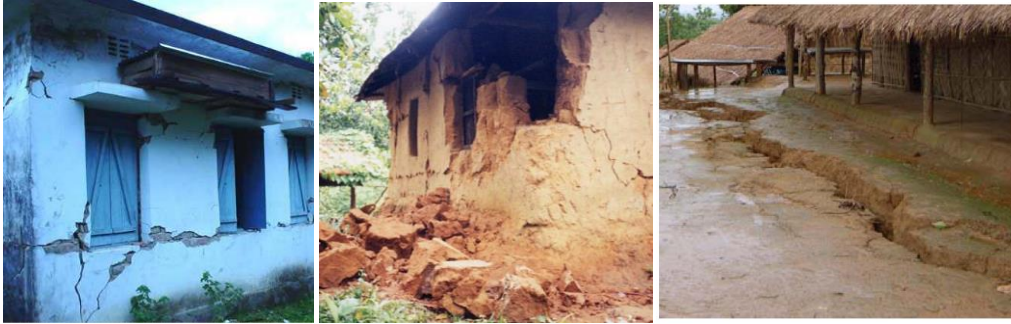
Figure 2: Building damages and ground displacement in Rangamati Earthquake in 2003 (image courtesy: www.cuet.ac.bd/ieer)

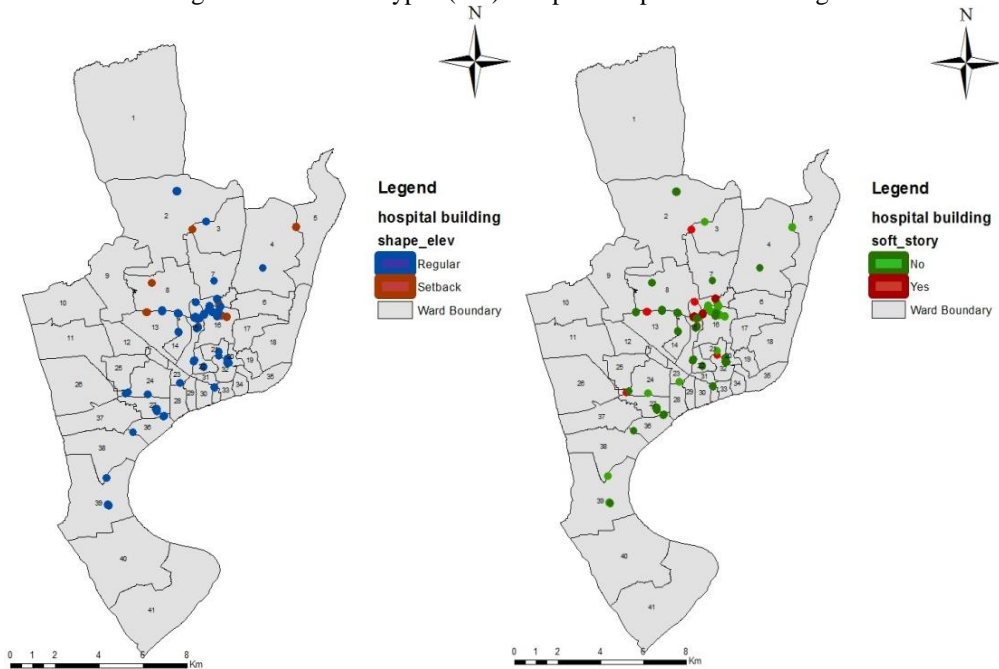
Figure 9: Building shape in elevation (left) and presence of soft story

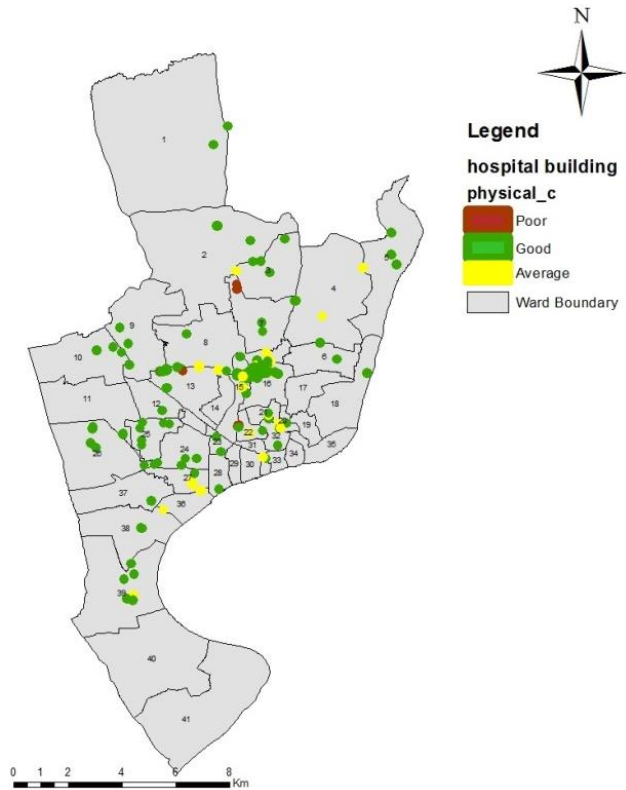
Figure 10: Visible physical condition of the buildings

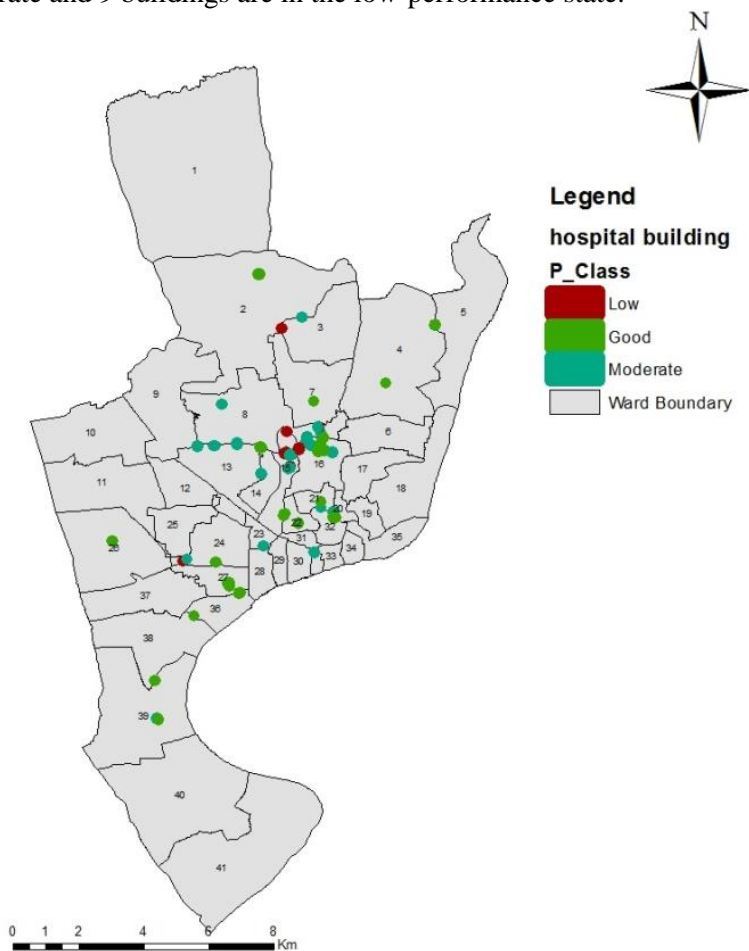
Among identified 172 medical facility buildings, 63 Pucca buildings were selected for second level assessment based on engineering judgment, analyzing first level data and building accessibility. The building performance divided into three categories (low, moderate and good) depending on performance score value. There is no specific guideline exist to categorize building based on performance score. Engineering judgment and local expert opinion typically used for categorizing building performance class. In this case, a score less than 40 was categorized as low performance and building with a performance score more than 70 was considered as good performance. Performance score from 40 to 70 was defined as moderate performance. Figure 12 shows building performance in GIS map. Building mean performance score was 65 whereas the mode value was 90. It was found that 30 buildings are in good, 24 buildings are in moderate and 9 buildings are in the low-performance state.

Figure 12: Seismic performance of medical buildings
