HISTORICAL ANALYSIS OF LANDSLIDES EVENTS IN MALAYSIA: IMPACT ON PHYSICAL AND SOCIO-ECONOMIC

Siti Nur Aishah Mohd Noor, Diana Che Lat*, Roslizayati Razali, Atiqah Najwa Zainuddin

Faculty of Civil Engineering, Universiti Teknologi MARA Johor, Kampus Pasir Gudang, Bandar Seri Alam, 81750 Masai, Johor, Malaysia

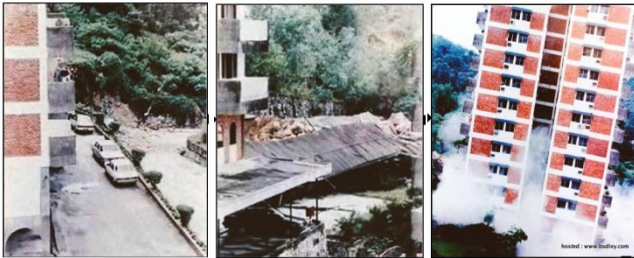
Highland tower was constructed between 1976 until 1979 which consist of three (3) building blocks and 12 stories. Majority of residential are from upper and middle-class families. Block 1 building which located at the southeast region collapsed on the 11th December 1993 which sacrifice a total of 48 residences. Prior to tower collapsed, this place received nonstop rainy day for almost ten consecutive days. Another factor that contributes to landslide is inadequate soil testing before the construction. To make it worst, the retaining wall close to the block 1 building also collapsed due to heavy rain as seen in Figure 3. Landslide can occur anytime for example before, during or after natural disasters like floods, earthquake, or volcanic eruptions. As stated by Azuwa et al. (2023), the landslide occurred due to poor planning during construction, which involved the cut and fill technique and relied on retaining wall to stabilise the terrain. The Highland Tower development faced issues because the terrain became unstable from water buildup due to poor maintenance. The building's foundation was weak, leading to its collapse. It could not handle the horizontal pressure from the landslide. This landslide was caused by inadequate drainage systems, poor maintenance, poor city planning, low-quality construction, and a lack of technical expertise (Bray et al., 2007; Azuwa et al. (2023).

Figure 3 Highland Tower condominium collapsed

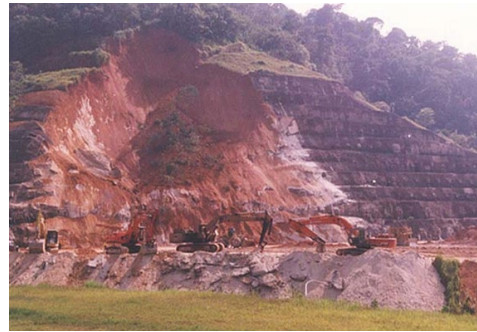
In January 6th, 1996 a cut slope at KM 303.8 of the North South Expressway which located near Gunung Tempurung, Kampar, Perak has failed (Figure 4). Debris from this landslide, including earth flow, rocks, and shotcrete materials swept a container truck off the road, killing the truck's co-driver. Besides that, another small landslide occurred at the top of the first. From the report, it can be confirmed that the area has a history of landslide, and the location of expressway was built along a highly sheared and fractured zone with natural weakness and relict structural planes. Another factor that contributes to the landslide is the site containing different types of rock which consist of granite, schists and hornfels resulting in soils with varying engineering properties. Although there was no rainfall at the time of the landslide, earlier rain had caused water to accumulate at the top of the slope.

Figure 4 Close view of Gua Tempurung Landslide at North South Expressway

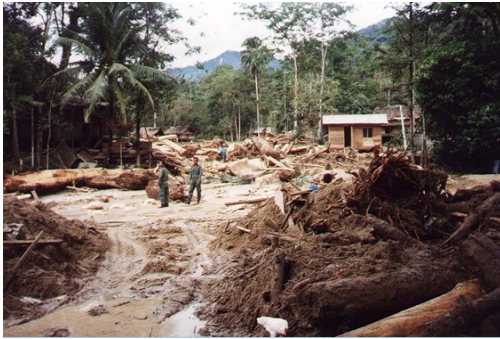
Komoo (1997) described a powerful debris flow in Pos Dipang, Perak, on August 30th, 1996. The powerful flow caused by heavy rains gave a massive force hit to the village, destroying almost everything in its path for over 5 km. It has uprooted trees, demolished houses, and swept away 44 people. Komoo (1997) also stated that heavy rain caused the disaster. In August 1996, 461 mm of rain fell, compared to 137 mm in 1993 and 281 mm in 1995. The excessive rain softened the ground, triggering landslides on steep slopes upstream of Sungai Dipang. This led to a massive mudflow that uprooted trees, eroded riverbanks, and created temporary dams. One of these dams, about 200 m upstream of Pos Dipang, eventually broke, releasing a huge flood of water and debris that overwhelmed the village. Figure 5 shows the aftermath of Pos Dipang after debris flow.

Figure 5 Pos Dipang debris flow

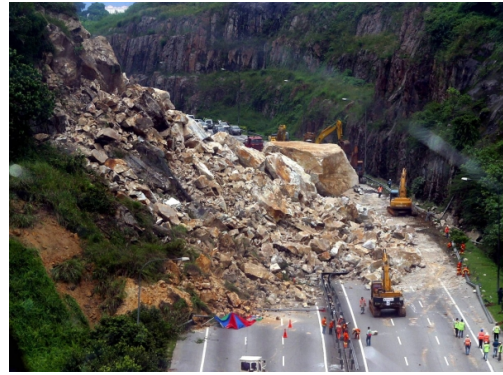
On November 26, 2003, a huge rock slope collapse happened near KM 21.8 of the Bukit Lanjan Interchange on the New Klang Valley Expressway (NKVE), as Figure 6 illustrates. The rock slope collapse was caused by rock debris, primarily angular stones of different sizes, which eventually came to rest on the road. The collapsing materials blocked the whole roadway, forcing traffic to be stopped. The breakage occurred in Bukit Lanjan on the steepest southern cut slope of a roughly north-south oriented cut. On the failing slope, which climbed more than 65 meters above the road, were six seats. The failure surface had a wedge-like structure, with rock debris hiding the southern end and a continuous significant discontinuity (presumably a fault plane) visible along its northern border (Komo et al., 2004).

Figure 6 Bukit Lanjan rock slope failure

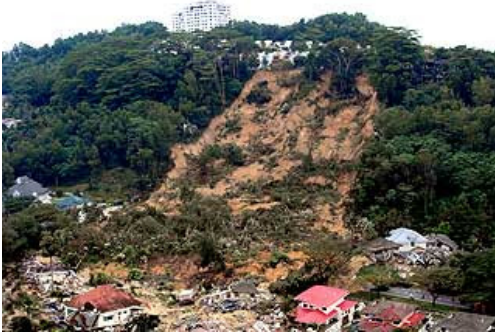
As seen in Figure 7, a landslide happened on December 6, 2008, 1.5 km northeast of the Highland Towers, on the eastern edge of the Bukit Antarabangsa township. Four people were killed and fifteen injured when a landslide badly destroyed fourteen expensive bungalows. Ulu Klang is prone to landslides and has experienced several fatal ones. In its hilly areas, heavy rainfall, human activity, and natural topography are the main sources of instability. In 2008, the Selangor State Government identified fourteen locations on hillsides that were prone to landslides. The majority of landslide accidents, as reported by the National Slope Master Plan (NSMP) 2009–2023, happened in developed zones, mostly in the foothills of the Titiwangsa Range (Azmi et al., 2013).

A poor development plan and inadequate slope strengthening related to monitoring and maintenance may have been the major causes of this disaster. The rainfall data before to the landslide tragedy shows that there were no notable downpours, hence rainfall cannot be considered the only triggering reason. Previous studies on the 2008 Bukit Antarabangsa landslide have also identified a number of interrelated causes that led to the slope failure. Among these, human error was the most important (Chigira et al., 2011; Danish et al., 2017).

Figure 7 Bukit Antarabangsa landslide in 2008

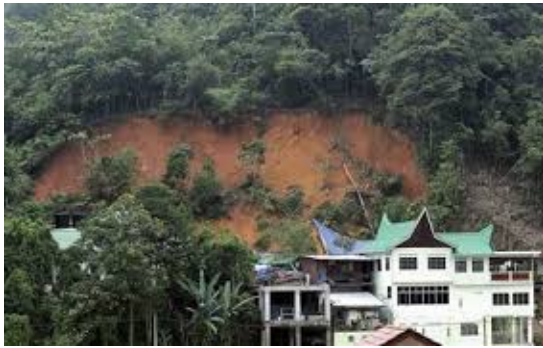
Figure 8 illustrates the landslide that occurred on May 21, 2011, at the Children's Hidayah Madrasah Al-Taqwa orphanage in FELCRA Semunggis, Hulu Langat, Selangor, as a result of heavy rains, killing 16 persons, primarily children and an orphanage caregiver. This landslide ascribes the disaster to human action because no slope fortification or protection was provided, the vegetation was cleared, and the extremely steep slope was cut. Furthermore, the slope region had neither a buffer zone nor a maintenance zone (BBC, 2011; The Star 2011).

Figure 8 Landslide at orphanage house in Hulu Langat, Selangor.

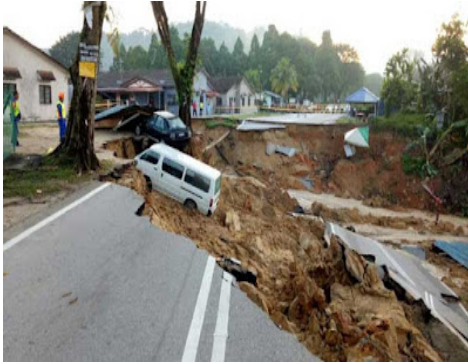
A notable incident that caused fatalities and property damage in 2016 was the landslide that occurred in Taman Idaman, Serendah, Selangor (Figure 9). Because of worries that the region is still unstable, local officials evacuated roughly 340 individuals from 60 residences within 600 meters of the event (Faisal and Farhana, 2016). One reason given for the collapse of a hillside and the subsequent buried of many dwellings in mud and rubble was heavy rains. Selangor State, which lies on Peninsula Malaysia's west coast, enjoys a wet tropical climate with high annual rainfall. However, there are certain seasons with higher rainfall in the winter months in the Northern Hemisphere, with November being the wettest month with an average of 260 mm of rain (Wong et al., 2016). In these kinds of places, landslides usually happen during the monsoon season, which is marked by heavy and protracted rainfall (Faisal and Farhana, 2016). The heavy downpour was identified as the main cause of the landslide as it made the steep slopes in the residential area less stable (Sardi et al., 2021). According to Nasir et al. (2018), this saturation decreased the soil's shear strength, causing dirt and debris to slide downward.

Figure 9 The scene of the 26 November 2016 Taman Idaman landslide.

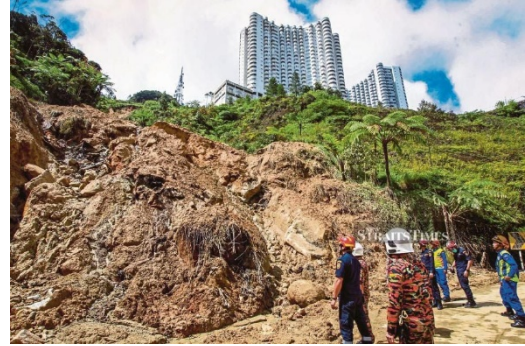
In November 2019, heavy rains caused landslides in Genting Highlands, resulting in evacuations and delays for transportation in several areas surrounding the hill resort. (Figure 10) Transportation was affected, and both locals and visitors were concerned about their safety. It is thought that the landslide that occurred at Genting Highlands' Jalan Genting-Amber Court was caused by a subpar drainage system. Local authorities and emergency services reacted quickly to clear debris, assess damage, and guarantee the safety of individuals in the impacted regions as a result of the landslides. Thankfully, no injuries from these landslides were reported (Shen, 2019).

systems (Kazmi et al., 2017). Mud and debris spilled onto the road because of rainwater destabilizing the soil structure along the slope and pushing the ground downward (JMG, Shen, 2019). These events highlighted the continuous difficulties caused by the high rains and unstable terrain in the Genting Highlands. The authority also stressed that in order to lessen the effects of natural catastrophes in such high-risk locations, it is imperative to maintain ongoing surveillance, take preventative action, and implement efficient emergency response methods.

Figure 10 Landslide at Genting Highland Road

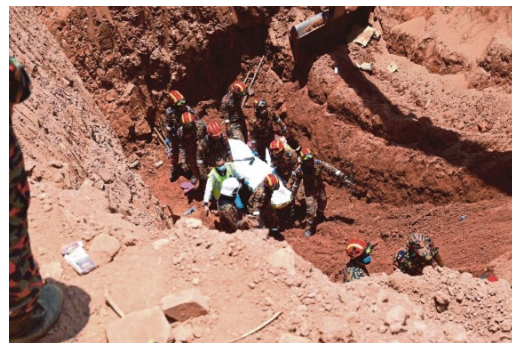
Major landslides occurred in Mount Jerai, Malaysia, in March 2020 (Figure 11), causing inconveniences and raising worries among officials and local populations. It's thought that the soil extraction operation at Gunung Jerai's base in Kedah was done without a license or approval. These actions have the potential to erode the ground's inherent stability, which might result in landslides and slope collapses. According to Cruden et al. (1996), soil excavation reduces the slope's stability by removing its natural support. There was no rain and pleasant weather at the time of the landslide disaster. The majority of the time, excavation-related landslides happen when human activity like mining, building, or excavating undermines the stability of a slope (Zhen et al., 2024).

Figure 11 Mount Jerai landslide

Strict adherence to legal requirements, public awareness initiatives, and community participation in the identification and reporting of questionable operations are all necessary to stop illicit excavation. In order to stop and prohibit such actions, government authorities, law enforcement, and environmental organizations are essential.

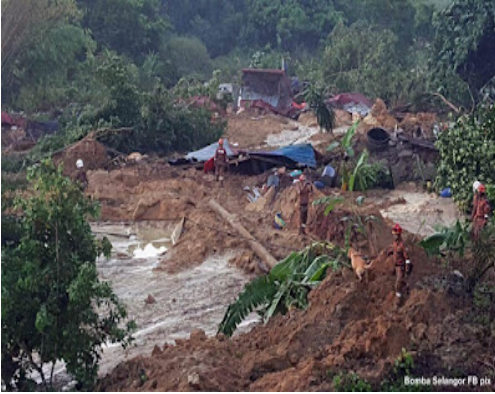
A landslide behind a two-story terrace house in Taman Kelab Ukay, Bukit Antarabangsa near Ampang, on May 29th, forced 40 residents of seven houses in the neighborhood to evacuate (Figure 12). It was thought that the landslide happened as a result of the area's soil shifting after persistent rain (Bryson et al., 2022). In addition to causing property damage, the landslide in Taman Kelab Ukay put the locals in danger. The significance of appropriate urban design, sufficient drainage systems, and slope stability monitoring in hilly and mountainous areas is emphasized in order to lessen the effects of natural disasters such as landslides.

Figure 12 Landslide in Taman Kelab Ukay, Bukit Antarabangsa.

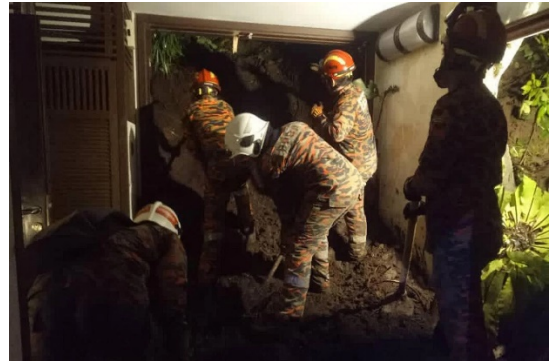
Two guests at the Banjaran Hot Springs Retreat in Ipoh, Perak, have perished in a landslide that is thought to have been caused by intense rain. Since Monday, the steep region has had a lot of rain, which has loosened the ground in the resort's location. Surrounding this region are hillsides and excess dirt. A landslide may result from soft soil (Nadirah, 2021). A landslide happened at the Banjaran Hot Springs Retreat in Ipoh, Perak, Malaysia, in January 2021 (Figure 13). The resort and the surrounding surroundings sustained substantial damage as a result of this tragedy. The resort is situated in steep terrain, and the severe rains that followed caused the soil to become saturated and the slopes to become unstable, resulting in a landslide. According to Khalil et al. (2011), prolonged and heavy rainfall might cause the soil to become more saturated with water, which will decrease its stability and lead to slope collapses. The resort is located in a mountainous terrain, and during periods of heavy rain, steep slopes become more susceptible to landslides. The likelihood of landslides can be affected by soil composition and geological circumstances. The property and infrastructure destruction caused by the landslide at Banjaran Hot Springs Retreat underscores the susceptibility of mountainous areas to similar natural calamities. To reduce the hazards connected with landslides in comparable locations, it emphasizes the significance of efficient disaster preparedness and mitigation tactics, such as appropriate land use planning, slope stabilization techniques, and early warning systems.

Figure 13 Rescuers digging through the mud, found the pair within five minutes of each other at Banjaran Hot Springs Retreat in Ipoh, Perak.

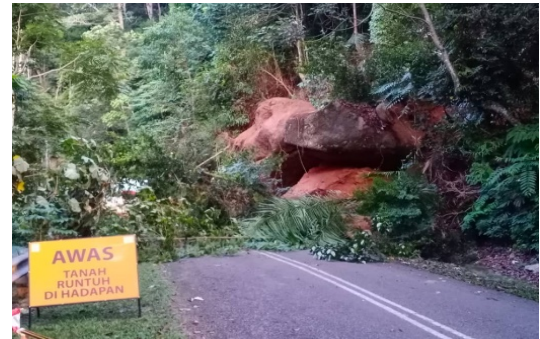
In humid tropical climates, a hillside region with a high population density is frequently vulnerable to several forms of mass migration (Lari et al., 2014). The Jalan Raub-Bukit Fraser road in Malaysia was blocked in December 2020 as a result of many landslides and rockslides (Figure 14). Heavy rains caused the soil to get saturated and the hills around the road to become unstable, which resulted in large pieces of rock and debris falling onto the road, which is what triggered this closure. The previous three days have seen a lot of rain, which is what caused the rockslide. Rockfall is a common geological occurrence that mostly occurs in mountainous regions or along man-made slopes, where it can endanger people's lives, property, infrastructure, and vehicles (Roslee et al., 2018). Thus, especially mountainous regions, precise rockfall prediction is essential for both hazard assessment and mitigation design.

Figure 14 Rockslides at Jalan Raub-Bukit Fraser

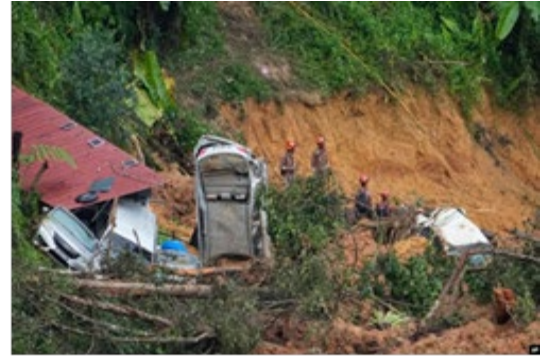
On 16 December 2022 a landslide has been reported at a private campsite named Father's Organic Farm near Batang Kali, Selangor (Figure 15). 31 people were killed and 61 were rescued, while 8 people requiring hospitalisation. The last body belonging to an 11-year-old boy was found on 24 Dec 2022. (Hashom et al., 2023). According to surveys and calculations by the Mineral and Geoscience Department (JMG), these affected areas involved a slope failure of 450,000 cubic metres of soil, across an area of 500 metres and 200 metres, with a depth of 8 metres. Experts believe saturated soil is one of the main causes of the landslide. Continuous rain for the past few days also caused the soil structure to weaken, thus making the slope in the area to become unstable.

Figure 15 Severe damage at Father's Organic Farm, Batang Kali

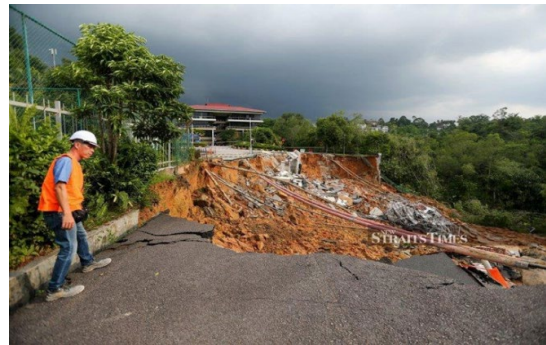
On April 2023, a landslide was reported and affected 76 administrative employees of the Malaysian Anti-Corruption Academy (MACA) and Malaysian Institute of Integrity (IIM) at Persiaran Tuanku Syed Sirajuddin, Kuala Lumpur (Figure 16). The landslide occurred in front of the MACA entrance and resulted the collapsed of a command post. The area affected by the landslide is estimated around 100 x 120 sq ft. The landslide was caused by a leakage in the underground pipe and the accumulation of water after recent heavy rainfall. It was reported that the MACA building structure is 40 years old and so are the piping systems. Thus, it may have worn out over the years, causing the underground water leakage and lead to the subsequent landslide.

Figure 16 Landslide in front of MACA building, Kuala Lumpur

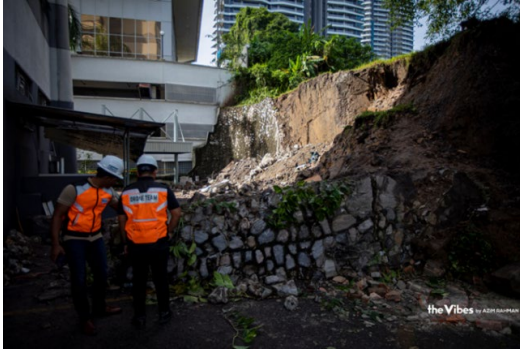
On May 3, 2023, a landslide at Wisma YPR in Taman Seputeh resulted in the fall of a retaining wall that was six meters high (Figure 17). Under the debris, a security guard was found buried alive. Behind Wisma YPR, a rock embankment had collapsed, allowing the earth to fall and levelling a guardhouse nearby. The area that was buried by the landslide was at least 6 by 12 meters. Although the main building's structural integrity was unaffected by the landslide, the impacted area has been roped off as a safety measure until restoration work is finished. It was thought that the occurrence was caused in part by the torrential rain that fell over most of the Klang Valley the previous evening.

Figure 17 Landslide T Wisma YPR, Taman Seputeh

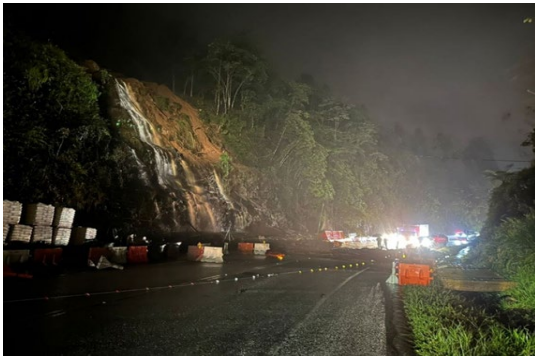
A landslide was reported by the STAR news on June 2023 at Section 45 of Jalan Simpang Pulai-Blue Valley, Ipoh due to heavy rainfall (Figure 18). The incident occurred near the rock shed. The location of the incident is a slope repair site that is being carried out by the Jabatan Kerja Raya (JKR) contractor. The high amount of surface runoff caused soil to fall onto the road. The landslide had caused the road to be blocked.

Figure 18 Landslide at Jalan Simpang Pulai Valley, Ipoh
