# A SIMULATION STUDY OF SLOPE STABILITY AFFECTED BY CONSTRUCTION OF NEW BUILDINGS AT UNIVERSITI TEKNOLOGI MALAYSIA, SKUDAI.

Azman Kassim<sup>1</sup>, Fauziah Kasim<sup>1</sup>

<sup>1</sup>Faculty of Civil Engineering, Universiti Teknologi Malaysia, Skudai, 81310 Johor Bahru, Malaysia

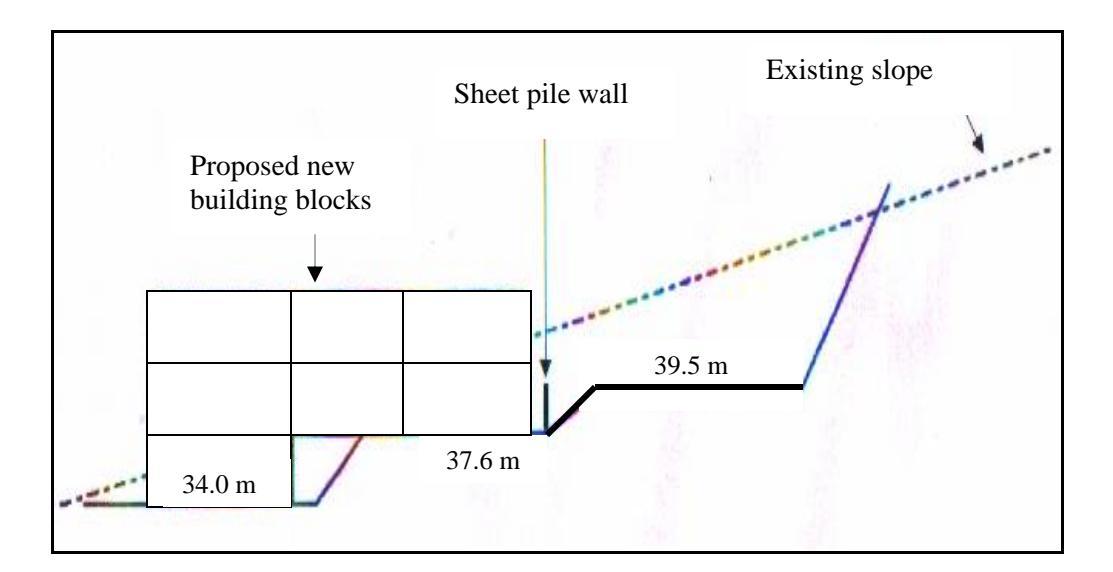
By June 2000, the tension cracks and slope movement had reached more than 250 m beyond the boundary of the proposed site and approached the existing water supply tank (at elevation of about 90 m). In an attempt to counter the slope instability or soil movement down the slope towards the proposed buildings, a row of sheet piles were installed at the toe of the slope between platforms at 37.6 m and 39.5 m (Figure 1). However, after three quarter of the piles had been installed, lateral movement of the piles was observed. The downhill force of global soil mass was so big that caused the pile wall shifted towards the road with end of pile as a center of tilt.

Figure 1: Installation of sheet piles between platforms at 37.6 m and 39.5 m.

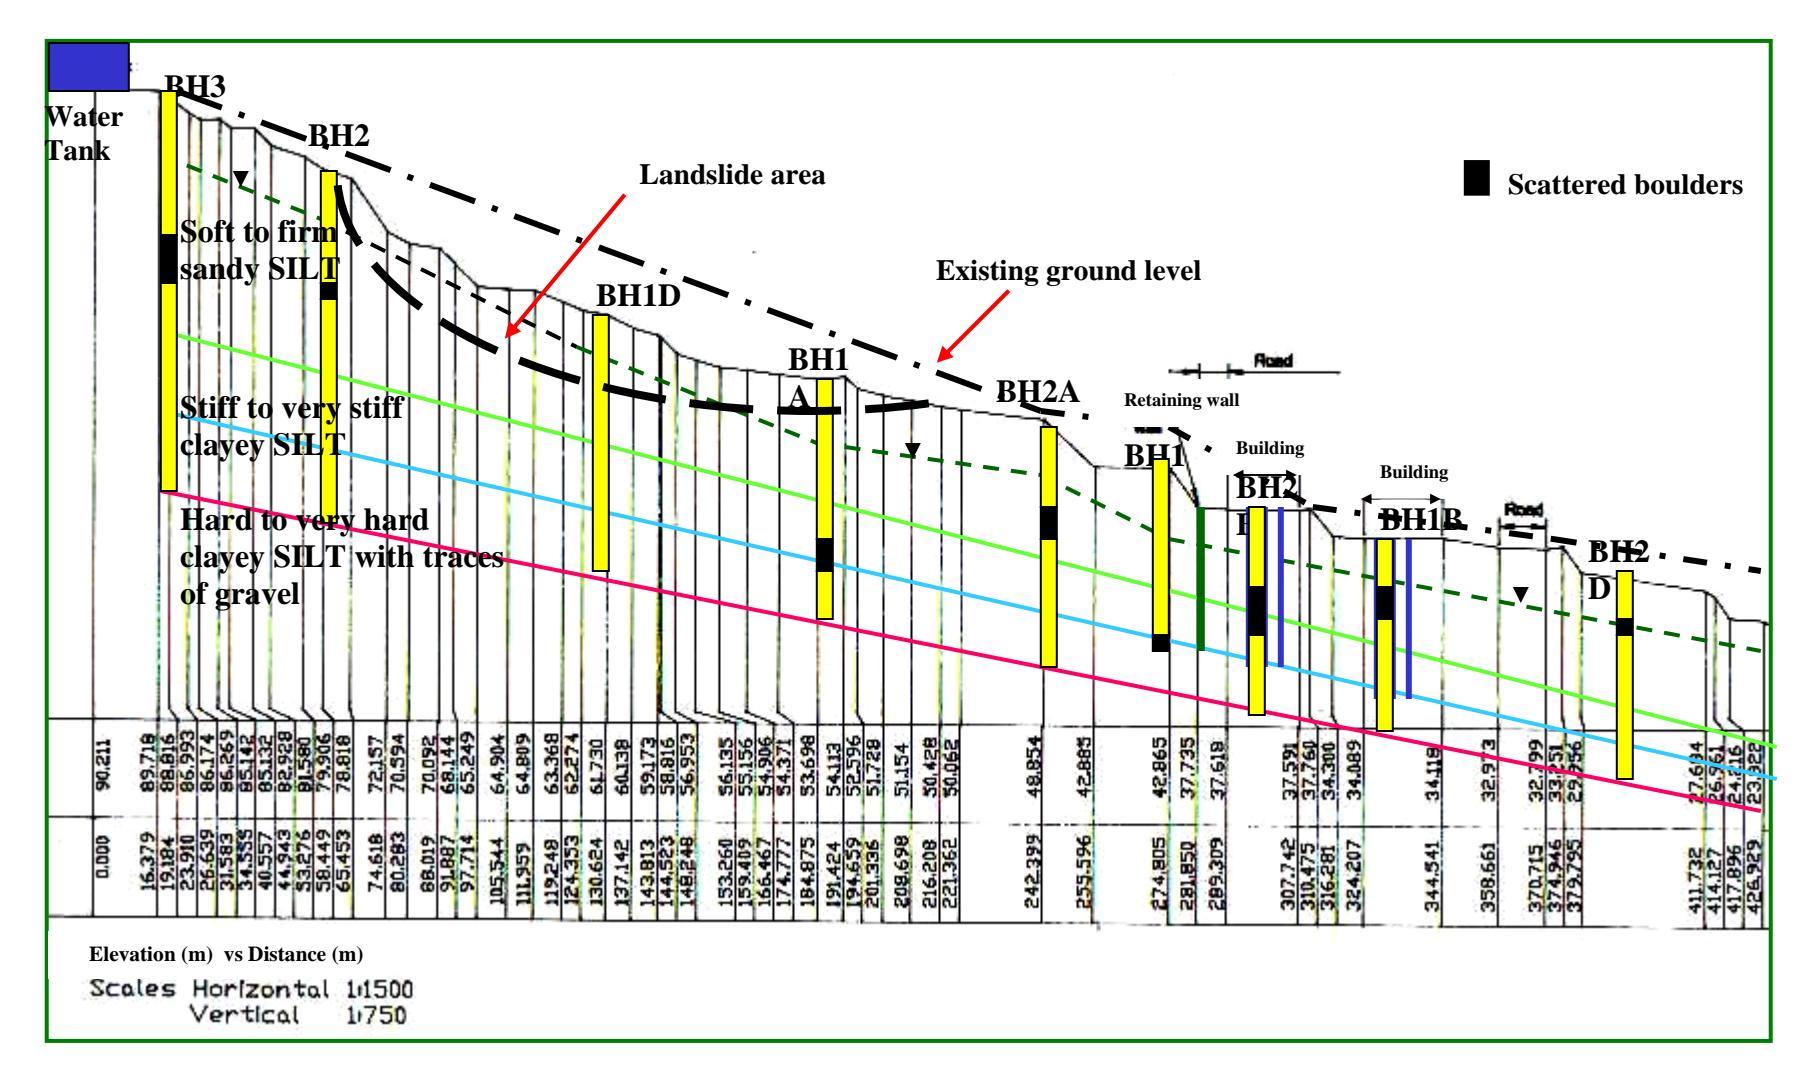
Figure 3: Cross sectional topography and geotechnical properties at the landslide area.
