DISTORTION-INDUCED FATIGUE CRACKING AT WEB-GAP OF WELDED I-BEAMS

Abstract

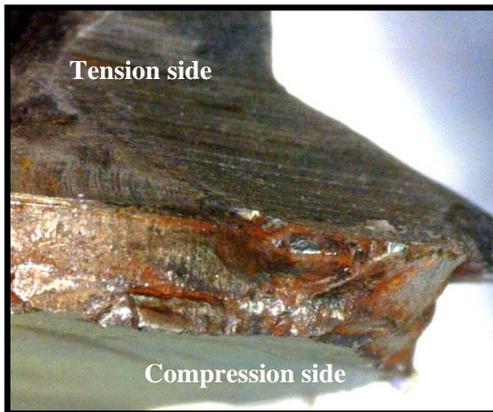
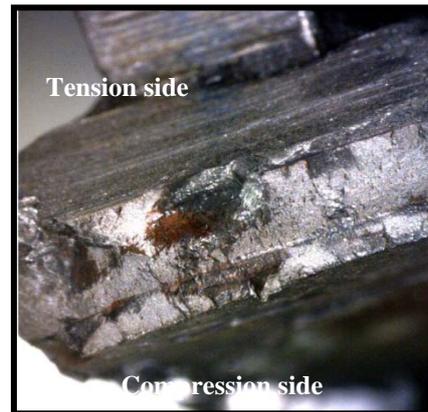
(A) Initiation of the first crack at weld toe

Figure 10. Crack surfaces of the first and second cracks

There are two main cracks initiated in the test specimens as shown in Figure 9. The first crack propagates upward to the top flange and the surfaces at points A, B, and C (see Figure 9) as shown in Figures 10A, 10B, and 10C respectively. The second crack propagates downward to the bottom flange (point D) and its cracks surfaces are shown in Figure 10D. From the crack surface of the first crack line (see Figures 10A, 10B, and 10C), the crack tip on the tension face propagates a little faster than the one in the compression face in the zone where the crack starts as shown in Figure 10A. When the crack propagates away from the end of stiffener, the crack tips on the tension and compression faces grow at the same speed as well as the same position at point B in Figure 9. It is also observed from the failure surface in Figure 10B that there are parallel scratches occurring on the surface, from tension to compression side. This is the evidence of the fact that the first crack propagates in the same speed for both faces of the web. When the first crack becomes critical (point C in Figure 9), the scratches at the crack surface (see Figure 10C) grow from both sides of web. The first crack becomes critical by the time the second crack breaks the bottom flange of the beam

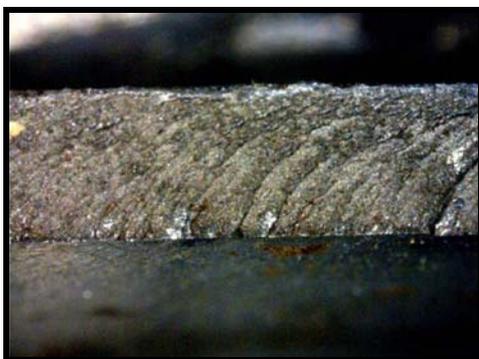
(B) Propagation of the first crack

(C) The critical first crack

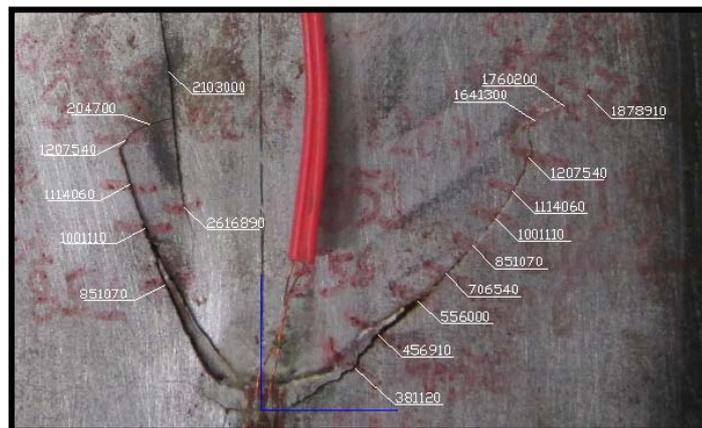
During the test, the crack propagation life was regularly recorded. The crack paths were recorded as the period of time and written directly on specimens to construct the S-N curves. The second stage of crack propagation is identified when the initial crack propagates out of the weld connecting web and stiffener. At this stage, the crack propagates in a stable manner according to the definition from Paris law. The testing machine was stopped after an exact time to record the length and direction of crack growth. An example of recorded fatigue life on test specimens is shown in Figure 11. The recorded data shows the same range of fatigue life and crack length after the same time. When the first crack becomes critical, the number of cycles is shorter, whereas the crack length becomes longer. The crack propagation is too complex to predict the direction due to the complicated stress field around the crack by the time the beam fails. Naturally, the lengths of the first crack at each side of the web are slightly different due to the residual stress in the specimen, and the approximate values of the crack lengths have been used in the data analysis.

Figure 11. Recorded fatigue life on specimen
