# REMEDIAL STRUCTURES TO STABILIZE LONG XUYEN RIVERBANK TO PREVENT SLIDING IN AN GIANG PROVINCE, VIETNAM

Sliding of structures along riverbanks in An Giang province has caused serious losses for local people and the current stabilized methods have been ineffective to treat sliding issues sustainably. This study attempts to propose some remedial methods to prevent sliding of structures along the Long Xuyen riverbank in An Giang. These structures were designed, constructed at the selected sites, and monitored their field performance for a flood cycle which is a year. The two stabilized structures were proposed, analyzed, and successfully constructed at the two selected sites. The field monitoring instruments such inclinometer casing and groundwater observation wells also were fully installed to obtain the field data to evaluate field performance of the proposed structures.

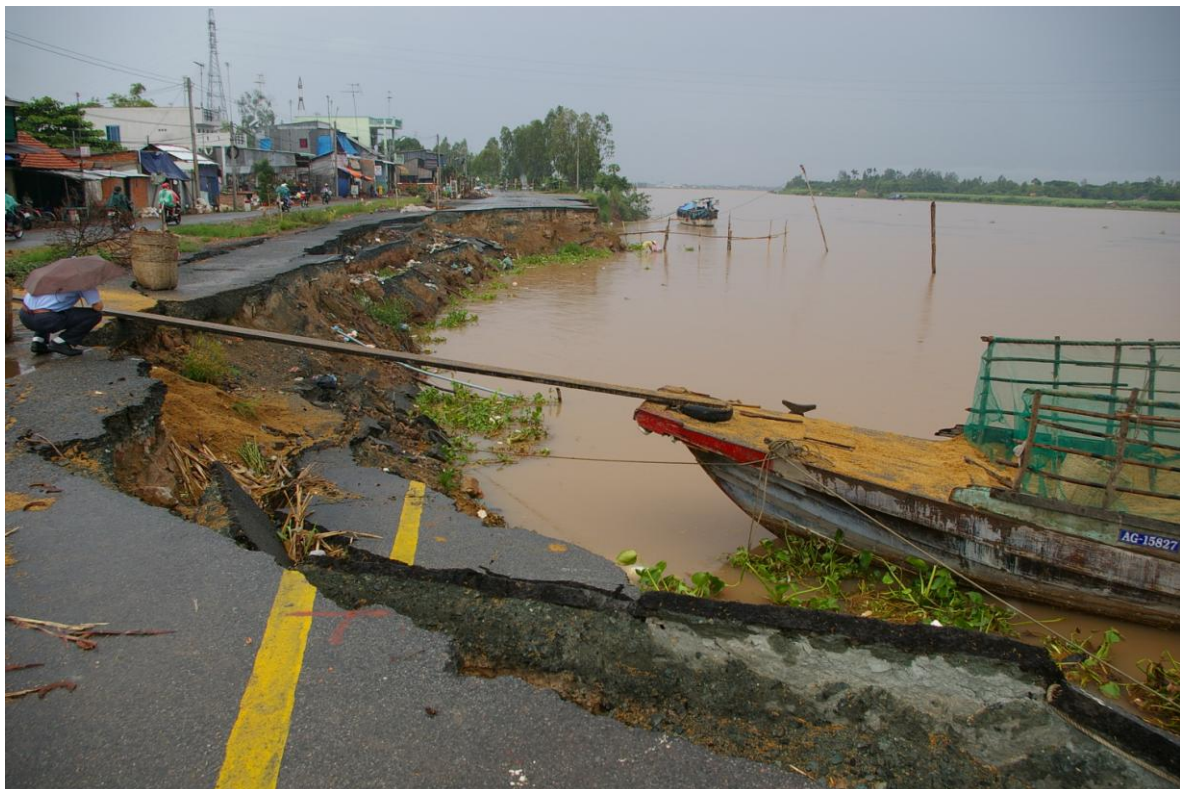
Figure 2. A sliding at km 88 + 937 on the national highway No. 91 along the Hau riverbank in Binh My, An Giang on March 22<sup>nd</sup>, 2010

Several sliding of structures along riverbanks in An Giang province which locates in the Southwest of and about 200 km from Ho Chi Minh City (Figure 1) have occurred recently such as Sliding at km 88 + 937 on the National Highway No. 91 on March 22nd, 2010 (Tran-Nguyen et. al. 2011, Tran-Nguyen & Le 2011) (Figure 2). Many houses, manufacturers, and highway embankments along riverbanks have failed due to riverbanks' sliding like a sliding of the Hau riverbank on May 26th, 2012 (Figure 3). This failure occurred about 100 m long and 20-25 m wide to damage about 25 houses. These failures have caused serious losses for An Giang people and the local people have searched for effective solutions to treat the sliding problems.

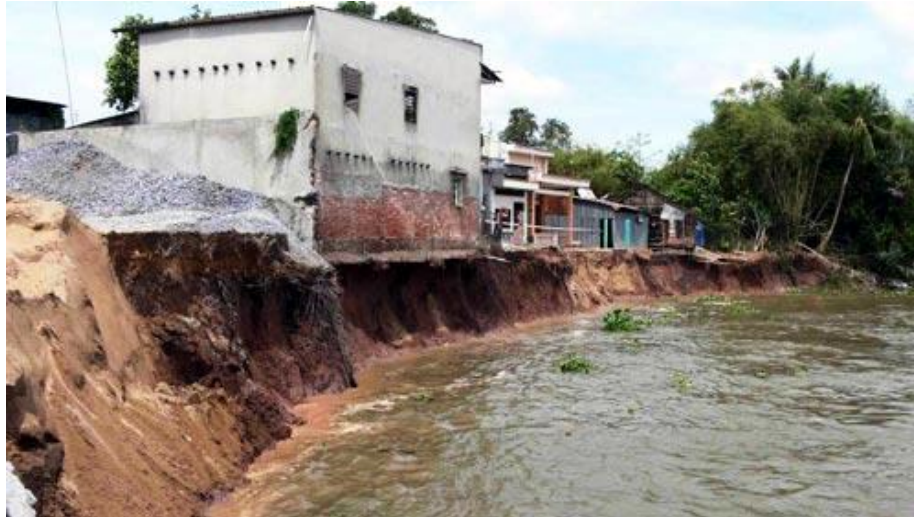
Figure 3. A sliding of the Hau riverbank in Long Xuyen, An Giang on May 26th, 2012 (An Giang newspaper)

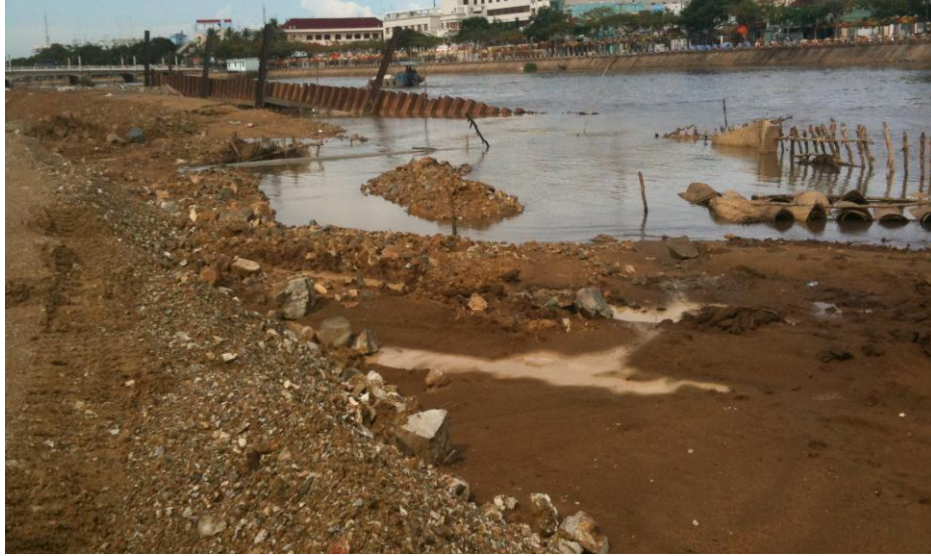
Figure 5. A sliding of the Long Xuyen riverbank under construction of a stabilized structure in an Giang on May 15th, 2012

The second stabilized structure was constructed against sliding of an embankment along the Long Xuyen riverbank. A failure has taken place under construction at this location (Figure 5). This location has three soil layers along a 30-m soil profile. A 20-22-m very soft clay layer lies between a 1.5-m top stiff clay layer and medium stiff clay underneath. The properties of soil layers along the soil profile are printed in Table 2.

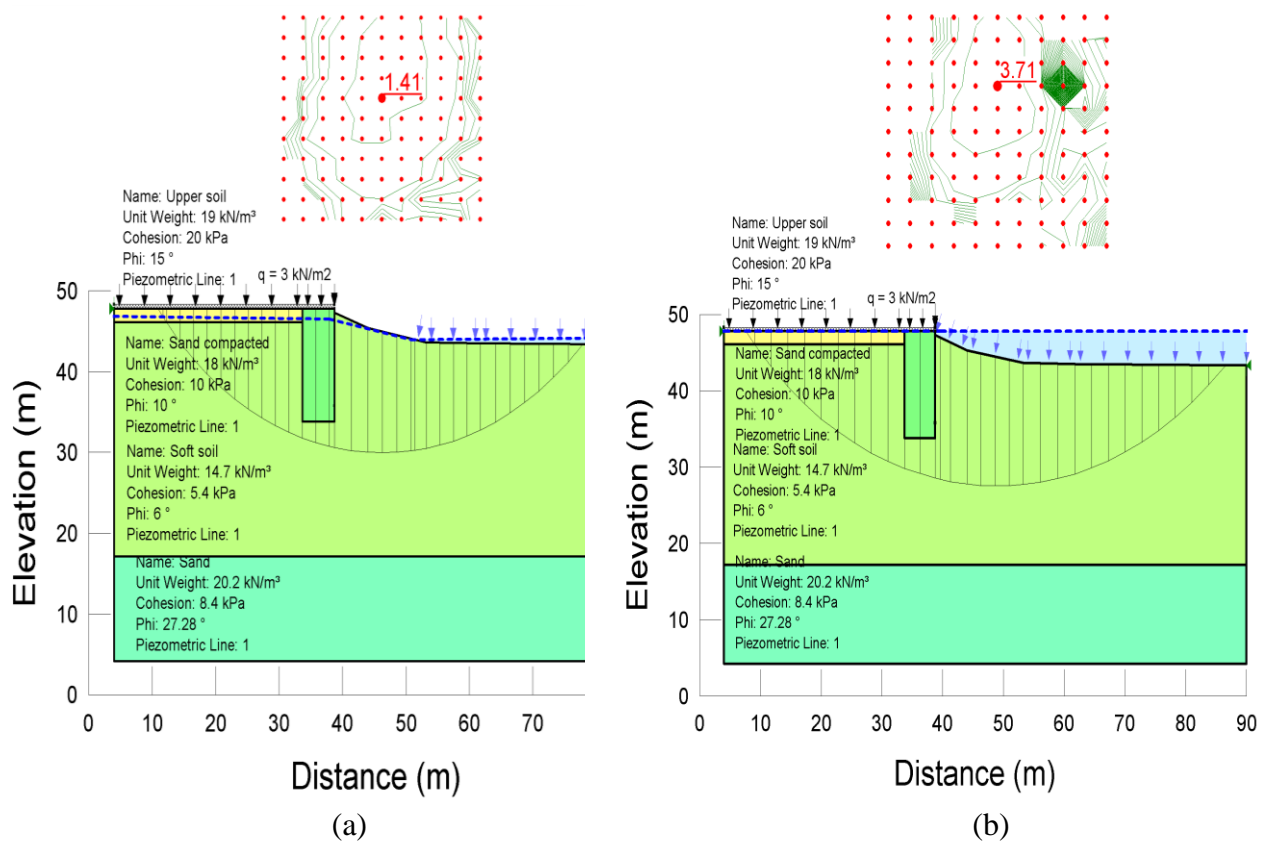
Figure 11. FS analysis for the proposed structure No. 1 using the Slope/W 2007 software for the highest and lowest water levels in the Long Xuyen river. (a) Slope stability analysis for the lowest water level in the river, (b) Slope stability analysis for the highest water level in the river

The analysis results using the Slope/W 2007 software are given in Table 3 and Figure 11. It can be seen that the FS of the both cases meet the requirement of the 22 TCN 262-2000 which is larger than 1.4. At the lowest water level in the river, the groundwater level in the soil mass also reaches the lowest level. The shear strength in the soil mass reaches the highest value due to the lowest pore water pressure value in the soil mass. The counter force of the water in the river in the front of the structure is lowest. The counter force decreases faster than the shear strength increases. Therefore, FS becomes the lowest. The annual statistics on sliding of An Giang Department of Natural Resource & Environment shows that a large number of sliding took place in the dry season or the lowest water level in the river.

On the contrary, at the flood season, the water in the river reaches the highest level and is maintained for months. The flood season which is also the rain season in An Giang may saturate fully the soil mass. Consequently, the shear strength in the soil mass reaches the lowest value. However, the highest water level in the river provides a counter force against sliding toward the river. This counter force affects immediately to sliding, whereas the shear strength loses slowly. Thus, the FS remains high.

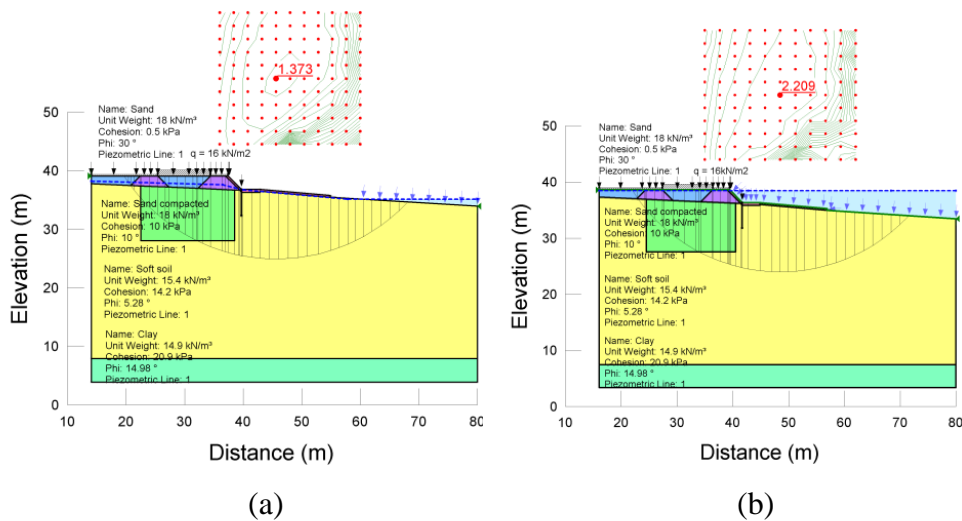
Figure 12. FS analysis for the proposed structure No. 2 using the Slope/W 2007 software for the highest and lowest water levels in the Long Xuyen river. (a) Slope stability analysis for the lowest water level in the river, (b) Slope stability analysis for the highest water level in the river

Similarly, the stability of this proposed structure was also analyzed using the Slope/W 2007 software. The results display in Table 4 and Figure 12. In this case, the *FS* at the lowest water level in the river is less than 1.4. However, this *FS* is acceptable because the calculated lowest water level (-1.00 m) only appears a few days in the dry season with a frequency of 1%, while the daily lowest water level in the river is around  $\pm 0.00$  m. Furthermore, An Giang authorities approved this proposed structure to reduce the total construction cost. In other words, this design qualified for the construction.

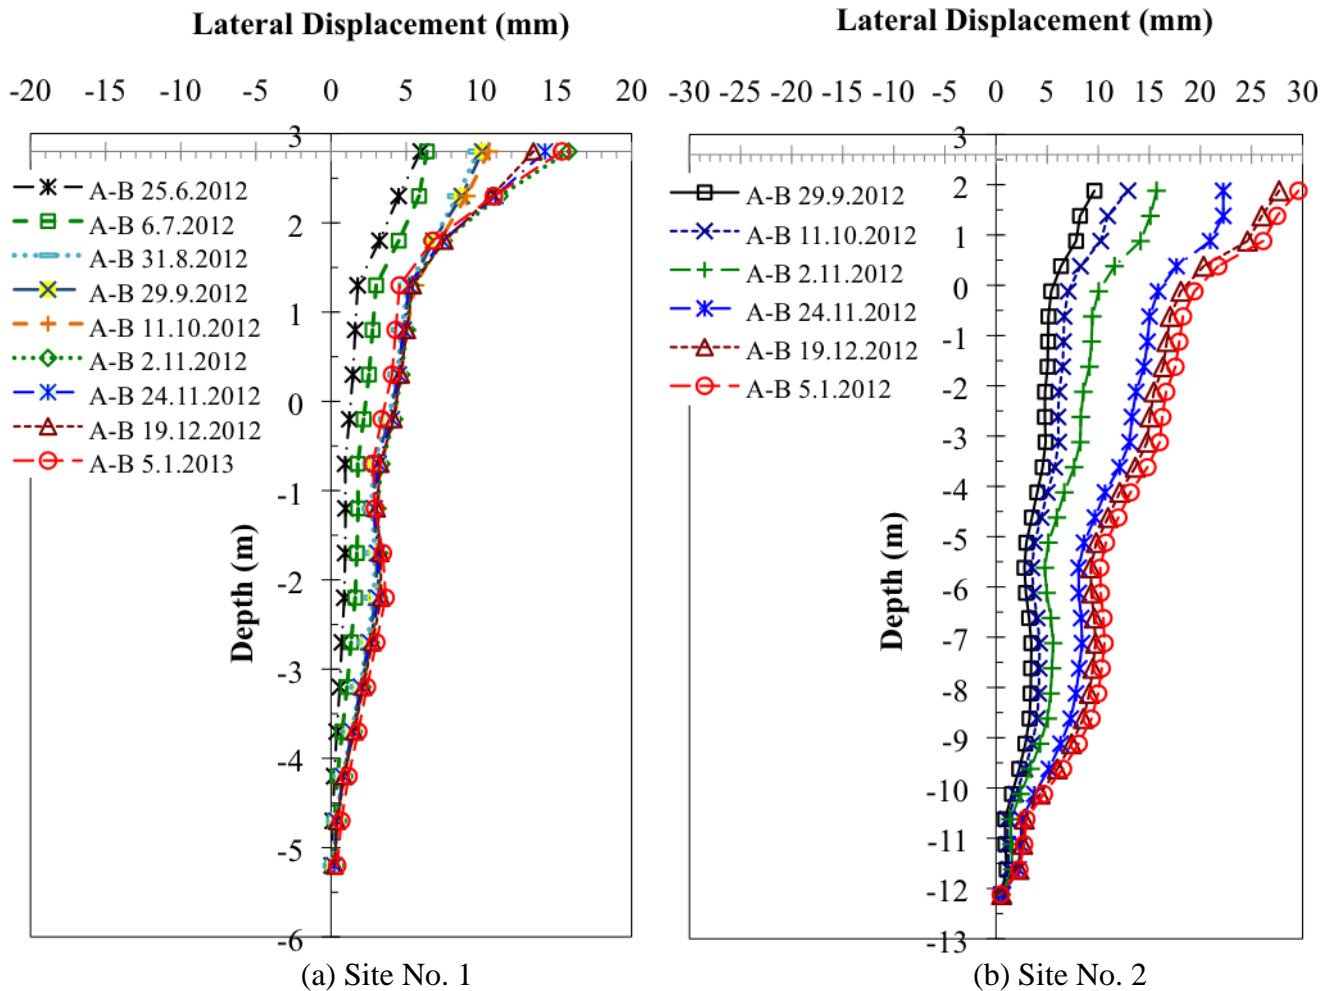
Figure 14. Monitoring results of lateral displacement for the two sites for six months

Groundwater fluctuation has been weekly and monthly measured and shown in Figure 13. Field lateral displacement measured using a Geokon inclinometer probe is plotted in Figure 14.

To verify field performance of the proposed structures, stability analysis using the Slope/W 2007 software was carried out using the field monitored data. The results (Table 5) indicate that the proposed structures have worked well after six months.
