EROSION MECHANISM OF NGA BAY RIVERBANKS, HO CHI MINH CITY, VIETNAM

Abstract

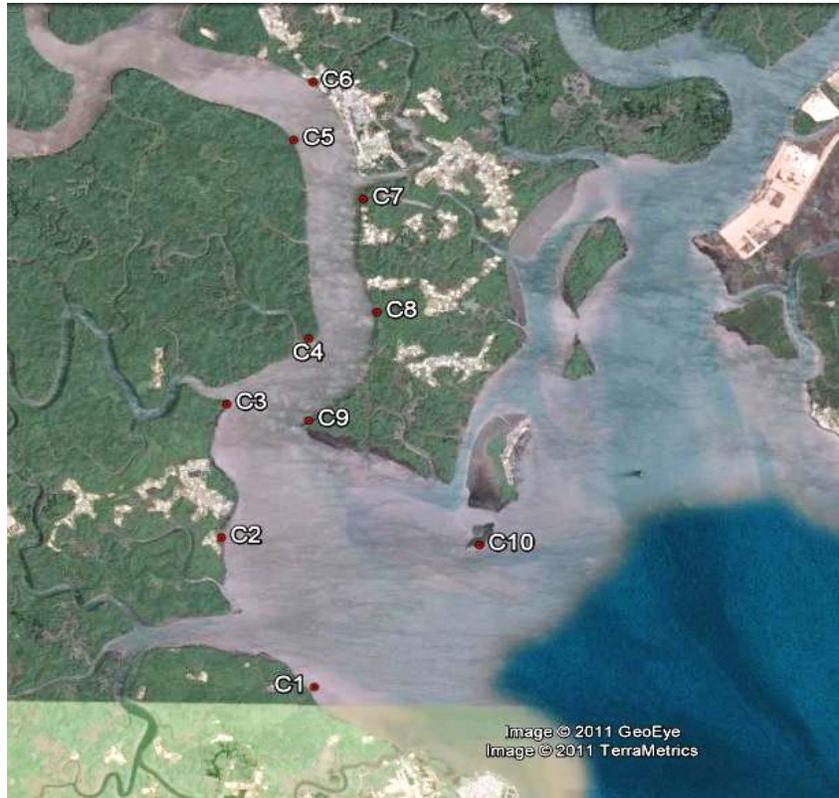
Figure 1. Study area and sampling sites [Google Earth 2012.5.12]

The authors investigated study area and took soil and water samples to determine riverbank materials and salinity of water. Thirty marking erosion pins were installed perpendicularly to the riverbanks (3 pins at each site, 3 m in length to each pin) at ten severe eroded sites along the riverbanks from October 2011 to November 2011 to estimate erosion rates. During the investigation, the impact factors on riverbanks like waves, tides, currents, mangrove forests, salt-ponds and shrimp ponds were also determined.

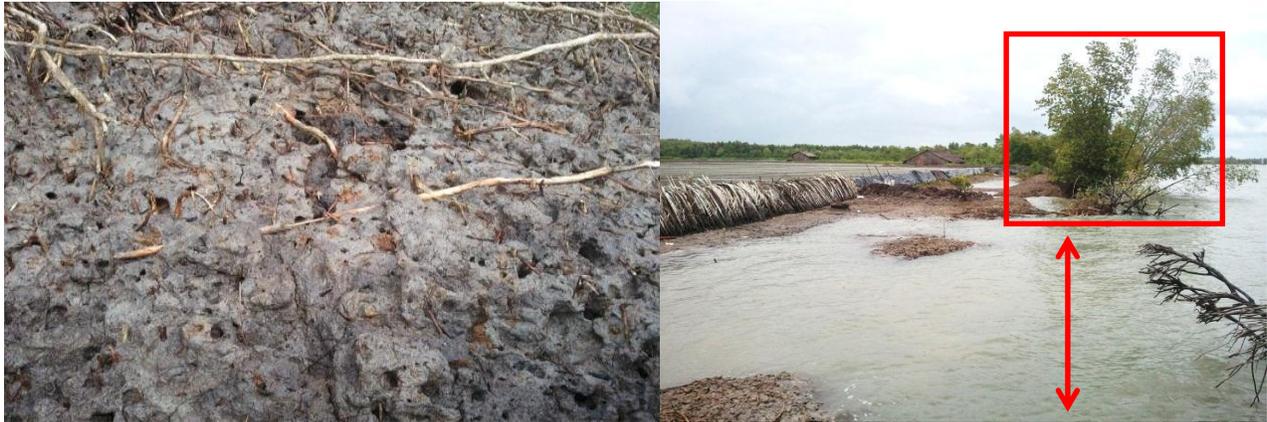
Figure 7. Burrowed holes of aquatic animals and weakened riverbanks

Along the riverbanks, mangrove tree fringes are dominated. The species of mangrove trees change from *Avicennia*, *Rhizophora* and *Nypa Palm*. These mangrove trees usually protect land from erosion. However, in the study sites, many mangrove trees have been collapsed because of hydraulic forces (waves, currents), exposed shallow roots to the environments and human factors. On the other hand, there are various aquatic animals such as crabs, shells, fish etc. which burrow and make many holes in the riverbanks. These holes will cause the mangrove trees unstable to waves and currents. Figure 7 shows shallow exposed roots of mangroves with many burrowed holes and weakened riverbanks.
