ASSESSMENT OF PRECAST WIDE U BEAM-COLUMN SYSTEM FOR MITIGATION OF STRUCTURAL FAILURE FROM SEISMIC HAZARD IN THAILAND

Ganchai Tanapornraweekit^{1*}, Rajendra Prasad Bohara¹, and Somnuk Tangtermsirikul²

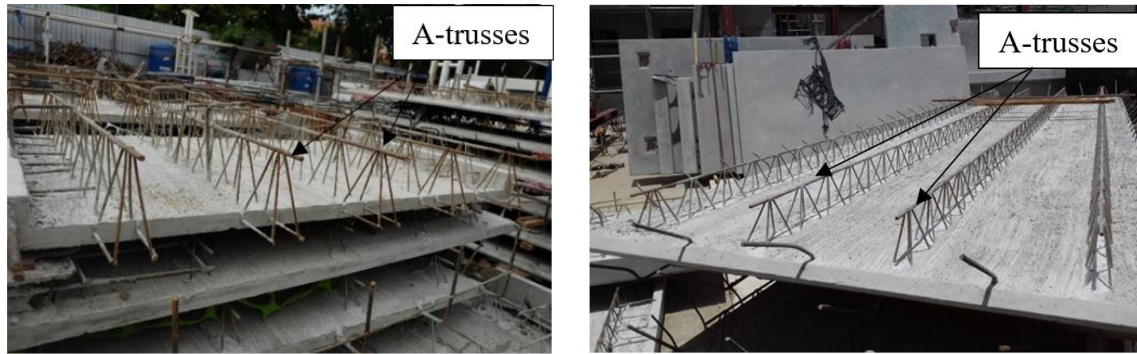
a. Precast U beam

b. Precast slab

Figure 1. Precast U beam and precast slab with A-trusses

The major components of precast wide U beam-column system are precast U beams and slabs with embedded A-trusses, precast columns and cast-in-situ concrete with post-tensioning. It is noted that the A-trusses work as a shear connection between the precast and the cast-in-situ concrete. Figure 1 shows the precast U beam and slab with A-trusses.

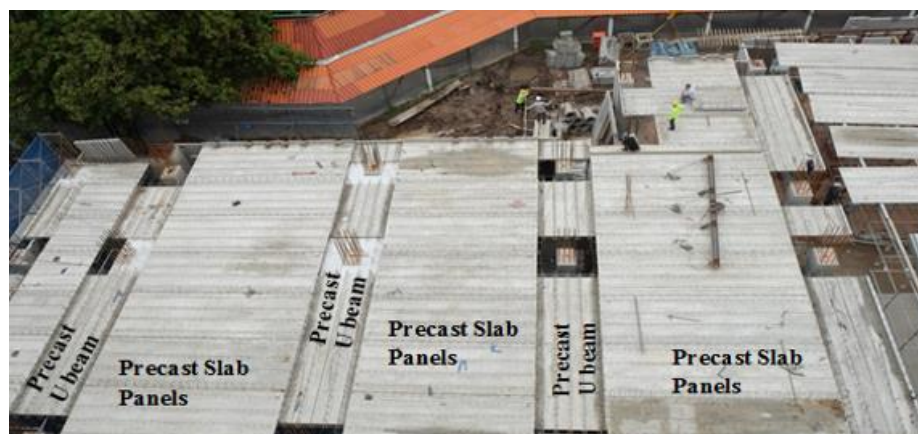
Figure 2. Precast U beam-column system during construction

After the erection of columns of a lower storey, scaffolding is set up and the precast panels are installed over it. The precast wide U beams are laid along the weak axis of the building and the one-way precast slab panels are spanned on these U-beams. These precast panels (U beam and slab) serve as permanent formworks. It is worth noting that no precast member is used in the vicinity of the joint but only the cast-in-situ concrete is used in the joint region. The adoption of cast-in-place concrete only in the joint region is expected to ameliorate the structural integrity of the precast system. A typical layout of the precast U beams and precast slabs during construction is shown in Figure 2.

After the installation of precast members and formwork in the joint region (as shown in Figure 2), joint reinforcements, beam rebars, and post-tension cables are set up. Then, cast-in-situ concrete is poured over the precast members. Post-tensioning is applied to the installed cables four days after casting of the cast-in-situ concrete.

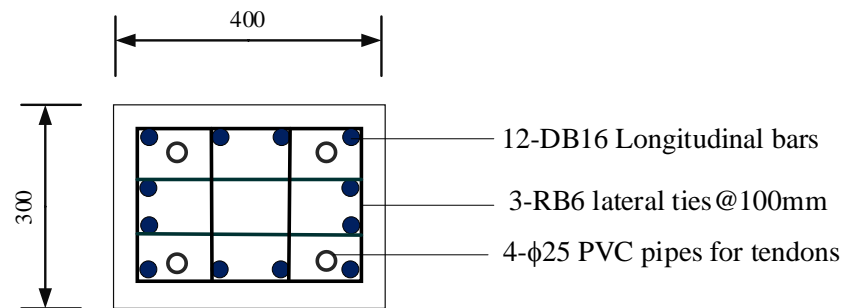
a. Details of precast column

Figure 3. Details of precast column and composite wide beam (unit: mm)

A precast column with dimensions of 300mm×400mm×1800mm consists of 12-DB16 rebars as longitudinal rebars and 3-RB6@100mm as lateral ties. Four PVC pipes with a diameter of 25mm are provided in the precast column to insert pre-stressing tendons (see Figure 3a). The elevation sizes of the half-scale composite wide beam are 180mm×1000mm, which consist of two layers of concrete (50mm precast and 130mm cast-in-situ). RB6 U bars @150 mm and three rows of RB6 A-trusses are rooted in the precast U beam (see Figure 3b). At the top and bottom of each A-truss, additional RB6 bars are welded. At the corner of precast U beam, 2-RB9 rebars are installed and tied with RB6@100mm bars. 7-RB6 bars are provided throughout the span as top longitudinal bars. Furthermore, RB6 rebars are distributed at the spacing of 250mm in transverse direction.

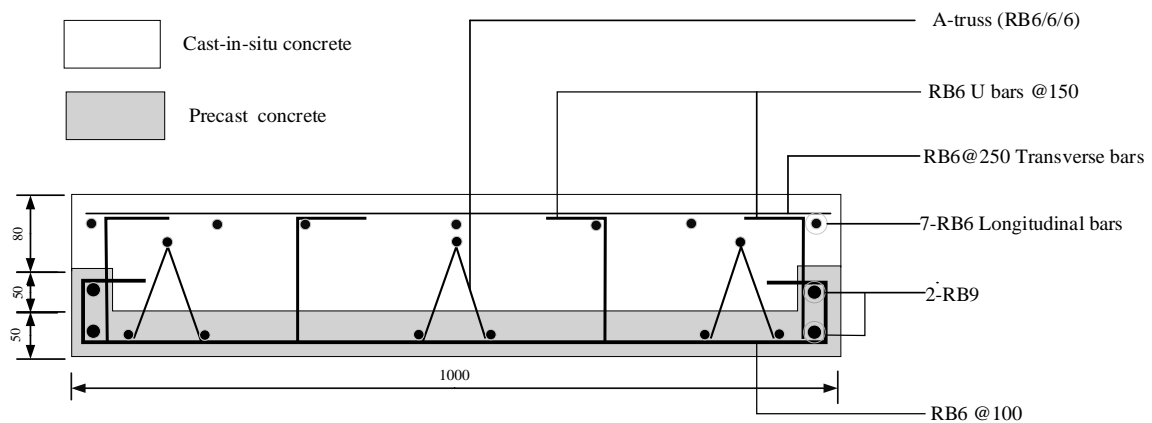
b. Details of wide beam

Building of Sirindhorn International Institute of Technology, where the investigated joint is between two unequal spans. Therefore, the tested specimen has unequal beam span lengths. The details of the half-scale specimen are presented in Figure 3.

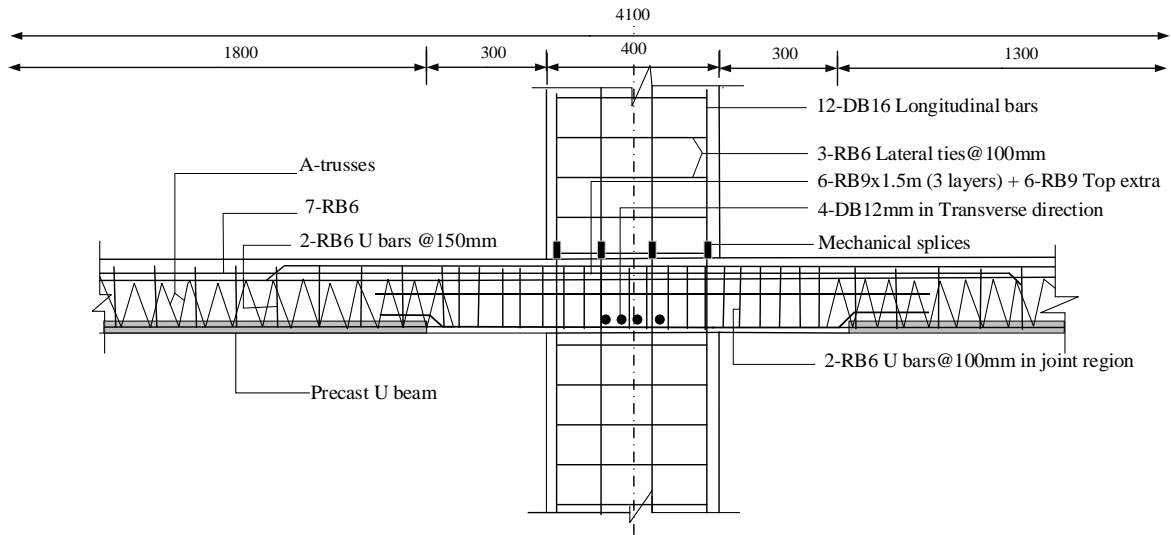
Figure 4. Longitudinal section of precast wide U beam-column interior joint (unit: mm)

As shown in Figure 4, three layers of 6-RB9 rebars having a length of 1.5m are distributed in the joint region. On the top reinforcement layer in the joint region, extra 6 RB9 rebars with a length of 1.5m are provided. Also, 4-DB12 bars are provided in both longitudinal and transverse directions of the joint. The spacing of U bars is reduced to 100mm in the joint region.

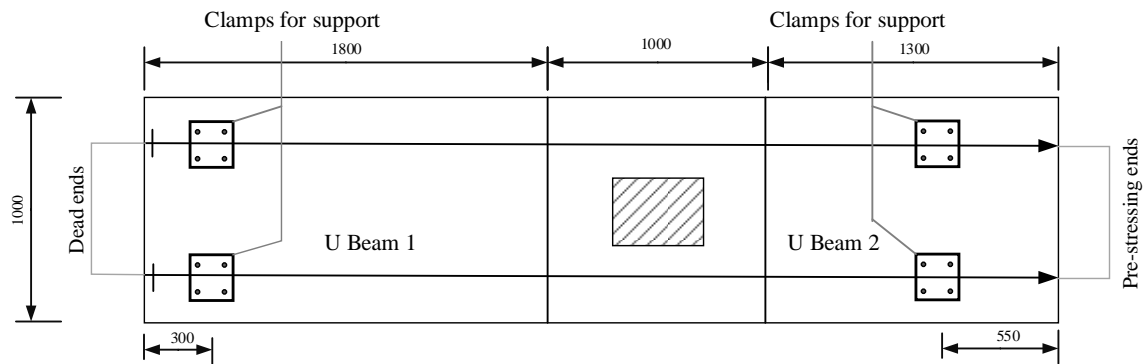
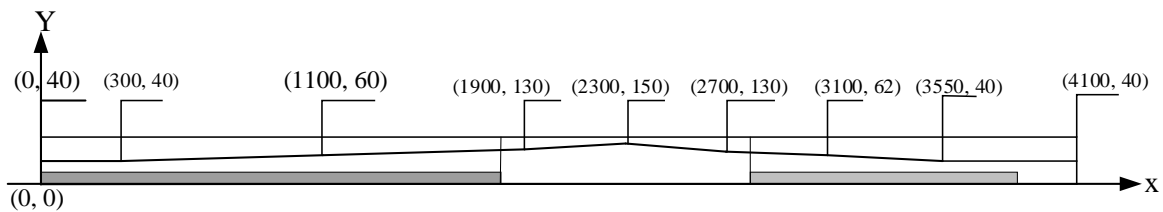
a. Tendon layout

b. Tendon profile

Figure 5. Details of tendons (unit: mm)

7-wire 2-strand tendons with a parabolic profile were used to prestress the U-beam. The layout and profile of the tendons are presented in Figure 5. It is worth mentioning that an extra 250 mm cast-in-situ concrete was added at prestressing end of the beam in order to provide a uniform prestressing force to the section of the wide beam. Therefore, distances of clamps from beam ends on short and long spans are 550 mm and 300 mm, respectively.

The crack patterns observed at various drift ratios are presented in Figure 10. The tested specimen exhibited the first crack at the second cycle of 0.35% drift ratio on the longer span (U Beam 1 in Figure 5a). The first crack originated from the bottom face of the wide beam and propagated upward to the upper face of the beam (see Figure 10a). A decrease in the slope of hysteresis curve was observed due to the formation of this crack (see Figure 7).

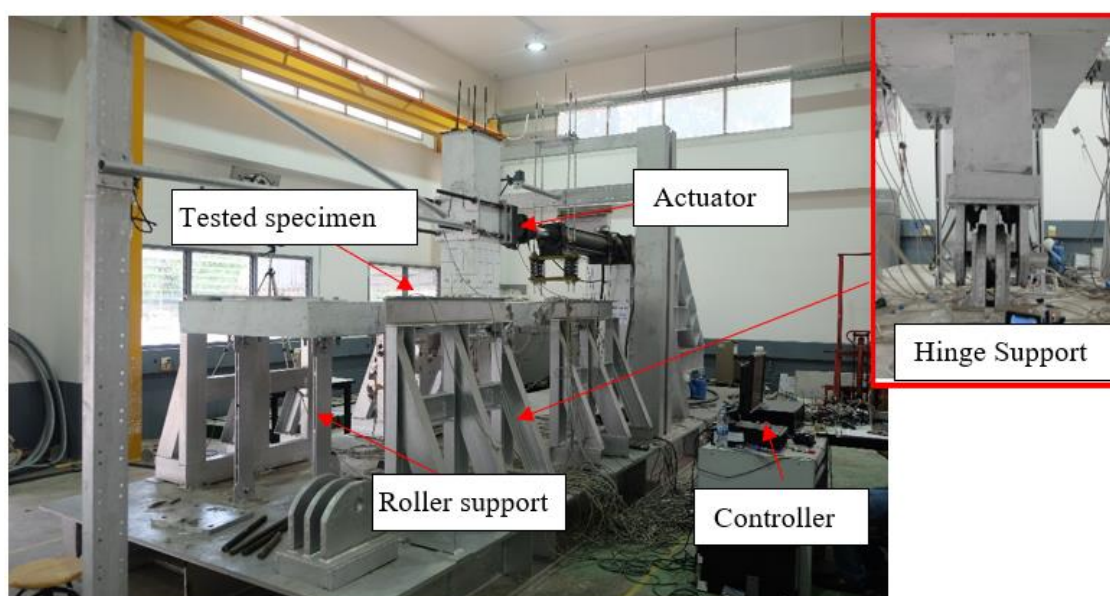
Figure 6. Test set up of the wide U beam-column joint specimen under lateral cyclic load

Similar to the previous researches [9][10], only the portion between inflection points was prepared and set up for the testing. The ends of the beam were supported with rollers whilst hinge support was assigned at the column base. An axial load on the column was applied through four prestressed tendons. Each tendon was subjected to an axial load of 9.8 tons. The application of the axial load on the column represents the gravity load from upper stories. A detailed illustration of the test set up is shown in Figure 6.

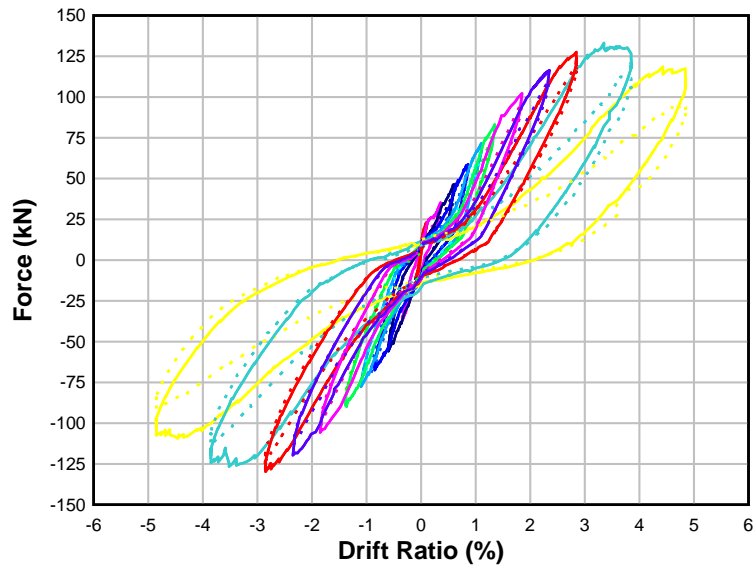
Figure 7. Hysteresis curve

The hysteresis curve (force-displacement) obtained from the experiment is shown in Figure 7. The solid and dashed lines in Figure 7 represent the hysteresis curves for the first cycle and second cycle of loading, respectively. The tested post-tensioned precast wide U beam-column interior joint exhibited the drift capacity (drift at peak load) of 3.35% and 2.85% in positive and negative cycles, respectively. The asymmetric drift capacity of the joint was mainly due to its unequal beam span lengths. The specimen was tested till 4.85% drift in both positive and negative cycles.

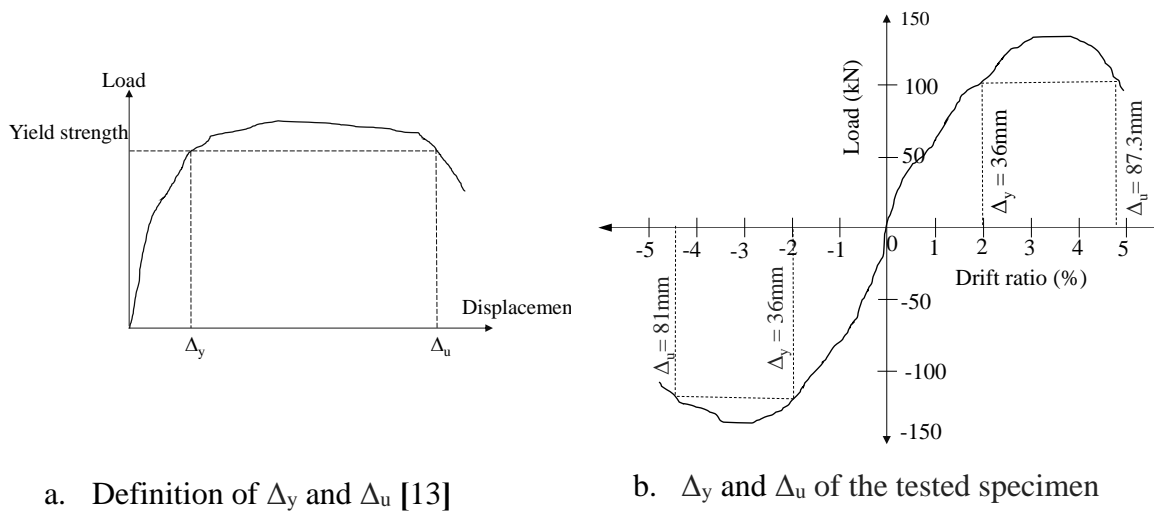
a. Definition of Δ_y and Δ_u [13]

b. Δ_y and Δ_u of the tested specimen

Figure 8. Yield and ultimate displacement of the specimen

After attaining the peak load, the specimen exhibited a rapid load drop (28% of the peak load) with the increased drift ratio. Crushing of concrete was observed on the wide beam near the column face. Ductility factor (μ), which is the ratio of ultimate displacement (Δ_u) to yield displacement (Δ_y), was adopted to evaluate ductility of the structure. As per JSCE guideline [13], Δ_y is the displacement when the main tensile reinforcement yields, and Δ_u is the maximum displacement at which load is equal to yield strength. Definition of Δ_y

and Δ_u are presented in Figure 8a [13]. The values of Δ_y and Δ_u for the tested specimen are shown in Figure 8b. It is worth mentioning that longitudinal bars of both column and beam yielded at 2% drift, which was equivalent to the lateral displacement of 36 mm. More details of the measured strain in rebars will be presented in the section “Strain Development in the Joint Core”.

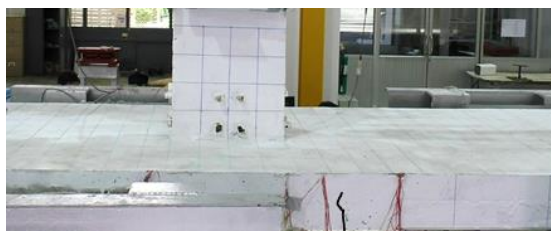
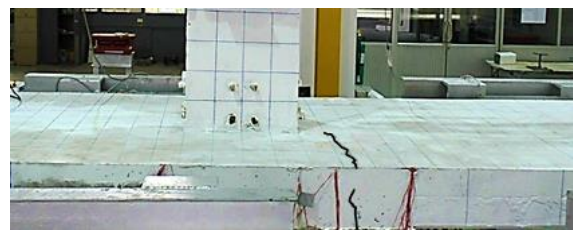
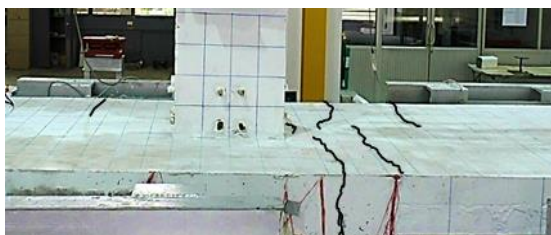
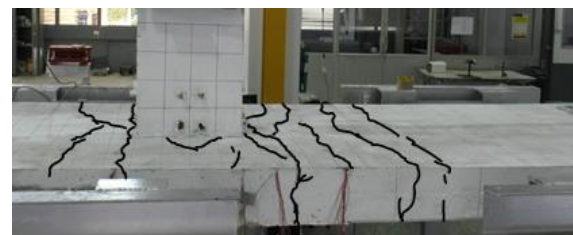
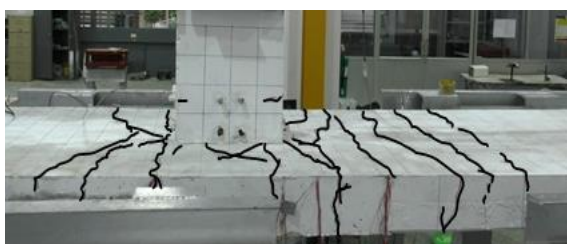
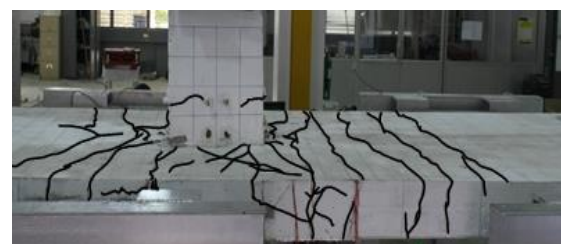
Figure 10. Crack patterns at various drift ratios

The first transverse crack on the top face of the wide beam was initiated at the drift ratio of 0.60% (see Figure 10b). This crack was located exactly above the first crack, which merged with this newly formed crack at 1.10% drift ratio. These transverse cracks were generated due to flexural action in the beam.

The first diagonal shear crack appeared at the drift ratio of 1.10% (see Figure 10c). After 1.10% drift ratio, several diagonal shear cracks were observed on both short and long spans of the tested joint specimen. Two diagonal cracks crossing each other on the beam near side face of the column appeared at the drift ratio of 1.85% (see Figure 10d). With the increasing drift ratio from 1.85% to 3.85%, these cracks became longer and reached the outer edge of the beam at 3.85% drift ratio (see Figure 10f). These cross-cracks in the joint witnessed the presence of torsional force in the joint vicinity when subjected to lateral cyclic load.

The yielding of rebars in the joint core can introduce some damages in the joint core, which should be prevented. Therefore, some improvements in the detailing of the joint core are required to apply to the system constructed in a high seismic zone. In this system, the width of the beam is wider than that of the column. As a result, bending stresses generated due to cyclic loading in the outer zone (away from column) of beam cannot be directly transmitted to the column core. These residual bending stresses on beam generate torsion. Therefore, additional reinforcement to account for this torsion should be considered for modification of reinforcement detailing in the future. It is noted that the torsional cracks can be observed in Figure 10d, 10e and 10f.

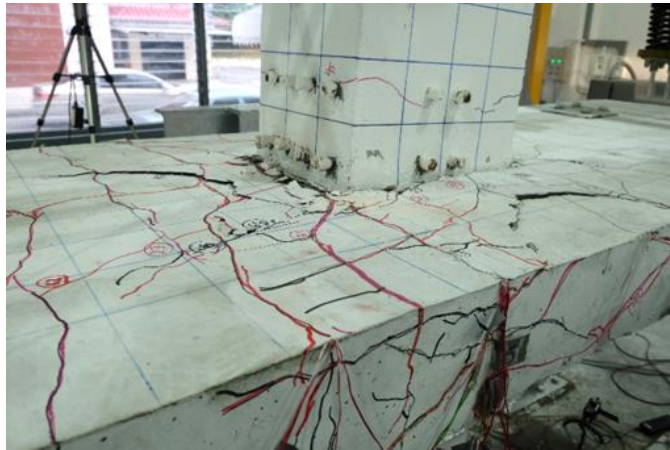
Figure 11. Crack pattern and concrete crushing around the joint region of the tested specimen at 4.85% drift ratio

Even though the wide beam experienced severe damage, there is no significant damage on the column up to 4.85% drift ratio. The diagonal shear cracks and transverse flexural cracks were the major crack types observed on the tested beam-column joint structure. Based on the observed damage on the tested specimen, it is worth mentioning that the specimen showed a strong column – weak beam behaviour. Only minor flexural cracks were observed on the column and there is no sign of rebar buckling failure in the column during the lateral cyclic load test. However, in addition to the aforementioned cracks, wide beam exhibited crushing. The crack pattern and crushing of concrete around the joint region of the tested specimen at 4.85% drift ratio is shown in Figure 11.

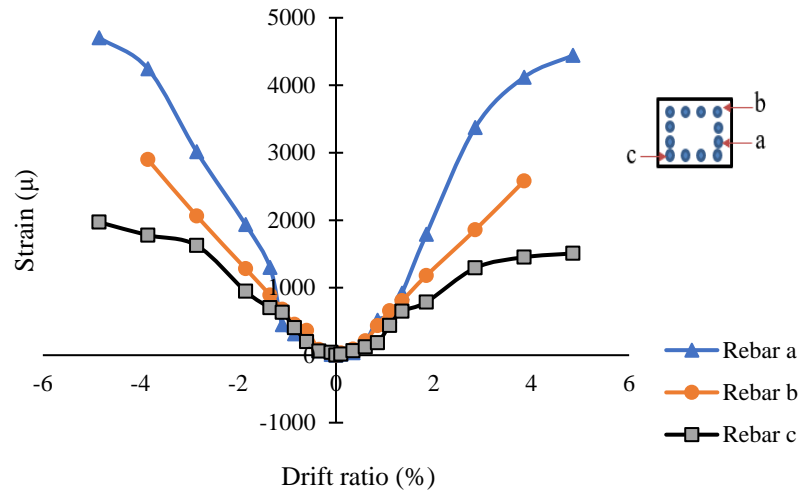
Figure 12. Strain development in the column rebars in the joint core

Beam-column joint core plays a vital role in maintaining the safety of a building frame. Therefore, design of an intact joint core is essential for a robust lateral load resisting structural system. In order to examine the behavior of the joint core of the tested specimen, strain gauges were attached on the longitudinal bars in the column of the joint region. The strain development in the column longitudinal reinforcement bars at different locations, and the first yielding of the longitudinal bar in beam are presented in Figure 12 and Figure 13, respectively.

Among the measured rebars, depending on the location the column cross section, the rebars yielded at different drift ratios. The rebar ‘a’ yielded first at 2.00% drift ratio in negative cycle and 2.15% drift ratio in positive cycle. Then, the rebar ‘b’ yielded at 3.00% drift ratio in both cycles. The rebar ‘c’ reached the yielding strain at 4.85% drift ratio in the negative loading cycle only. This deviation of strain in positive and negative loading cycles was mainly due to asymmetric span lengths of the beam. During the early cycles of lateral load, strain measured at different rebars did not exhibit a significant difference. However, strain of different rebars varied remarkably after 1.50% drift ratio. In comparison to the mid rebar (rebar ‘a’ in Figure 12), the corner rebars showed smaller strain in the joint core. This behavior was due to the presence of prestressed tendons (used to apply axial load to the column) near the corner rebars. Since some part of the tensile stress in the joint core is carried by the tendons, strains in the nearby longitudinal rebars was found to be lower than those in other positions.

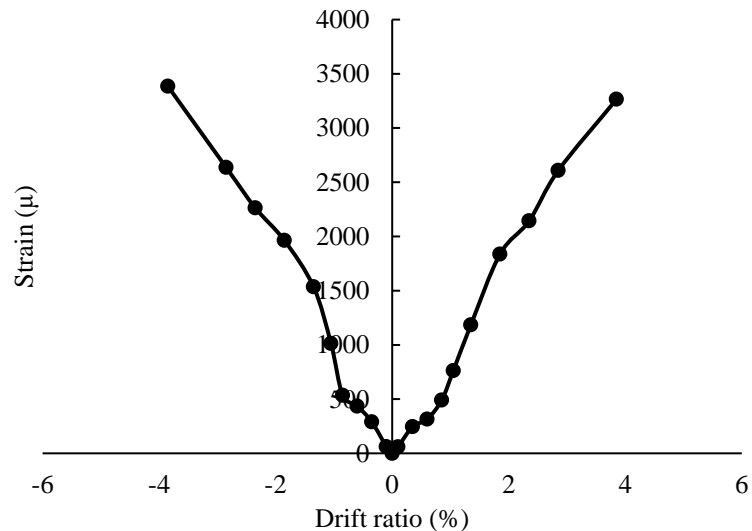
Figure 13. Strain development in the beam longitudinal bar passing through the joint core
