# POWER LOSS REDUCTION OF DISTRIBUTION NETWORK IN DENSELY INDUSTRIALIZED COASTAL BELT BY DEVELOPMENT OF HYDROPHOBIC COATING APPLYING ACCELERATED AGING FOR CERAMIC INSULATOR

Basit Ali\*, Abdul Attayyab Khan, Ahsan Ali, Marya Maqsood, Rohma Nisha

Department of Electrical Engineering, Bahria University Karachi Campus, 13 National Stadium Road, Karachi, Pakistan

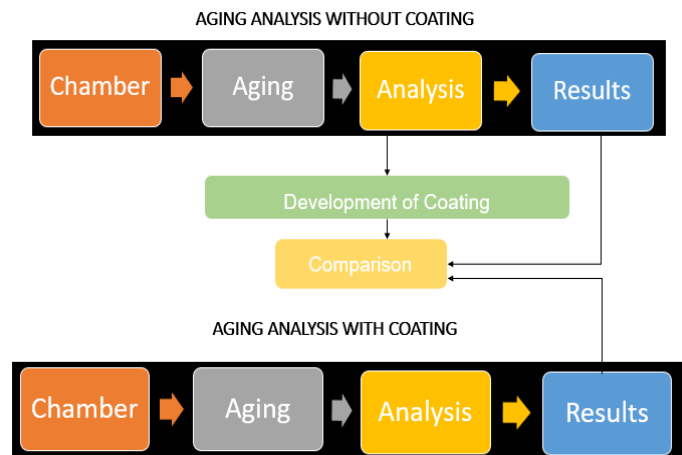
Figure 4 Block Diagram of the System

pH of the water is measured using a sensor installed in an experimental chamber. Noted and observed every referenced year temperature, rain rate, and dust deposition alongside humidity. It will repeat itself in three cycles for each year. After performing the aging analysis on five years of collected contamination from the surface of the insulator, its weight will measure the contamination for observation and analysis. Alongside the experiment, the camera will be recording the whole process from inside the chamber. The same will repeat by applying hydrophobic coating on the sample of the insulator. A camera installed in the experimental setup recorded all the steps, alongside the sensors working automatically on the input reading provided. Figure 4 depicts the complete block diagram of the system.

To perform accelerated aging referencing, one of the periods of 5 years (2015-2019) on an insulator sample modeled for an industrialized coastal area, the team designed an experimental chamber. The block diagram shows the complete flow of the experiment. Based on acquired data of rainfall area and minerals present in the rainwater salts has been added. Salts description and quantity are mentioned below in Table 1.

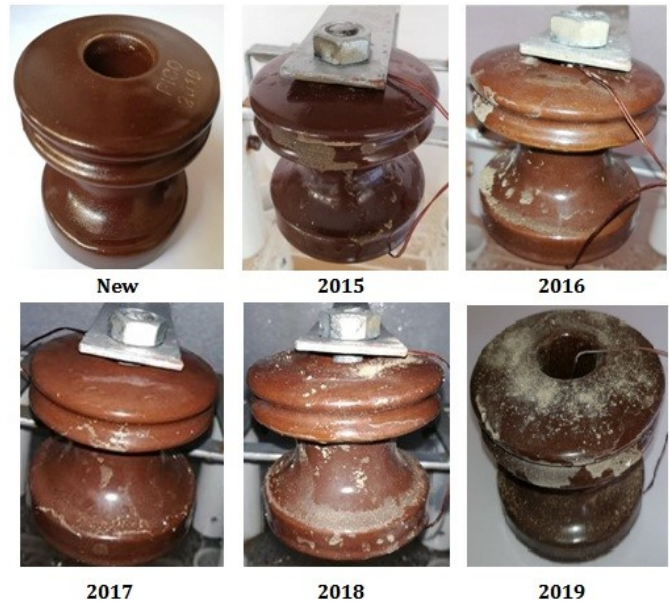
The accelerated aging process is executed for an uncoated insulator for five years in the experimental chamber within the given data of rain, temperature, humidity, fog, and dust. The feedback sensors controlled and monitored the complete process. Table 2 shows the weather conditions set for an accelerated aging process for each year. Also, figure 5 will be showing images for each year of aging.

**Figure 5** Accelerated aging of uncoated insulator as per coastal area weather condition

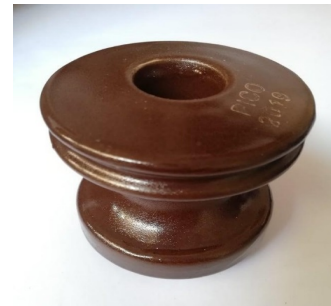
The Hydrophobic coating containing nitrocellulose dissolved in a solvent mixture of hydrocarbons applied on the insulator sample was kept aside for 16 hours to dry. Figure 6 shows the coated insulator sample.

**Figure 6** Insulator after applying Hydrophobic coating

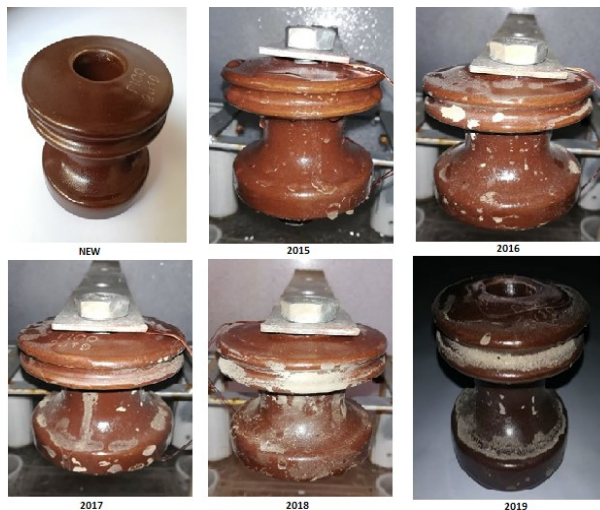
After the aging process on an uncoated insulator, the accelerated aging process for a coated insulator will be done for five years in the experimental chamber on the given weather data of rain, temperature, humidity, fog, and dust. Feedback sensors control and monitor the complete process. Weather conditions set for an accelerated aging process for each year have shown in Table 3. Figure 7 shows the images for each year of the accelerated aging processes.

**Figure 7** Accelerated aging of coated insulator as per coastal area weather condition

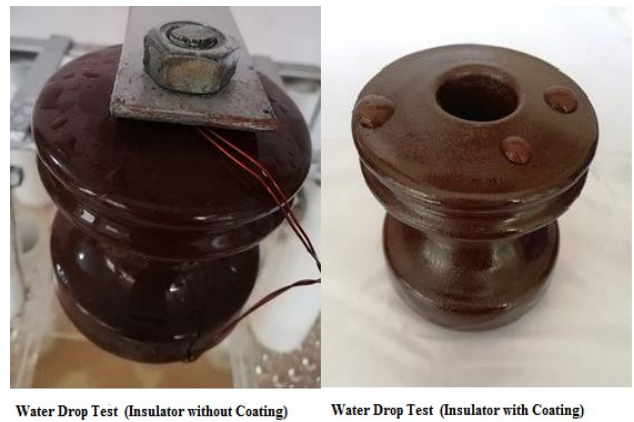
Water drop test containing minerals ( $MgCl_2$ ,  $KCl$ ,  $CaCl_2$ ) was performed on coated and uncoated insulators and kept under the same for 10 minutes and dry under artificial sunlight in the aging chamber. The water on the coated insulator vanishes out quickly as compared to the uncoated insulator sample. The ease in water flow helps limit the contamination layer formation eventually, resulting in fewer power losses due to the coating applied. Figure 8 shows the comparison results.

**Figure 8** Water drop test on coated and uncoated insulators
