# MECHANICAL PROPERTIES OF CARBON NANOTUBES-MODIFIED EPOXY GROUT FOR PIPELINE REPAIR SYSTEM

Hanis Hazirah Arifin<sup>a</sup>, Nurfarahin Zainal<sup>a</sup>, Libriati Zardasti<sup>a\*</sup>, Nordin Yahaya<sup>a</sup>, Lim Kar Sing<sup>b</sup>, Norhazilan Md Noor<sup>a,c</sup>

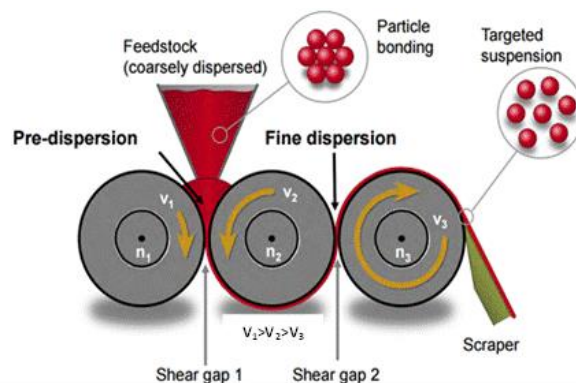
**Figure 1** Schematic of the calendaring process (Source: EXAKT Advanced Technologies GmbH [21])

An appropriate dispersion technique was applied to CNTs in order to totally utilize the unique properties of this special material. Before the mixing process, these carbon nanoparticles were pre-dispersed in acetone using Hielscher Ultrasonic Homogenizers UP200s (Hielscher Ultrasonics GmbH, Germany) according to the prepared weight percentage and were left to evaporate for 24 hours at room temperature. It then underwent another dispersion using Three-roll mill EXAKT 80E (EXAKT Technologies, Inc.) with resin as shown in Figure 2. The calendaring process was applied four consecutive times. The resin with CNTs mixture was poured directly into the first roll, sheared in Gap 1, and followed by Gap 2. The sheared mixture was then manually poured back into the machine for the next process. The rollers turned at a speed ratio of 9:3:1 and the time taken for each calendaring was approximately 10 minutes. The parameter details of the three-roll mill process such as gap size between the rollers and the speed (represent the lowest speed) are tabulated in Table 1. Figure 1 and Figure 2 show the schematics and process of dispersion using the three-roll mill machine.

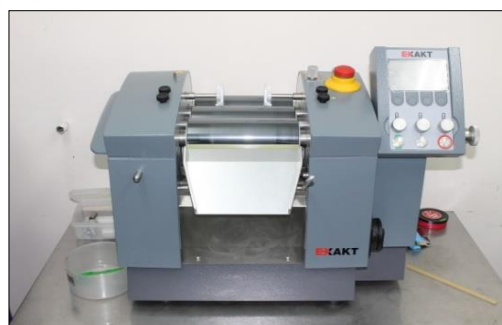
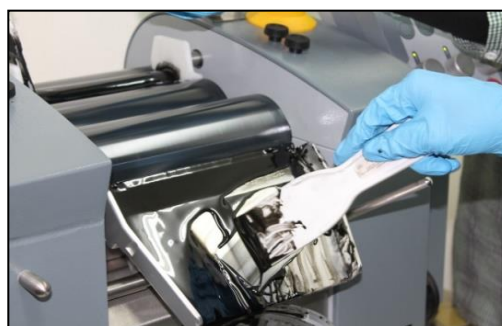
**Figure 2** Dispersion process using three-roll mill machine

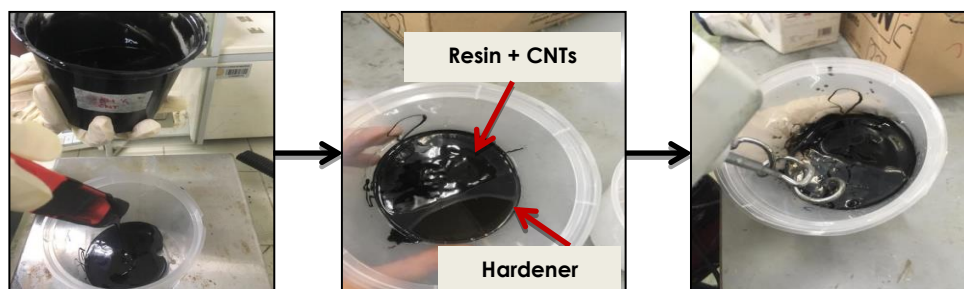
Figure 3 Mixing process of modified epoxy grout

The specified composition of resin and hardener in the ratio of 2:1 was mixed together at the room temperature. The mixing process of CNTs/epoxy nanocomposite with hardener was done thoroughly in a clean dry container; denoted as modified grout; by using an electrical hand mixer at low speeds until a smooth consistency specimen was achieved as shown in Figure 3. Then, the mixture was transferred into the designated moulds and left for 24 hours at room temperature for curing process. Prior to testing, all cured specimens were polished to eliminate any impurities and defects on the surface of the specimen. Later, the modified epoxy grout will be compared with the existing commercial epoxy resin grout, denoted as neat epoxy grout. The above mentioned steps were also used in preparing the neat epoxy grout.

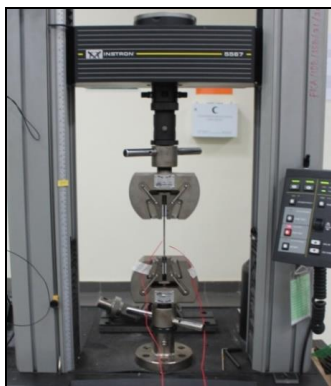
Figure 4 Universal Testing Machine (INSTRON 5567)

To evaluate the effects of adding CNTs into the infill material, laboratory testing on the infill properties was carried out by referring to the industry standards. Table 2 shows the summary of mechanical properties tests for all grouts. Relevant standards and practices are also shown in Table 2. All the tests were carried out using a Universal Testing Machine (INSTRON 5567) with the capacity of 25 KN as shown in Figure 4. The strain gauge was used in the compressive and tensile test to determine Young's modulus of tested grouts. A Low Voltage Displacement Transducer (LVDT) was used in the flexural test to measure the deflection at the midspan. Data logger (TDS-530) was used to record the strain and LVDT value throughout the test. A minimum of five specimens of each grout were tested for each property.

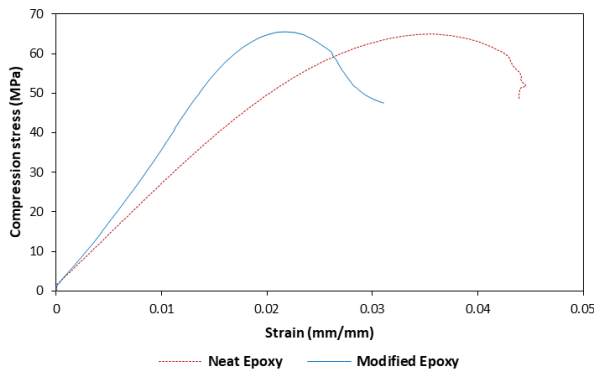
**Figure 5** Stress-strain curves for compression specimens

Figure 5 shows the typical stress-strain curves behaviour of the neat and modified epoxy grout. Both of the tested grouts show similar behaviour to each other. Based on the graph, both tested grouts exhibited a linear response during the initial loading stage, followed by strain softening behaviour beyond its ultimate compressive strength. The tested grouts demonstrated ductile behaviour with noticeable deformation after the initial elastic behaviour and no

sudden failure had occurred throughout the testing. The plots illustrate that the modified epoxy grout shows the stiffer slope at the elastic region.

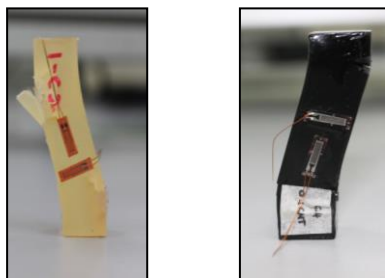
(a) Neat epoxy grout (b) Modified epoxy grout

**Figure 6** Specimens failure under compression

The failure patterns of the tested grout under compression loading are shown in Figure 6. Both tested grouts exhibited a noticeable deformation as they started to buckle after the initial elastic zone. The top and bottom of the specimens experienced maximum stress as the initial cracks were spotted in that area. It was then followed by gradual reduction in stress before failure. Through observation, no lateral expansion occurred on the tested grout specimens.

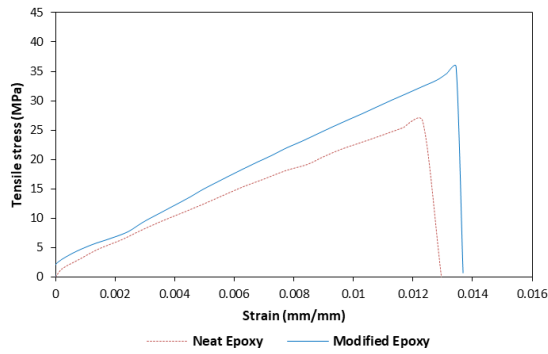
Figure 7 Stress-strain curves of tensile specimens

Figure 7 and Figure 8 show a typical stress-strain curve and failure pattern for the tested grouts under tensile loading. Both grouts exhibit lower strength as well as lower ductility under tension as compared to its respective compressive strength. Based on the plotted graph, the tested grouts show linear elastic behaviour at the initial region, which exhibit ductility stage before its failure and there is no plastic deformation detected during the test. Under tensile load, the failure of specimens has occurred without noticeable deformation and sudden failure occurred as the material reaches its ultimate tensile strength. All grouts have undergone fracture due to splitting which is perpendicular to the length of the specimen.

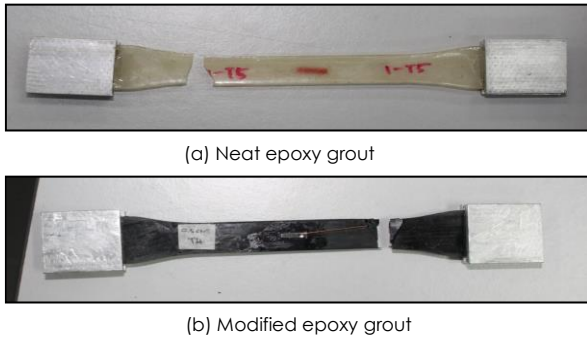
Figure 8 Specimens failure under tension

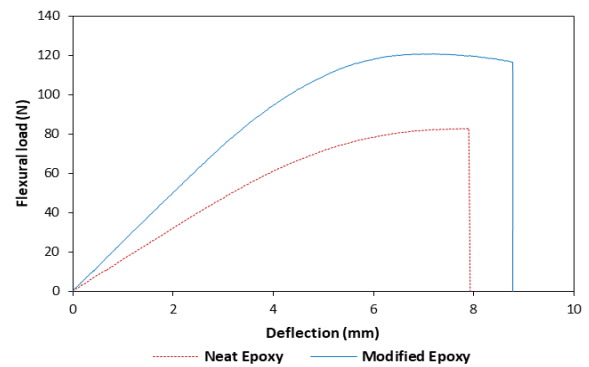
Figure 9 Load-deflection curves of flexural specimens

Table 5 represents the summary of the strength and modulus of tested grout under flexural. From the table, the modified epoxy grout has higher flexural strength and stiffness compared to neat epoxy grout with 78.41MPa and 2.16 GPa respectively. This is an increment by 29% and 27% for flexural strength and stiffness respectively. The comparison of the load-deflection behaviour of the grouts in flexural testing can be seen in Figure 9. Both grouts demonstrated linear elastic load-deflection behaviour prior to failure. The load-deflection behaviour of neat epoxy grout shows lower strength than the modified epoxy grout, but not much difference in deflection. Through observation on the crack formations on the surface of the grouts, the visible wedge was formed at the middle of the specimen indicated that the crack occurred from the bottom part (tension) and propagate to the top part (compression) as shown in Figure 10. The enhancement in strength for the modified epoxy grout can be explained by taking into account the orientation of the CNTs in the matrix, which might be in line with the axis and almost perpendicular to the loading. Due to that orientation, the load transfer from the matrix to the CNTs particles needs to be large enough for it to be broken under flexural loading.

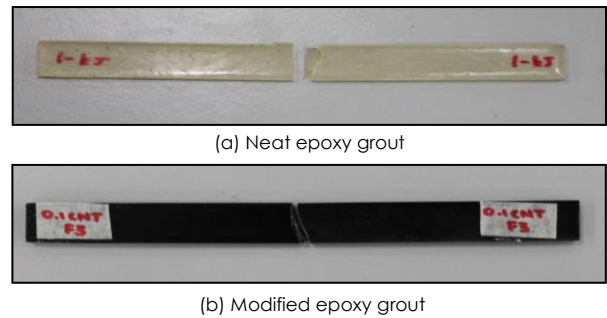
Figure 10 Specimens failure under flexural
