# RETROFITTING OF SELF COMPACTING RC HALF JOINTS WITH INTERNAL DEFICIENCIES BY CFRP FABRICS

Qasim M. Shakir\*, Baneen B. Abd

Department of Civil Engineering, University of Kufa, Najaf, Airport Street, Iraq

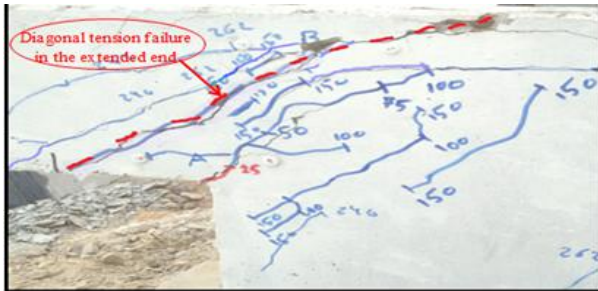
Figure 9 Loading history for specimens HCONT-A

Figures 9 and 10 show the cracking history for specimens HCONT-A,  $a/d=1.5$  and HCONT-B,  $a/d=1.0$ . The effect of moment is more obvious and the

compression force at the top fibers of the specimen HCONT-A is higher than for the specimen HCONT-B. Therefore, it is obvious that the crack emanating from the support starts with an angle of about  $60^\circ$  and tends to be horizontal gradually with loading progress.

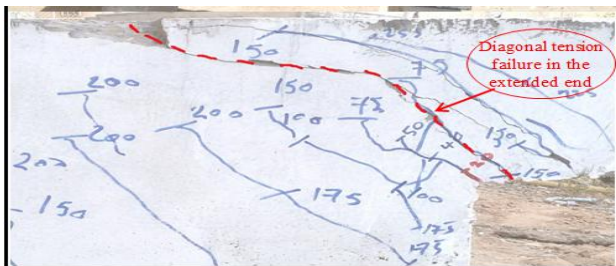
Figure 14 Crack pattern for specimen NCONT-B

For specimen NCONT-B, it can be seen that the first crack initiated at the re-entrant corner and cracks propagated around with more loading but the reduction in NR (nib reinforcement) results in increasing the effect of bending moment at a rate less than NCONT-A. Thus, crack that developed the failure plane shifted accordingly to the support reaction. In addition, the angle of crack is about  $45^\circ$  but when reaching the compression zone, the angle of crack became less due to the effect of the compressive force at the upper face. This can be explained as the lack of tension reinforcement within the extended end resulted in reducing the flexure resistance. In addition, increasing  $a/d$  value resulted in increasing bending moment. All these led to formation of crack of the flexure type. Moreover, due to the weakness and reduction in stiffness at the junction, Most of cracks will propagate at this region. Noticeable curvature at the junction occurred due to the lack of BM resistance. Thus, increasing the compression force at the top fibers, which increased with loading progress. For specimen NCONT-A, at load level of 182 kN, spalling at the top layers occurred. This resulted in a rapid failure, because it reduced the vertical path to be followed by flexure cracks. Regarding the intensity of cracks within the full depth beam, less number of cracks can be seen with adopting small ( $a/d$ ) values.

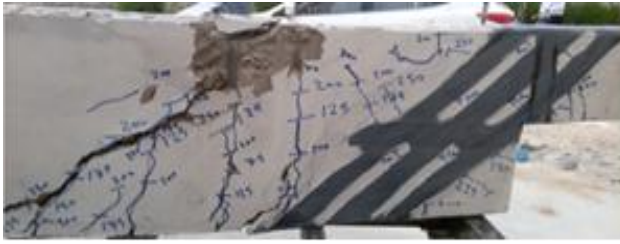
**Figure 16** Cracks patterns for strengthening beams HSTR1-A

Comparing failure modes of specimens HSTR-1 and CONT-A and putting in mind that in specimen CONT-A provided with full reinforcement whereas specimen HSTR-A included reduced hanger reinforcement. Specimen CONT-A failed with the diagonal cracking at the extended end due to the large value of  $a/d = 1.5$ . While specimen HSRT-1 failed by a mode similar to diagonal cracking for deep beams and the crack occurred beyond the point of load application (out of the disturbed zone). It can be seen that using the inclined strips resulted in significant enhancement of the response of the disturbed region. Small number of cracks initiated within the strengthened zone. Furthermore, no diagonal cracks from the re-entrant corner occurred nor at the extended end. The first developed crack from tension face towards point of load application is of the flexural type and it is vertically oriented. Further loading resulted in more crack to occur away from the upgraded half joint, Figure 16. When reaching the weak region, a diagonal cracks that are initiated from the far side of the specimen developed quickly and resulting in failure of the specimen. Thus, it is expected that using full shear reinforcement at this region may improve capacity considerably. The crushing at the top face around the point load refers to the high strength of the extended end that resisted curvature of the beam then, developing more capacity. Table 5 shows that this arrangement could retire efficiently the capacity of the full reinforced half joint with a ratio of (300/285) with lower deflection at failure of (8.9/10.3) compared to the specimen CONT-A.

Comparing the crack patterns for specimens HSTR1-A and HSTR2-A with the specimen HCONT-A, it can be seen almost few cracks formed in the extended end and hanger regions and most of cracks are shifted away from the strengthened zone. Also, a change in failure mode to diagonal shear failure at the deep beam action zone while it was diagonal tension failure in the extended end for beam HCONT-A. This may be due to the presence of the CFRP sheets which results in shifting cracks far away towards the mid span of the beam.

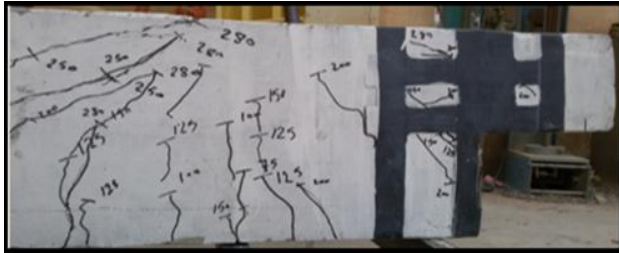
**Figure 17** Cracks patterns for strengthening beams HSTR2-A

For specimen HSTR2-A, it can be seen that the first crack initiated at the re-entrant corner at a load level less slightly than 125 kN, Figure 17. This reveals that the strengthening scheme HSTR1-A is more effective than scheme HSTR2-A. With further loading, some of cracks developed around this point but with less number and lengths if compared with the non-strengthened specimen HCONT-A.

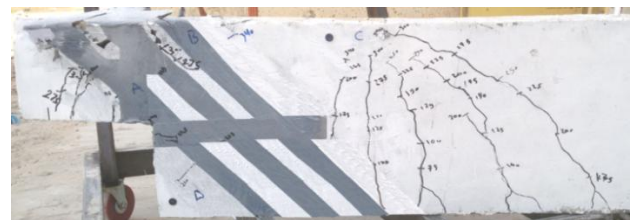
**Figure 19** Cracks patterns for strengthening beams HSTR1-B

Figure 19 shows the cracking pattern for the specimen HSTR1-B. It reveals that the first crack initiated as flexural crack at load level (75) and the first shear crack initiated at the re-entrant corner at load level of 120 kN. This may be because that effect of shear at the early stages is the dominant with smaller  $a/d$  value but with loading progress curvature increased and the effect of CFRP restricted cracking growth increase accordingly. Thus, few cracks penetrated through the strengthened zone as in HSTR1-A. Most cracks developed near the mid-span (non-strengthened zone) with cracking width smaller than the case in specimen HSTR1-A. It is suggested to provide more bond strength when strengthening half joint with smaller  $a/d$  values. The same configuration for the specimen HSTR2-A was adopted to be used in specimen HSTR2-B. However, due to its relatively high stiffness the DE resisted higher loads up to a load level of 340 kN when a bond failure between CFRP and concrete occurred which terminated the test. Thus, it is expected that the specimen may yield more capacity if this secondary failure is avoided. Regarding the cracks patterns the two, few cracks were observed in the extended end and hanger regions, and cracks did not penetrate through the CFRP sheets. Thus, led to a shifting of cracks away from the strengthened region and the failure of the strengthened specimens occurred due to rupture of the CFRP sheets, as shown in Figures 19 and 20.

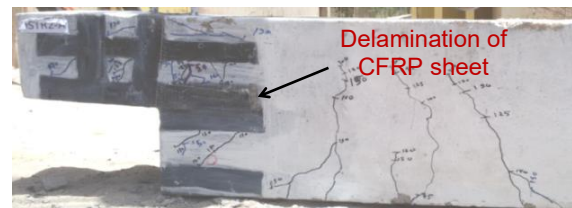
Figure 23 Cracks patterns for strengthening beams NSTR2-A

For specimen NSRT2-A, it can be seen that stiffness of the beam and the failure load were enhanced noticeably. The first diagonal crack at the re-entrant corner was due to the combined action of shear and moment developed at 50 kN followed by the flexural crack by 80 kN. Failure occurred by delamination of CFRP sheet at load of 200 kN. It can be concluded that with more bond length, better ultimate load may be obtained. The first shear crack (at re-entrant corner) appeared at a load level of 100 kN in comparison with 50 kN for NCONT-A. While the first flexural crack developed at a load, level of 75 kN, which is close to that of NSTR2-A, 80 kN.

Shear failure is observed of the L-shaped CFRP sheets for specimen NSTR1-A. However, with adding the horizontal strips at the nib, Figure 23, more stiff behavior has been achieved and some development in ultimate load. Specimen NSTR1-B continues to accommodate loading up to the instant when bond failure between the epoxy and concrete occurred. Thus, one may conclude that using more layers of the L-shaped and the horizontal strips may results in increasing load capacity considerably.

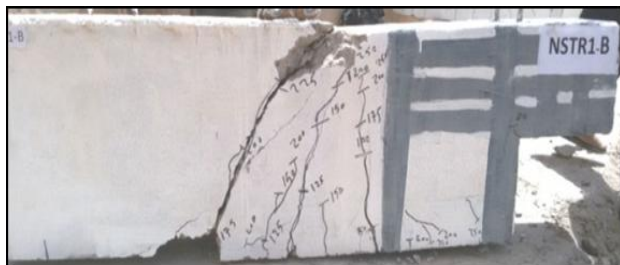
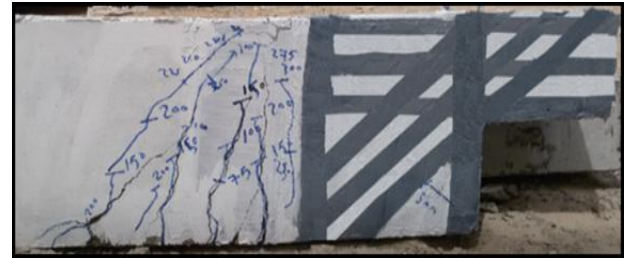
Figure 25 Cracks patterns for strengthening beams NSTR1-B

Comparing crack patterns of the upgraded specimens, Figures 25 and 26, with that of specimen NCONT-B, it can be seen almost few cracks in the extended end of dapped beam. Moreover, the mode of failure is changed to diagonal shear failure at mid span of the beam whereas diagonal tension failure has been observed in the extended end for beam NCONT-B and cracks did not penetrate through CFRP sheet from the loading point towards the far support.

This may be explained that with higher a/d value, the re-entrant corner will be relatively weak zone. Thus, the first crack initiated from the corner at load level (as observed) of 50 kN. Then, flexural crack occur at load level of 80 kN. For specimen NSTR2-B, the stiffer zone due to strengthening and the smaller a/d value caused shifting of cracks out of the strengthened zone and the re-entrant corner. The first crack was flexural and developed at mid span (under the point load directly) within load of 75 kN. With further loading, the first shear crack occurred at level of 100 kN across the deep beam region. Stagnation of cracking occurred within the half joint without shifting to the far side, as it can accommodate more stresses up to failure at 300 kN which occurred by diagonal shear mode compared with specimen NSTR2-A which failed by bond failure of the vertical CFRP strip.

It can be seen that the first crack developed out of the strengthened zone as a flexural crack and most of cracks shifted to the far side of the beam. Diagonal crack developed at load level of 70 kN within the zone of deep beam action. This crack penetrated rapidly causing failure as in deep beams. It is expected that if the deep beam region was design adequately, more failure load may be obtained of 150/80 ratio. The above expression emphasizes the efficiency of the strengthening scheme to retire the lack of nib reinforcement of the dapped ends and half joints.

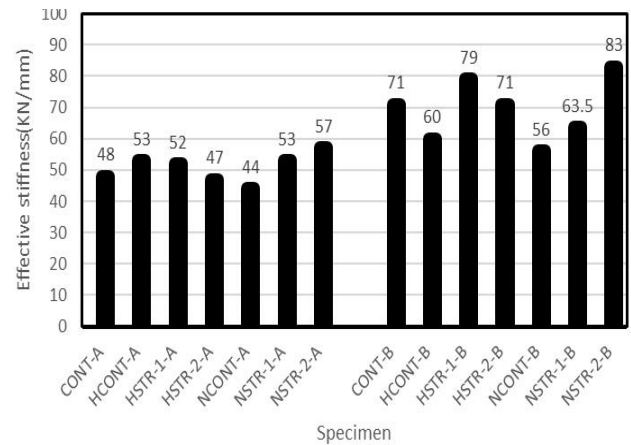
Figure 30 Effective stiffness values for the tested specimens

Figure 30 shows the effective stiffness values for the tested half joints. It can be seen that the useful

(effective) stiffness increases with reducing  $a/d$  ratio. Furthermore, it can be observed that stiffness for specimen NCONT-A is slightly higher than the specimen CONT-A. This may be attributed to shifting the failure to the region of full depth rather than being occur in the extended end. Moreover, it is clear that the inclined configuration of strengthening (HSTR1-A) yielded better results and that the arrangement NSTR2-A may be adopted in strengthening the deficient nib end with  $a/d=1.5$  unless that the arrangement NSTR2-B shows better results.

For  $a/d=1.0$ , it can be seen that arrangement HSTR1-B, (inclined configuration) yielded higher stiffness. For nib end strengthening, the configuration NSTR2-B, yield better performance. Thus, it is recommended to carry out further tests to check the adequacy of the arrangement NSTR2-B to be applied for half joint deficiently reinforced at nib end with  $a/d=1.5$ .

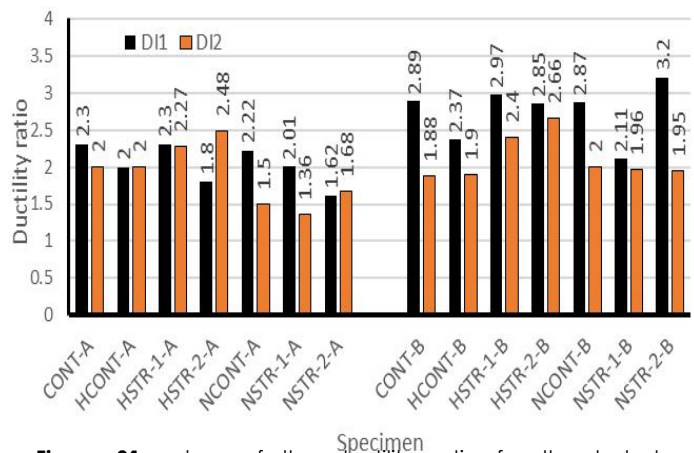
Figure 31 values of the ductility ratio for the tested specimens

Figure 31 shows the ductility ratios calculated for the tested half joints based on Equations (2) (DI1) and (3) (DI2). It can be seen from Equation (1) that the ratio of the total to the elastic energy makes the expression not very sensitive to the stage of loading at which failure occurs. This can be seen for specimens NSTR1-A and NSTR2-A which failed at early stages compared to other specimens.

In contrast, Equation (3) is affected by the value of maximum deflection that specimen yielded. Hence, it seems that Equation (3) yielded more acceptable and reasonable results. Furthermore, it can be seen that the ductility ratio increases with reducing  $a/d$  ratio.
