IMPACT RESISTANCE ASSESSMENT OF INTERLOCKING COMPRESSED EARTH BRICKS (ICEB) INCORPORATING CRUMB RUBBER

Interlocking compressed earth bricks (ICEB) are a cleaner and sustainable alternative to conventional fired bricks and it has comparable strength to other masonry systems, making it feasible for both cladding and load-bearing purposes. However, it tends to be brittle and has poor performance under impact loading. Impact resistance of masonry walls are important as one of the main purposes of cladding is to protect its occupants from external projectiles. This study was commissioned to investigate the feasibility incorporating both crumb rubber (CR) and treated CR into ICEBs in place of sand to improve its impact resistance. The drop weight impact tests carried out concluded that ICEBs containing CR have better impact resistance and this was further improved with heat-treated CR. Heat-treated CR ICEBs also had less catastrophic failure compared to untreated CRs which had pieces of materials spalling off. Mechanical tests also show that this improvement in impact resistance comes at the expense of a minor loss in compressive and flexural strength at replacement levels higher than 7

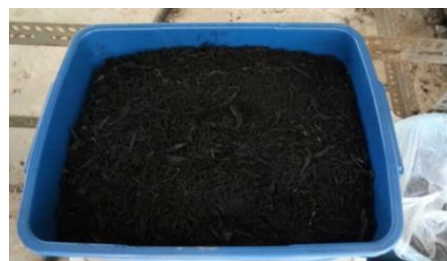
Figure 1 Crumb rubber as supplied

The main test material is crumb rubber (CR) which was sourced from a local business specializing in disposal and re-threading of used tyres. Visual inspection of the CR showed pre-dried black strips of cut rubber (Figure 1) from the tyres. The CR was supplied in large sealed polyethelene bags.

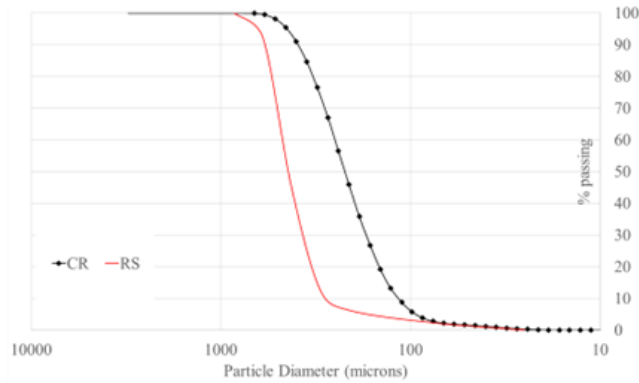
Figure 2 Particle size distribution of crumb rubber (CR) vs river sand (RS)

specific surface area. The particle size distribution of both CR and RS are presented on Figure 2.

The particle size of CR tested ranged from 445 to 132 µm. Other papers, however, have reported size distribution as large as 9.5 to 0.5 mm [19], indicating that there could be great variability in CR particle sizes. The CR samples that were replacing the RS generally appeared finer with a mean particle size of 252.0 µm as opposed to the 443.0 µm for the RS samples as shown on Table 2. This again is in contradiction with past research where the sand samples were finer than the crumb rubber [17]. In fact, the d₉₀ sizes of CR were very similar to the mean sizes of RS. Similar observations were also made for the 10th and 90th percentile sizes. As a result of its fine particles, the CR particles had more than twice the specific surface area at 27.6 m²/kg compared to the 12.6 m²/kg of the RS samples¹.

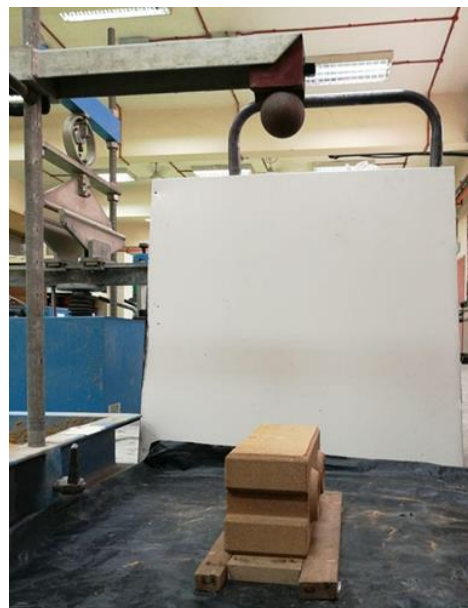
Figure 4 Drop impact test apparatus setup

Finally, to determine the impact resistance of ICEB units, drop weight tests were conducted. The drop weight impact tests allow assessment of the magnitude of impact energy the ICEB units can absorb. Similar test have been used in the past to investigate impact resistance of concrete [21]. The test setup is depicted in Figure 4. The setup is a variation of the drop test proposed in the past for testing polymer composites [22] and fiber reinforced concrete [23]. The apparatus consisted of a wooden frame, an electromagnetic release device, a 1 kg steel ball as the impactor and a white witness plate for the background for video recording. A rounded ball projectile was used as it would be similar to a bullet head. The ICEB units were laid on their side to simulate projectile impact onto the exposed side surface of the units when they are eventually used as wall units. To avoid the ICEB from coming into direct contact with the floor, which could affect the outcome of the impact test due to the support from the floor surface, a wooden frame was used. A

magnet held the impactor in place at 0.45 m above the target surface until such a time when the weight is ready to be dropped. This allowed for a maximum impact velocity of nearly 3.0 m/s, corresponding to an impact energy of 4.4 J.

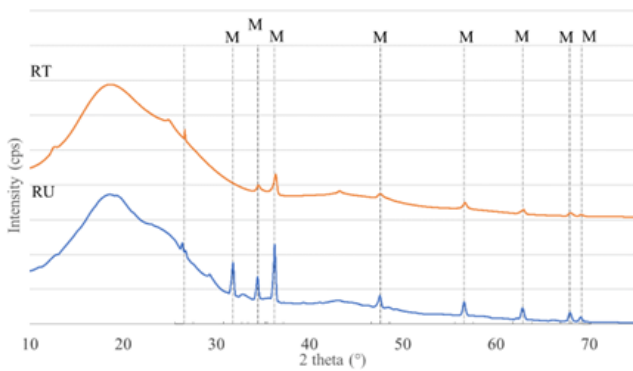
Figure 6 X-Ray Diffractogram (XRD) comparing RU and RT

The XRD analysis of RU (Figure 6) detected mostly crystalline manganese zinc oxide (denoted by 'M'), with the highest intensity occurring at 2 theta of 36.24 °, followed by 31.79 ° and 34.43 °. The minor crystallinities were detected at 47.6 °, 56.56 °, 62.85 ° and 67.92 °. Overall crystallinity of the material was estimated to be about 32%.

After being subjected to heat treatment, the RT samples reduced in overall crystallinity by about 6% to 26%. This can be seen in the markedly reduced peaks on the diffractogram in Figure 5 for RT sample where the highest peak of 36.24 ° had gone down to an intensity of 1661 from 2770. This loss in crystallinity was expected as most research have indicated that heat treatment would tend to reduce crystallinity of materials and rendering it more amorphous [24].

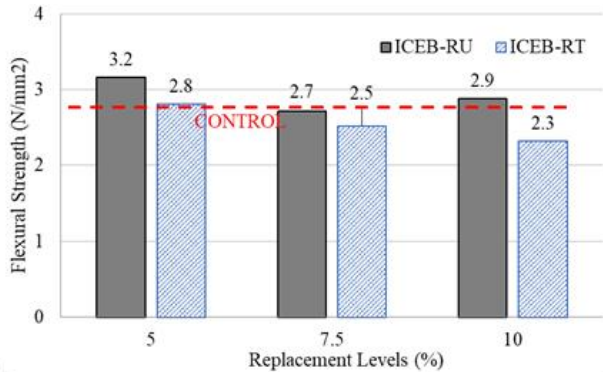
Figure 8 Flexural strength of ICEB containing partial replacement of RU and RT

As seen in Figure 8, the control ICEB unit attained a flexural strength of 2.82 N/mm² which, as expected, was lower than the compressive strength. However this was higher than what was discovered in post research involving similarly sized ICEB unit [27]. ICEB-

RU demonstrated very slightly elevated flexural resistance for units with 5 and 10 % RU replacements at a strength of 3.2 and 2.9 N/mm² respectively. However, the ICEB-RU with 7.5 % replacement had slightly lower strength than the control unit.

Incorporating RT in ICEBs saw decline in flexural strength across all three levels of replacements investigated when compared against ICEB-RU. ICEB-RT with 5 % replacement was still able to generate sufficient flexural strength to surpass that of the control unit but at higher levels, the strength was consistently below that of the control unit.

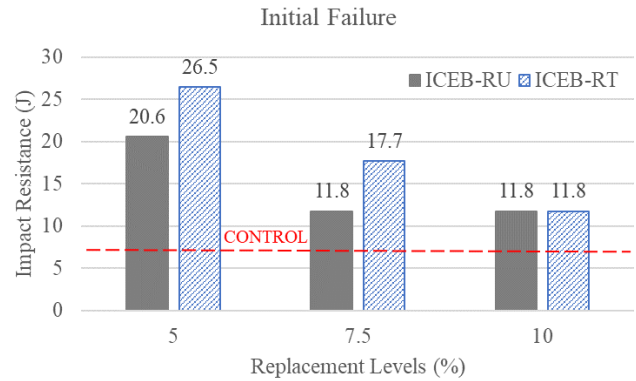
Figure 9 Impact resistance at initial failure

The energy absorbed by the ICEB units just prior to initial failure is shown on Figure 9. The control ICEB unit was able to absorb 7.36 J prior to development of first cracks. Partially replacing the sand contents with RU saw a very significant increase in the ability to absorb energy across all levels of replacement. The most significant of these was observed at 5 % replacement where the impact resistance increased to 20.6 J, which represented an increase in excess of 280 %. However, as replacement levels increased, the ability to absorb impact energy also decreased, as evident from the ICEB-RUs with 7.5 and 10 % replacement both absorbing 11.8 J at initial failure. Despite this,

Replacing the RTs with RUs improved the ICEB units ability to absorb energy even further generally, exceeding the ICEB-RU energy absorption level across all levels of replacement. The ICEB-RT units with 5 % replacement yielded the highest energy absorbed at 26.5 J, followed by 17.7 J at 7.5 % replacement and finally 11.8 J at 10 %. As with the ICEB-RU units, as levels of replacement increase, the ability to absorb energy reduces.

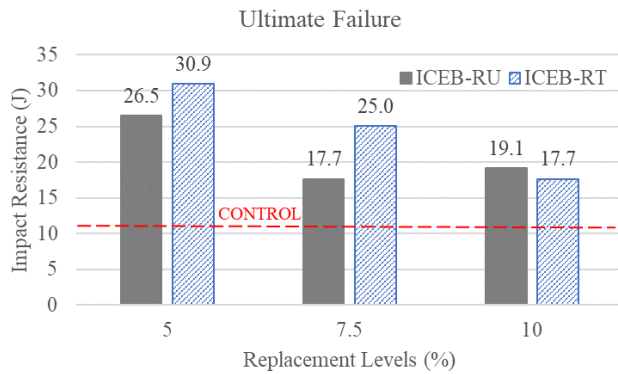
Figure 10 Impact resistance at ultimate failure

As expected, for ultimate failure to occur, the overall impact energy was clearly higher than those needed for initial cracking of the ICEB units. As seen in Figure 10, the control ICEB unit was able to absorb up to 11.8 J just prior to ultimate failure. With the incorporation of RU at 5 % replacement, the impact resistance improved to 26.5 J although subsequent increases in replacement levels reduced in efficacy. This is evident as 7.5 % replacement saw a drop in the resistance down to 17.7 J whilst at 10 % replacement it was also lower at 11.8 J.

Incorporating RTs in place of RU saw increase in impact resistance at ultimate failure. The highest impact resistance was achieved by ICEB-RT unit with 5 % replacement at an energy of 30.9 J, whilst the unit with 7.5 % attained the second highest resistance at 25.0 J. The ICEB-RT unit with the lowest resistance was the one with the highest amount of replacement at 10 %, offering only 17.7 J of resistance which was even lower than that of its equivalent ICEB-RU strength. These results agree with past research where heated-treated blocks of concrete containing RU showed improved impact resistance [17].

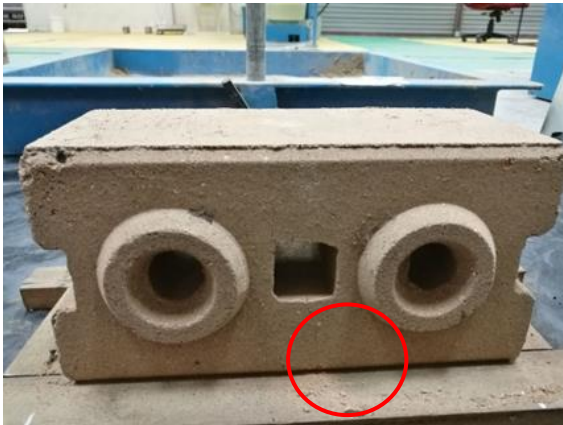
Figure 11 Crack pattern at initial failure

A visual inspection of the ICEBs upon initial cracking showed hairline cracks less than 0.1 mm developing from the impact point at the top surface of the unit that propagated all the way down to the bottom (Figure 12). Besides the expected minor abrasion caused by the dropped weight, there was no other noticeable spalling damage or denting to the impact surface of the unit.

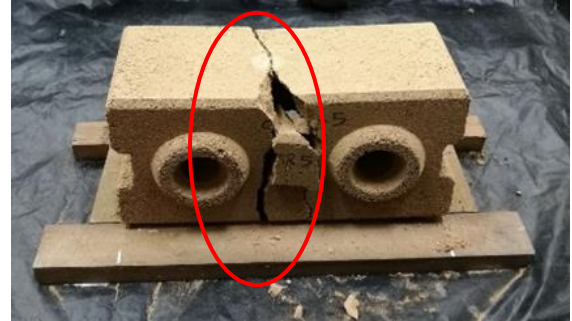
Figure 12 Crack pattern at ultimate failure, ICEB-RU

At ultimate failure, a full depth crack developed across the width of the surface of the ICEB-RU unit (Figure 11) where the impact occurred. This was expected as it presented the shorter path to the unrestrained edge of the unit as opposed to one that runs along the longitudinal length of the unit which would have presented a longer path to take. As it

propagated down the unit, the crack path diverged and split into two which allowed a piece of the ICEB unit to fracture and become loose. More microcracks were also observed to have developed on the impact surface, spreading outward from the impact point in a spiderweb pattern.

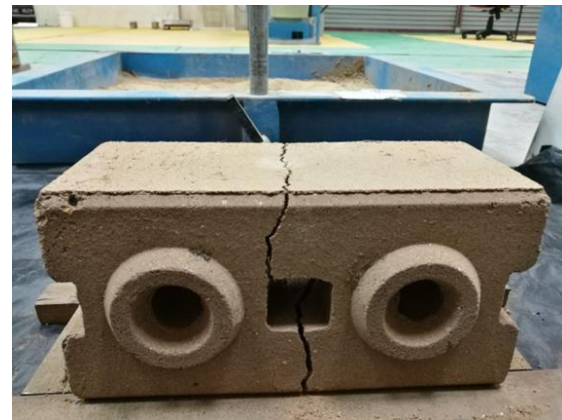
Figure 13 Crack pattern at ultimate failure, ICEB-RT

Similar observations could be made for ICEB-RTs (Figure 13) as well with fracture line developing across the width of the unit and extending downward to the bottom as well.

This observation signified that the cracks on the impact surface tend to develop in toward the closest unrestrained edges of the unit. This is very similar to how the flexural cracks develop in suspended slabs as well.
