EXPERIMENTAL STUDY ON THE EFFICACY OF ULTRASOUND IN IN-SITU DETECTION OF CORROSION IN PALM OIL REFINING EQUIPMENT

Jan Lean Tai^a, Mohamed Thariq Hameed Sultan^{b,c*}, Farah Syazwani Shahar^b

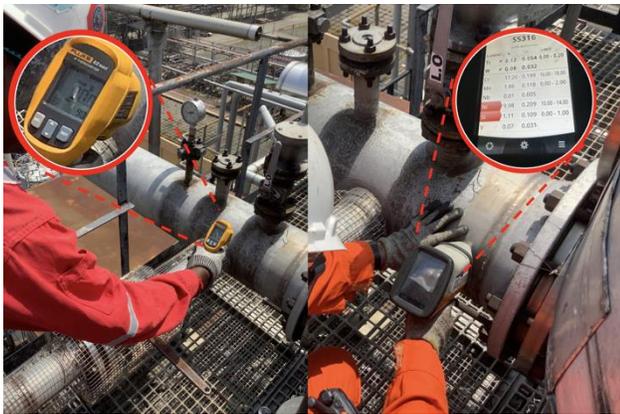
Figure 8 depicts the utilization of a handheld thermometer to accurately determine the operating temperature of a 12-inch schedule 10s stainless steel pipe, which was measured at 90°C. The pipe in question was then subjected to a Positive Material Identification (PMI) test using X-ray Fluorescence (XRF) technology to confirm that the material matched the fabrication record, indicating it was SS 316.

Figure 8 Temperature and material verification on the operating steam pipeline

The subsequent step in the investigation involved ultrasonic inspection. Initially, the UT machine was calibrated based on the velocity of SS 316 at the operating temperature of 90°C, which was determined to be 5692.8 m/s, as presented in Table 1.

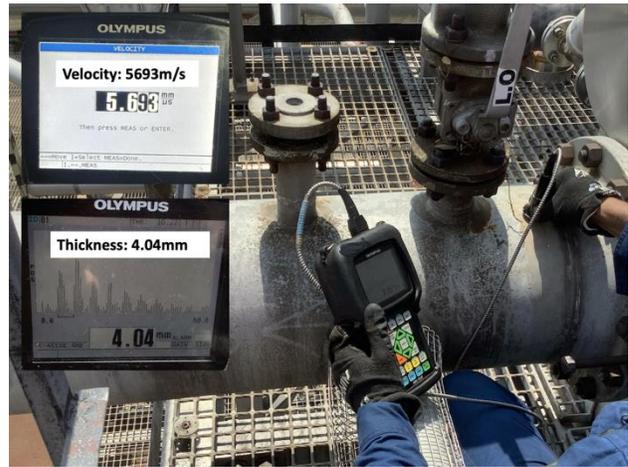
Upon conducting the ultrasonic inspection, the detected wall thickness of the SS pipe was measured and found to be 4.04 mm. This measurement indicated a wall loss of 0.53 mm compared to the original thickness of 4.57 mm. These results are illustrated in Figure 9.

Figure 9 Ultrasonic inspection to detect the material thickness

The data obtained from the ultrasonic inspection provides valuable insights into the condition of the SS pipe after 15 years of operation.
