EFFECT OF STIRRUPS AT BEAM CROSSINGS USING COCOPEAT AS A CONCRETE AGGREGATE SUBSTITUTE FOR SAND

T. Q. K. Lam^{a*}, T. A. Le^b

^aFaculty of Civil Engineering, Mien Tay Construction University, 85000, Vinh Long, Vietnam

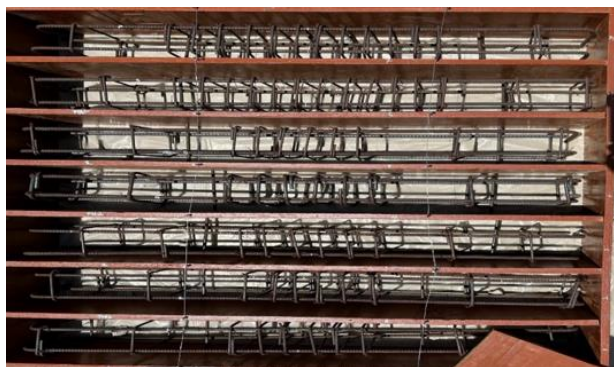
Figure 3 The formwork and reinforcement for the beams

The procedure for the manufacture of reinforced concrete beams consists of two primary steps: creating formwork (Figure 3) and pouring concrete (Figure 4). The concrete used is of grade B15, according to TCVN 5574:2018 [7].

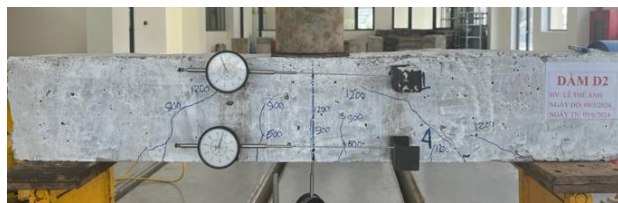
Figure 5. The front surface of beams

The front surface of beams (shown in Figure 5)

Cracks were observed in beams D1 to D6 at a load level of 30kN (600psi), whereas beam D7 exhibited the first crack at a load level of 15kN (300psi). Both beams D1 and D6 ultimately failed at a load level of 75kN (1500psi). Research on experimental beams revealed that the formation and propagation of cracks in the beams aligned with results from [6] and [8]. The experimental results indicated that the cracks were inclined at an angle of 45 degrees at the midpoint between the beam and the support, with vertical crack development occurring near the center of the beam.

Beam D1 is a normal reinforced concrete beam (0% cocopeat content replacing sand aggregate), with a load-bearing capacity of 75kN. When 20% of the sand aggregate is replaced with cocopeat, the load-bearing capacity of the beams decreases to 60kN (1200psi). Cocopeat is an organic material that is highly porous and lightweight. When covered by an outer layer of cement, it retains internal space, meaning that when incorporated into concrete, it does not achieve the same solidity as normal concrete. This results in a reduced bearing capacity, a typical mechanical property associated with this type of material.

Beam D6, that includes 20% cocopeat content as a substitute of sand aggregate and includes additional stirrups at section b+2h, demonstrates an increase in load-bearing capacity, matching that of beam D1, which contains 0% cocopeat content. Both beams fail at the same load level of 75kN.

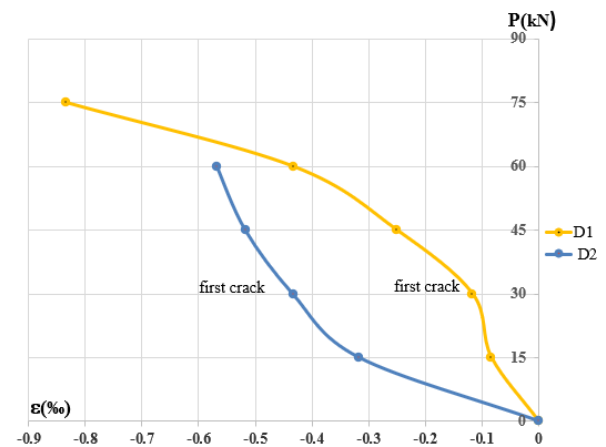
Figure 6. Load-compressive strain of beams D1 and D2

Beam D1 and D2: Beam D2 includes 20% cocopeat instead of sand, which causes it to deform more than the normal concrete beam D1 does. This is because the bonding and adhesion between the particles causes major deformation when the beam is under compressive stress. At a load level of 30kN, the difference in deformation is most significant, reaching 73%. Upon reaching a load level of 60kN, beam D2, that includes a cocopeat component, fails, whereas beam D1, constructed with normal concrete, continues to deform up to a load value of 75kN (Figure 6).

The results of the compression (Figure 6) and tensile (Figure 12) deformation tests on beams D1 and D2 show that the deformation of beam D2 at the failure position in the compression zone is 0.6‰, whereas the deformation of the tensile zone at the failure position of beam D2 is 1.5‰. This indicates that the deformation of the tensile zone is 2.5 times greater than that of the compression zone. In a way similar to beam D1, the compressive deformation at the failure position has been measured at 0.84‰, whereas the tensile deformation at the same position for beam D1 stands at 2.6‰. This indicates that the deformation in the tensile zone is three times greater than that in the compression zone. This indicates that in beams D1 and D2, the tensile zone exhibits superior load-bearing capacity compared to the compression zone. Additional reason is due to the presence of longitudinal rebars having higher strain capacity and holding the cracks propagation after first crack.

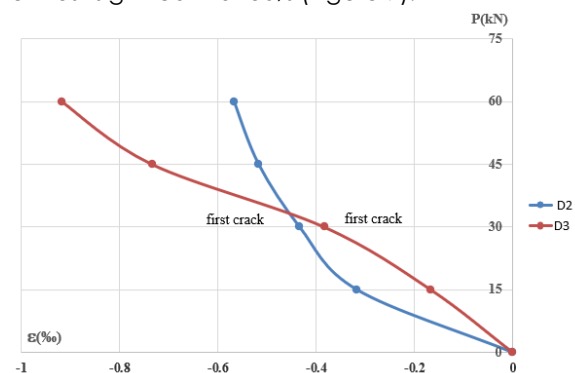
Figure 7 Load-compressive strain of beams D2 and D3

Beam D2 and D3: Both contain 20% cocopeat content substituting sand aggregate in concrete, yet they differ in reinforcement arrangement, resulting in varying compressive strain values for each beam. At a load level of 15kN, beam D2 exhibits a value that surpasses that of D3 by 46%. Upon reaching a load level of 30kN, where the first crack emerges, both beams D2 and D3 exhibit very similar strains, ultimately resulting in identical strain values. This involves to the impact of stirrups when the load reaches a significant magnitude. At a load level of 60kN, where both beams fail, the strain in beam D2 is less than that in D3, with the difference in strain being the most significant at 56% (Figure 7).

The experimental results of the deformation in the compression zone (Figure 7) and tension zone (Figure

13) of beam D3 indicate that at the failure load level, the deformation in the compression zone reached 0.92‰, while the deformation in the tension zone at the failure position was 1.1‰. This indicates that the tensile strain is 1.2 times greater than the compressive strain. It suggests the load-bearing capacity of beam D3 in the tensile zone exceeds that of the compressive zone.

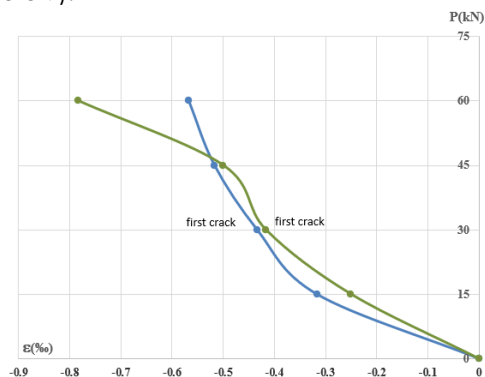
Figure 9 Load-compressive strain of beams D2 and D5

The deformities of the D2 and D5 beams are nearly the same from the beginning of loading up to a 45 kN load. In the experiment, the difference was observed when the longitudinal rebars were changed from $\phi 10$ to $\phi 12$ (which indicates a minimal rise in steel content). This change occurred in the tensile zone and happened when the load levels were relatively low. Both beams D2 and D5 showed cracks and had deformation values of 0.42 % and 0.44 %, respectively, when the load reached around 30 kN. As the load was increased above 45 kN, the compressive deformation became progressively significant, and both were destroyed at 60 kN. This occurred before the load was increased further. (Figure 9).

The results of the compression zone deformation test (Figure 9) and the tensile zone deformation (Figure 15) of beam D5 indicate that the deformation at the failure position in the compression zone reaches approximately 0.8‰, while the tensile zone deformation at the failure position of beam D5 reaches 1‰. This indicates that the tensile zone deformation is approximately 1.25 times greater than the compression zone deformation. This indicates that the load-bearing capacity of the tensile zone in beam D5 exceeds that of the compression zone.

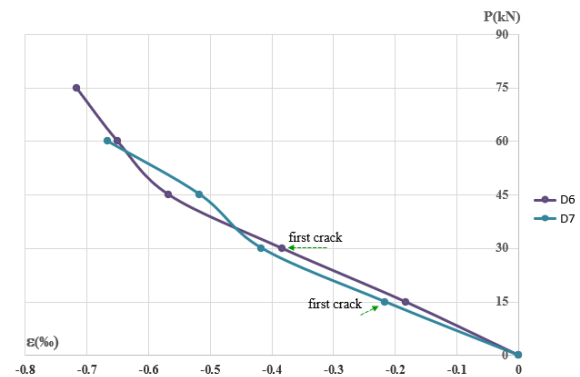
Figure 10 Load-compressive strain of beams D6 and D7

The compressed deformation value of the D6 and D7 beams is nearly identical. At a load of 15 kN, the D7 beam exhibits the first crack and reaches a deformation value of approximately 0.23 %. In contrast, the D6 beam shows its first crack at a load of 30 kN, achieving a deformation of 0.39 %, indicating that the D6 has a noticeable trace. The crack of D6 is double that of D7. Upon reaching a load of 60 kN, both beams exhibit an equal deformation of 0.63 %. However, the D7 beam fails at this point, while the D6 beam remains capable of withstanding an additional load of 75 kN before failure occurs (Figure 10).

The results of the compression (Figure 10) and tensile (Figure 16) deformation tests on beams D6 and D7 indicate that the deformation of beam D6 in the compression zone is 0.71‰, whereas the tensile deformation of beam D6 is 1.7‰. This indicates that the tensile deformation is 2.4 times greater than that

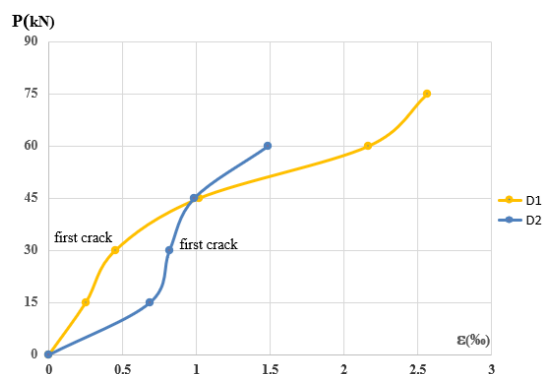
Figure 12 Load-tensile deformation of beams D1 and D2

D1 beams and D2: When subjected to a 15 kN load, the deformation of D2 beams is 68% greater than that of D1 beams. Subsequently, at a loading of 45kN, both beams exhibited a deformation of 1 %. At a 60 kN load, D2 experiences a deformation of 1.51 %, which is less than D1's deformation of 2.41 %. However, D2 ultimately fails, while D1 can endure up to 75 kN before failure occurs (Figure 12).

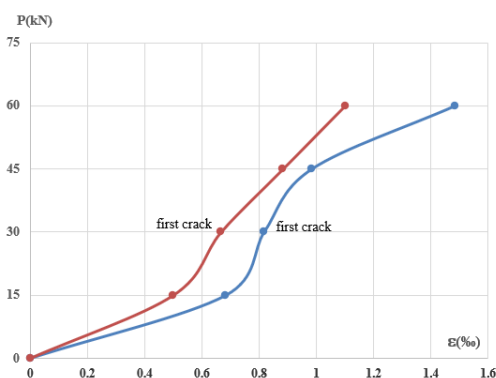
Figure 13 Load-tensile deformation of beams D2 and D3

Before cracks developed in the beams, the tensile strain of beam D2 was 18% greater than that of D3. Both beams sustain damage at a load level of 60kN, with the tensile deformation of beam D2 being 27% greater than that of D3 before failure (Figure 13).

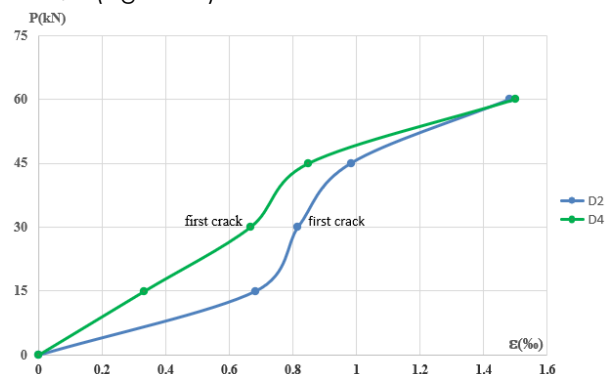
Figure 14 Load-tensile deformation of beams D2 and D4

The deformation in the tension zone of beams D2 and D4 is consistent across the various load levels. Before cracks developed in the beams, the tensile strain of beam D2 was 54% greater than that of D4. Both beams sustained damage at a load level of 60kN at the same position, exhibiting a deformation of 1.5‰ (Figure 14).

The results of the compression zone deformation test (Figure 8) and the tensile zone deformation (Figure 14) of beam D4 indicate that the deformation at the failure position in the compression zone reaches 0.62‰, while the tensile zone deformation at the failure position of beam D4 reaches 1.5‰. This indicates that the tensile zone deformation is 2.4 times larger than the compression zone deformation.

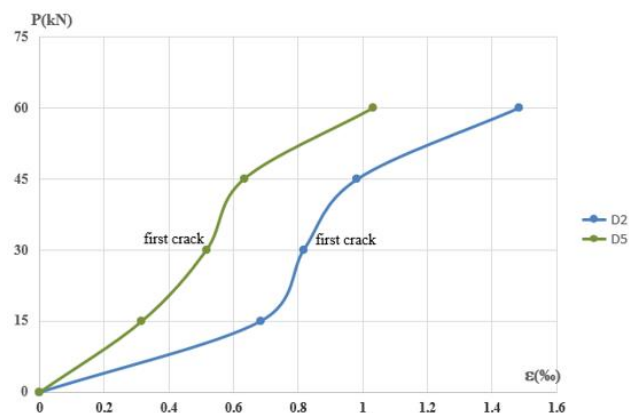
Figure 15 Load-tensile deformation of beams D2 and D5

Beam D2 and D5: The deformation observed in the tensile zone of the two beams indicates that both straight lines show comparable deformations across the various load levels. Nonetheless, regarding value, beam D2 exhibits greater deformation compared to beam D5. At the 15kN position, beam D2 exhibits a deformation that is approximately 57% greater than that of D5. Additionally, at the load of 30kN, where the crack appears beam D2 is around 37% larger than D5. Both beams showed relatively stable deformation and sustained damage at a load level of 60kN. At the same position, the deformation of beam D2 was approximately 35% greater than that of D5 (Figure 15).

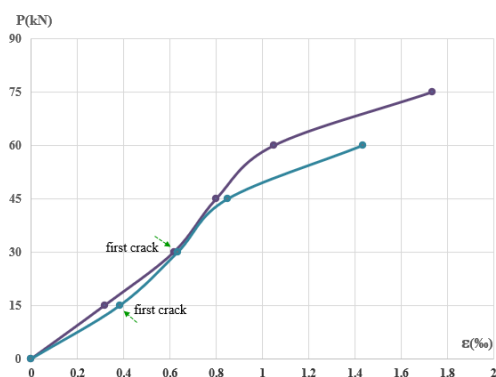
Figure 16 Load-tensile deformation of beams D6 and D7

Beam D6 and D7: The deformation diagram of the tensile zone for the two beam samples shows similar shapes; however, at various load levels, each beam sample provides different evaluation numbers. When the load ranges from 0 kN to 45 kN, both beams D6 and D7 show identical tensile zone load-bearing capacities. At a load of 60 kN, beam D7 shows a deformation that is approximately 29% greater than that of D6 (Figure 16).

of the compression zone. In the same way, beam D7 shows a compressive deformation of 0.68‰, whereas its tensile deformation measures 1.42‰, indicating that the tensile deformation is twice as large as the compressive deformation. This indicates that in beams D6 and D7, the load-bearing capacity of the tensile zone exceeds that of the compression zone.

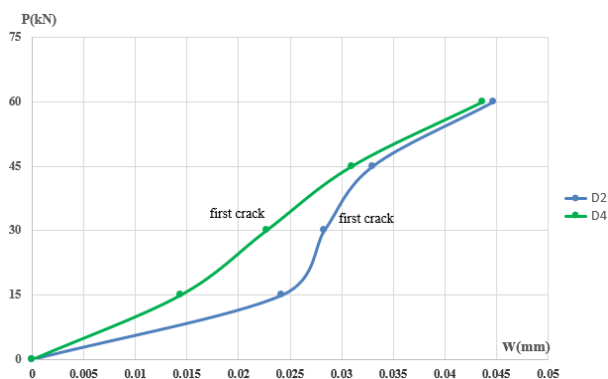
Figure 20 Load-displacement of beams D2 and D4

Beam D2 and D4: When subjected to a load of 15 kN, the vertical displacement at mid-span of beam D2 is 1.6 times greater than that of beam D4, which also occurs at the point of maximum vertical displacement. At the load level of 30 kN, both beams exhibit cracks, and the vertical displacement of D2 is 1.2 times greater than that of D4. As the load continues in rising following the cracking of the beams, the vertical displacements at the mid-span of the beams tend to converge closely. (Figure 20).

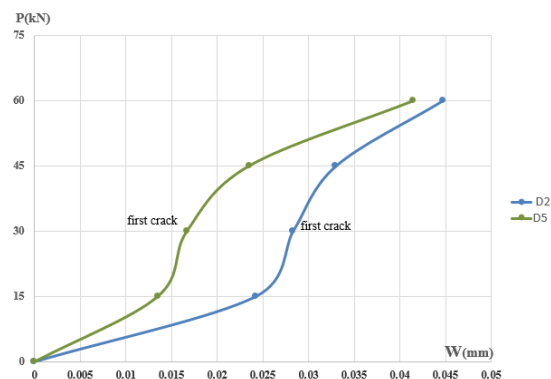
Figure 21 Load-displacement of beams D2 and D5

Beam D2 and D5: When subjected to a load of 15 kN, the vertical displacement at mid-span of beam D2 is 1.6 times greater than that of beam D5. At the 30 kN load level, both beams exhibit cracks, and the vertical displacement of D2 is 1.8 times greater than that of D5. At the 45 kN load level, the vertical displacement of D2 is 1.3 times greater than that of D5. At the 60 kN load level, it is observed that the vertical displacement of D2 has shown improvement in comparison to D5 when damaged. The experimental results indicate that the vertical displacement measured between the beams shows beam D2 exhibiting a greater vertical displacement compared to beam D5 (Figure 21).

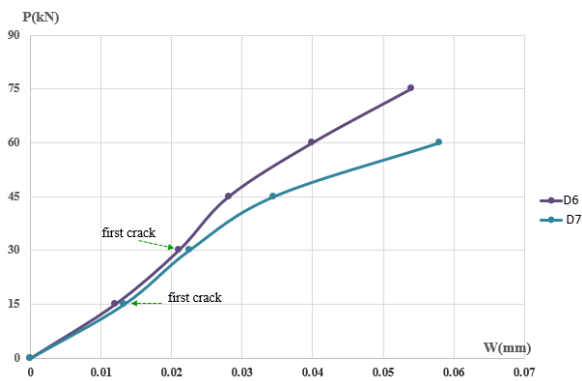
Figure 22 Load-displacement of beams D6 and D7

Beam D6 and D7 exhibit similar vertical displacements within the load range of 0 kN to 30 kN. However, beam D7 experiences a significant change in vertical displacement starting at a load level of 45 kN. At a load level of 60 kN, the vertical displacement of beam D7 is 1.4 times greater than that of D6, leading to its failure. Beam D6 continues to support the load up to 75 kN before it ultimately fails. The results of the vertical displacement measurement test between beams indicate that beam D7 exhibits a greater vertical displacement compared to beam D6 (Figure 22).

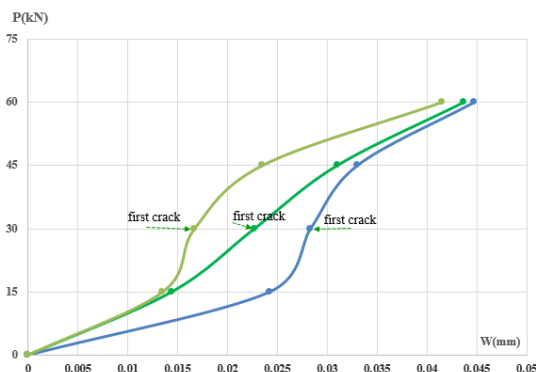
Figure 23 Load-displacement of beams D2, D4 and D5

Beams D2, D4, and D5 show similar vertical displacements. However, within the load range of 15kN to 45kN, the vertical displacements of beams D2 and D5 show unstable variations, in contrast to beam D4, which maintains stable variation across the load levels. For load values below 15kN, there is no difference in the performance of beams D4 and D5 when the rebars are increased from $\phi 10$ to $\phi 12$. In beam D2, the influence of the stirrup diameter is clear. As the beams begin to crack, the longitudinal rebars and stirrups have started working (Figure 23).
