# Performance-based Pushover Cyclic Test For Innovative Prefabricated Hybrid Industrialised Building System Sub-Frame

The paper presents a pseudo-dynamic cyclic load test to evaluate the structural performance of innovative prefabricated hybrid Industrialised Building System (IBS) subjected to earthquake-induced ground motions. Two beams, three columns and six wall panels with scale of 1:5 were casted using concrete grade 30. Steel bars with diameters of 6 mm and 1.5 mm were used as main reinforcement and links, respectively. The frame was set-up and tested in two reversal directions of cyclic lateral loads in the structural laboratory. Eight Linear Variable Displacement Transducers (LVDTs) and seven strain gauges were instrumented in the model to record deflections and strains. This experiment was conducted in displacement-controlled mode. Four cycles of loads were applied corresponding to the initial targeted lateral displacement to obtain hysteresis curve. The structural performance was assessed using structural seismic demand parameters such as story displacement, displacement ductility and energy dissipation. Three structural performance levels that were Immediate Occupancy (

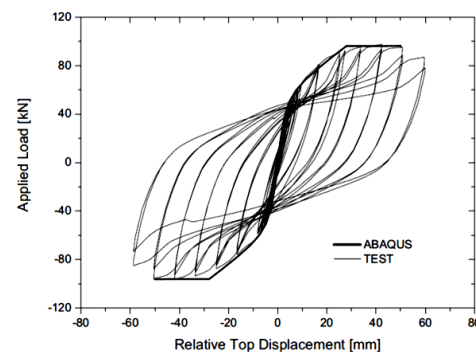
Figure 1 Hysteresis loops of the steel frame [20]

Vatansever and Yardimci [20] have demonstrated the cyclic behaviour and numerical modelling of a steel frame. Figure 1 shows the cyclic response of the specimen that is characterized by an open stable hysteretic behaviour superimposed on the push over curve from the numerical analysis. The load-deflection envelopes of the specimen for the pushing and pulling directions were plotted in Figure 2 to examine the load capacity and to compare the initial stiffness and the ultimate strength of the system.

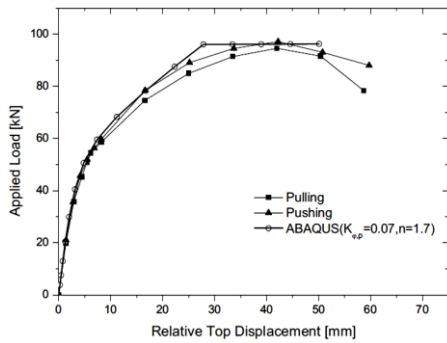
**Figure 2** Envelopes of the steel frame in the pushing and pulling directions [20]

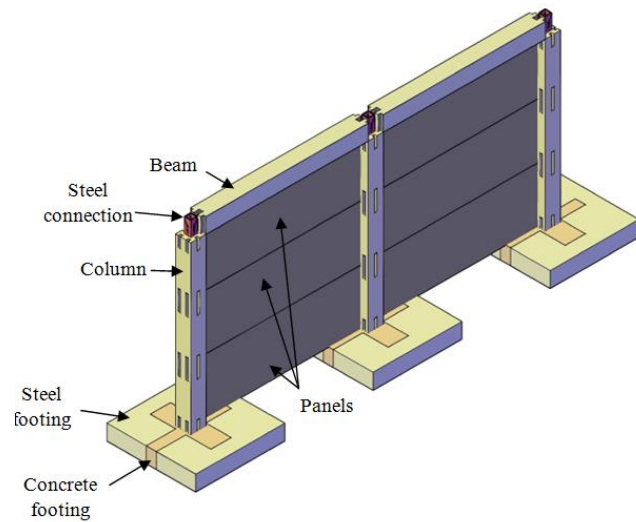
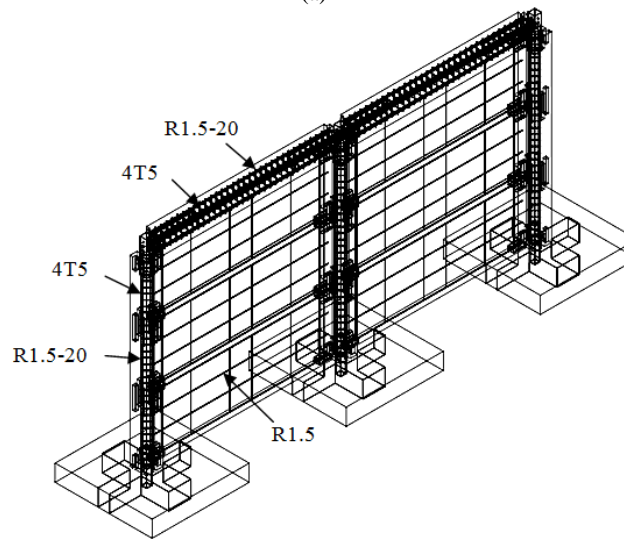
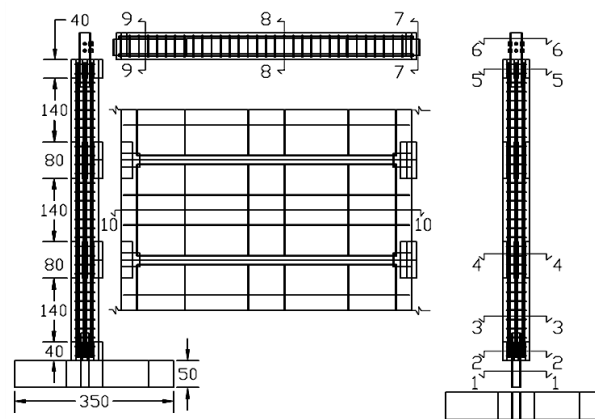
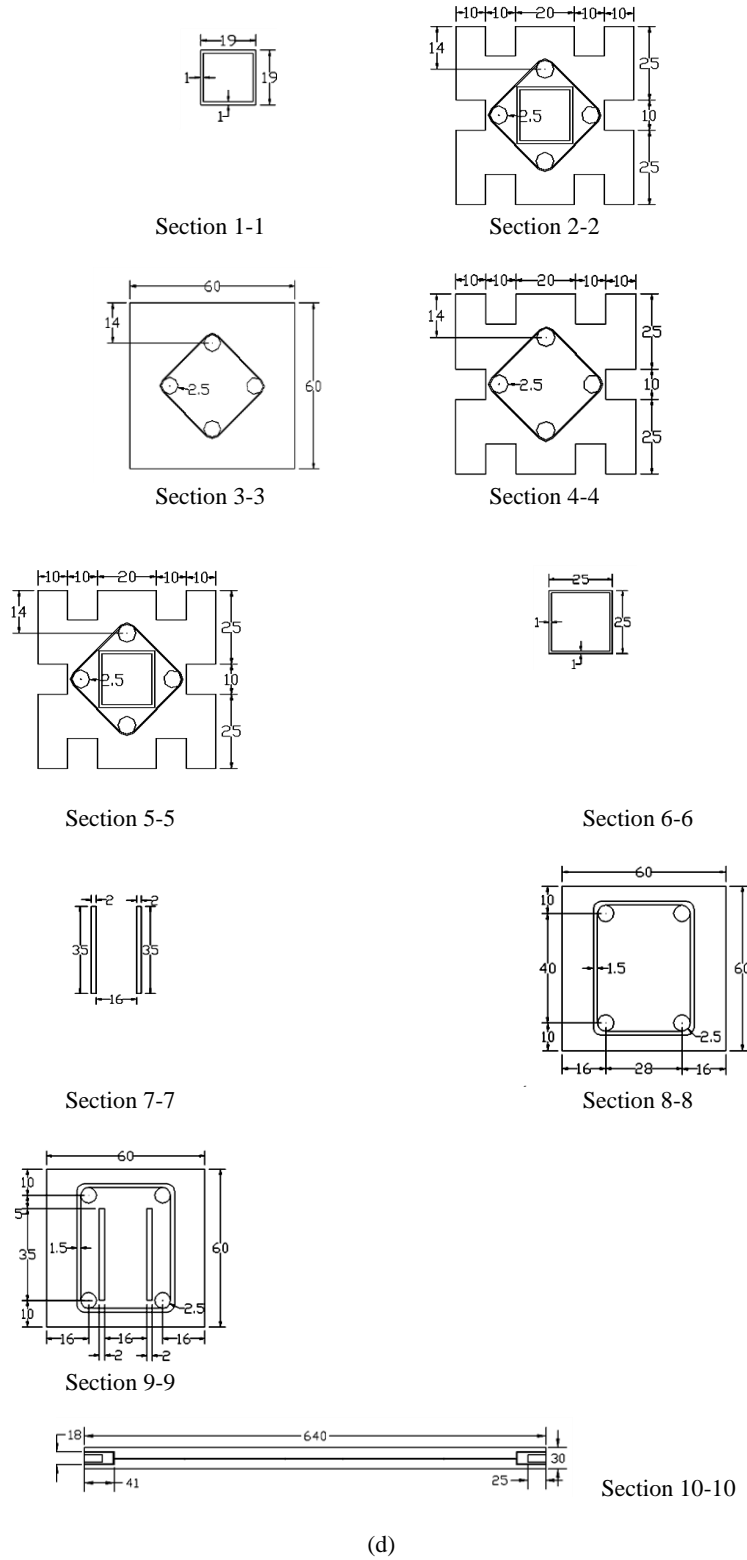
**Figure 4** IBS model elevation view and details (Building Assembly System): (a) 3D perspective view; (b) 3D wireframe view; (c) 2D front view; (d) cross sections

**Figure 4** IBS model elevation view and details (Building Assembly System): (a) 3D perspective view; (b) 3D wireframe view; (c) 2D front view; (d) cross sections (continue)

The diameter of all reinforcements and links were 6 mm and 1.5 mm respectively. The concrete cover of 6 mm was provided to the main reinforcements. All the materials used for the small-scale model were based on availability of steel and concrete materials in the market. Figure 4 shows the specifications and details of the IBS frame formation.

The U-shaped steels plates were tied together with two 6 mm diameter longitudinal main reinforcements at top and bottom in the IBS beam. The half height of steel rectangular hollow section of column was casted together into the concrete to provide bond between the concrete and connectors.

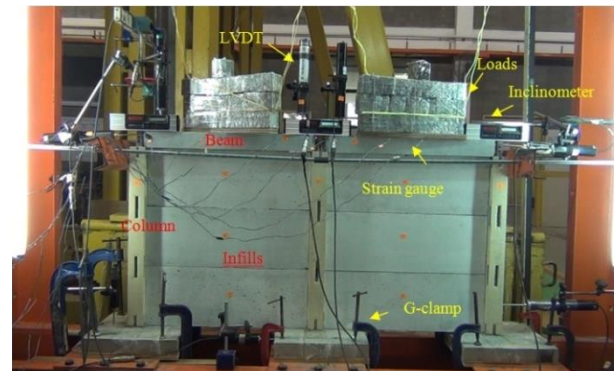
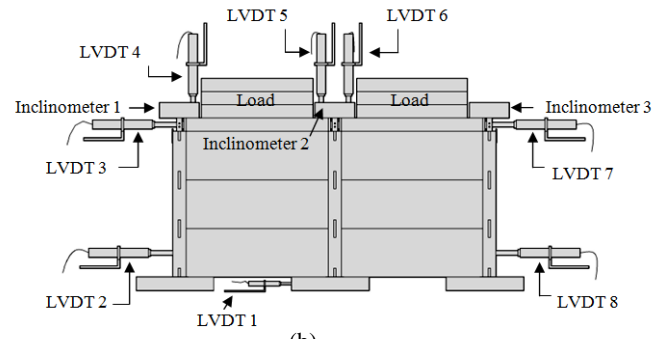
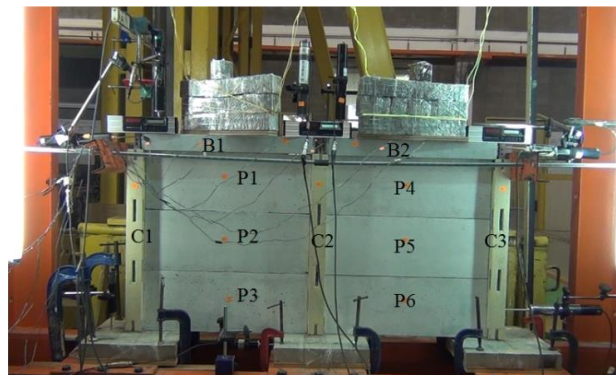
**Figure 5** Test set-up of scale 1:5 sub-frame: (a) experimental set-up; (b) perspective view of set-up; (c) identity of components

**Figure 5** Test set-up of scale 1:5 sub-frame: (a) experimental set-up; (b) perspective view of set-up; (c) identity of components (continue)

The localised responses were measured using electrical strain gauges glued on reinforcement bars and column RHS. The magnitude of lateral induced loads was measured using a load cell. After equipments were set, total load of 0.4 kN using steel blocks were imposed on both beams' clear span to act as a permanent dead and imposed load on the beams. Two steel bars were installed on the frame together with the transfer bar. The lateral cyclic load was applied pulling the model through the hydraulic jack horizontally.

The model was displaced horizontally in four cycles of loading and unloading in both lateral directions. Any cycle will be stop when the target displacement was achieved. For each cycle, the load was applied in several small incremental of displacement steps to predetermined levels. Each cycle was loaded according to the pre-calculated target displacement on structural performance level from FEMA 356 calculations. This procedure is not applied to the ultimate capacity test where the model was displaced up to failure in a single push. Figure 5 shows the test set-up of the system in laboratory.

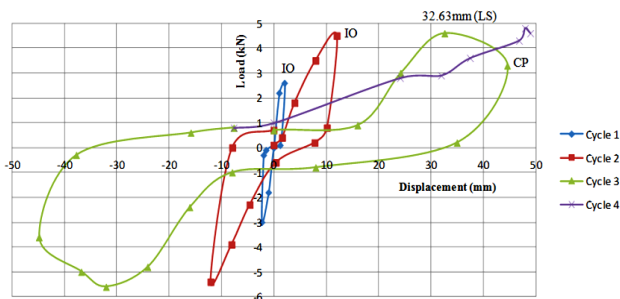
Figure 6 Hysteresis curve of frame

Figure 6 shows the hysteresis profile of frame assembly. Hysteresis profile was used to distinguish the degradation of strength and stiffness for nonlinear dynamic analysis. Under reverse cyclic loading, the frame apparently losses in strength under increasing deformations due to concrete cracking and crushing, shear failure, and bond slip.

Three performance levels that are Immediate Occupancy (IO), Life Safety (LS), and Collapse Prevention (CP) were identified in the experiment as compliance with FEMA 356. The initial stiffness in the first cycle of load represents the stiffness of structure at undamaged state. As the reversal displacement cycles were conducted, the initial stiffness at the beginning of each new cycle was degraded due to the damages from the previous loadings cycles. The strength and stiffness were observed to degrade after each cycle of load.

The first cycle of loading was conducted to detect the instance of the first crack that indicates the system was at the limit of serviceability limit state. The frame was essentially at fully elastic state and at performance level of IO since the system was detected to be able to return to its original position when all loads were released.

In the second cycle of loading, the frame was pushed to the limit of IO performance level. Some new minor hairlines and extended cracks were observed in columns and wall panels. This indicates that the frame starts to undergo the post-elastic process. In the third cycle of loading, the frame was in LS performance level at 32.63 mm displacement. Then, the frame reached CP performance level at the end of third cycle at 43.5 mm lateral displacement.

In the fourth cycle of loading, the frame was loaded until fail. The frame almost collapsed in this final cycle with increment of lateral displacement but decrement of taken load. This phenomenon was happening when the frame has lost its internal resistance to resist any additional lateral load.

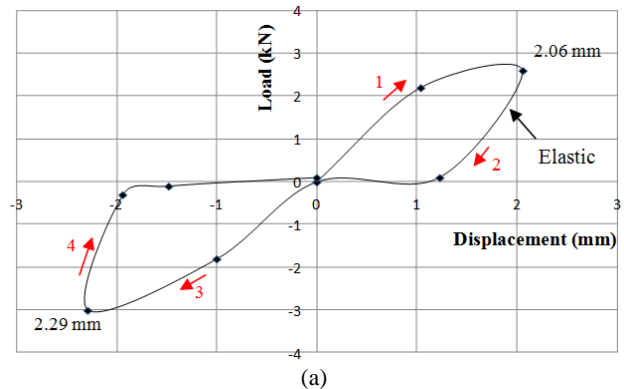
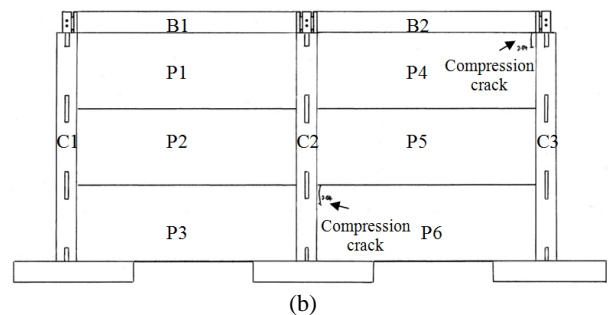
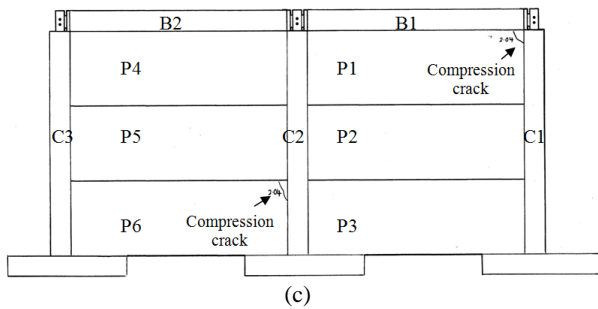
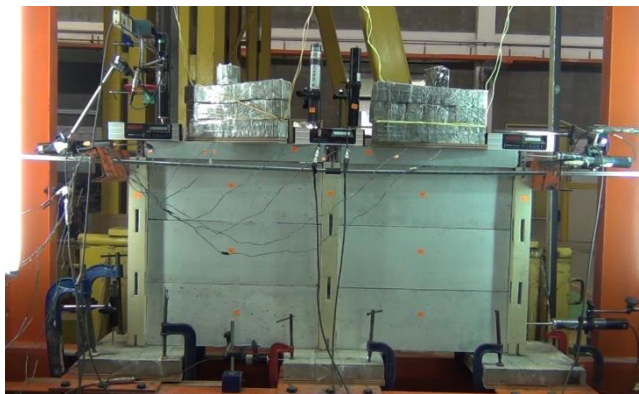
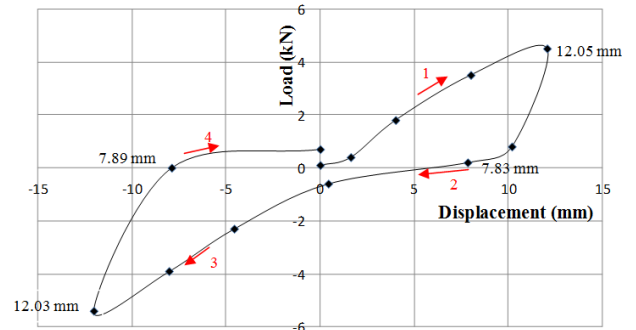
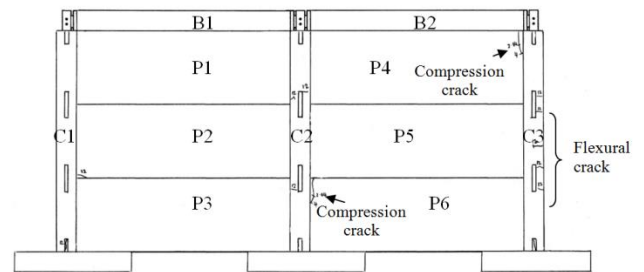
**Figure 7** Cycle 1: (a) load - horizontal displacement relationship; (b) sketch of front view crack pattern; (c) sketch of back view crack pattern; (d) photograph

A sketch of crack pattern of front and back view of the frame at the end of cycle 1 are shown in Figures 7(b) and (c). The photograph in Figure 7(d) was taken to conclude all the cracks and deformation of the frame.

Based on the assessment of frame, only some minor compressive cracks on panel surface were observed. Some minor cracks were observed at the slot connections of wall panel P1, P4 and P6. This was happening because when load was applied horizontally, the column is forced to move and push towards the panels, and this creates stress at the corner of panels. Wall panels were cracking because of the compressive force acting from the column. Insufficient gap between wall panel and column, and stiff of slot connection caused the part to crack. According to FEMA 356, the system was in Immediate Occupancy level since there is no permanent drift with minor overall damage. The structure retains its original stiffness since it can return to original position when it was fully unloaded.

sliding at joints and separation of 2 mm from column. Hence, the system was in the limit state of Immediate Occupancy state.

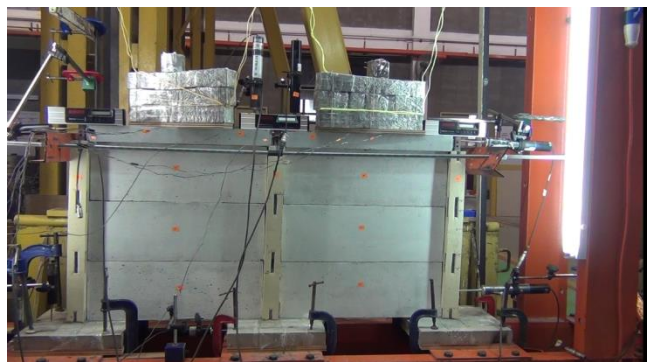
**Figure 8** Cycle 2: (a) load - horizontal displacement relationship; (b) sketch of front view crack pattern; (c) sketch of back view crack pattern; (d) photograph

In the second cycle, the frame was loaded horizontally to 12.05 mm with load of 4.5 kN. As the applied load was increasing, the frame displacement was also increasing. Then, the frame was unloaded after reaching the target displacement in second cycle. However, the frame had permanent drift of 7.83 mm when it was fully released from loaded stage. In this stage, the frame was not able to self-repositioning to its original state. Then, the jack was moved to the opposite side of the frame to jack the frame back to its original position. Hence, this condition can be observed in Figure 8(a) that an additional load was required in negative direction to push the frame from permanent drift of 7.03 mm back to its original position.

A sketch of crack pattern of front and back view of the frame at the end of load cycle 2 were shown in Figures 8(b) and (c). The photograph in Figure 8(d) was taken to conclude all the cracks and deformation of the frame.

It was observed that the cracks originated at the corners of wall panels have propagated. Some newly visible narrow compressive cracks also appeared at the other corner of wall panels P2 and P3. Some visible minor flexural cracks with cracks width less than 0.2 mm were developed at the mid-span of column C1, C2 and C3. However, no crushing and spalling of concrete were observed at the end of cycle 2. The wall panels have some

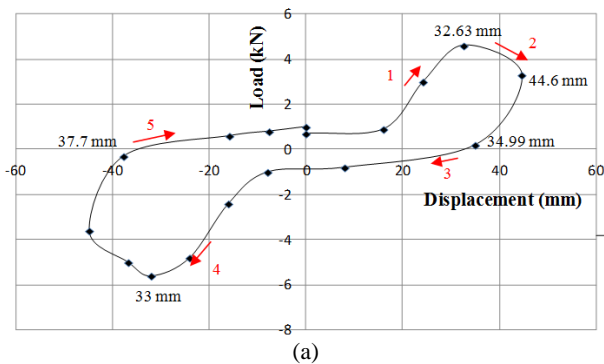
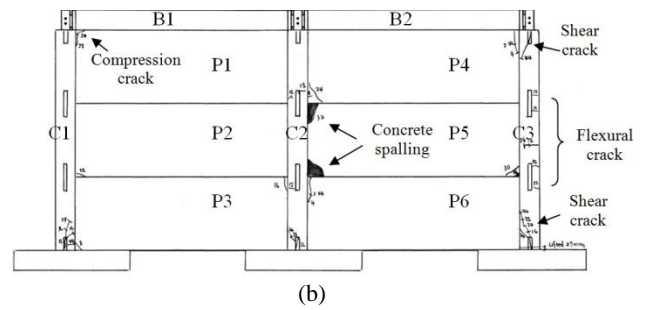
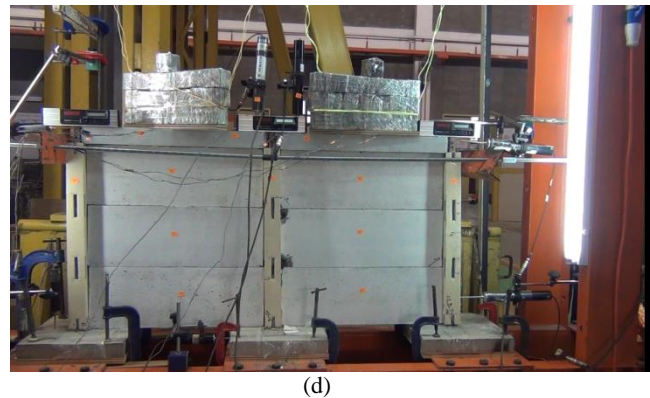
Figure 9 Cycle 3: (a) load - horizontal displacement relationship; (b) sketch of front view crack pattern; (c) sketch of back view crack pattern; (d) photograph

Figure 9 Cycle 3: (a) load - horizontal displacement relationship; (b) sketch of front view crack pattern; (c) sketch of back view crack pattern; (d) photograph (continue)

Then, the frame was slowly unloaded. However, the frame was permanently displaced at 34.99 mm when it was fully released from loaded state as shown in Figure 9(a). In this state, the frame was not able to self-reposition to original state. The jack was again moved to the opposite side of the frame set-up to jack the frame to its original position. This condition can be observed in Figure 9(a) that the additional load was required in negative direction to push the frame from permanent drift of 34.99 mm back to its original position.

A sketch of the crack pattern of front and back view of the frame at the end of cycle 3 are shown in Figures 9(b) and (c). The photograph in Figure 9(d) was taken to conclude all the cracks and deformation of the frame.

At the 32.63 mm lateral displacement, some minor concrete spalling and visibly wide cracks were observed on the surface of wall panels P2 and P5. Column C2 and C3 have some visibly clear cracks and minor concrete spalling in this state.

At 44.6 mm lateral displacement, extensive concrete spalling were observed at the corner of wall panels P5 and P6 whereas minor spalling were observed at the corner of wall panel P1. The wall panels have some sliding at joints and is separated 5 mm from the column. Steel plate connections of wall panels P5 and P6 were exposed with extensive concrete spalling. The wall panels can be concluded as damaged components in this state.

Flexural cracks at the mid-span of columns C1, C2 and C3 have propagated with cracks width greater than 2 mm. In addition, the wide shear cracks have also propagated upward from bottom column and propagated downward from top of the column. The wide cracks cause the separation of RHS from column core concrete. At the end of the third cycle of test, the column C3 has uplifted 25 mm from footing. Based on the visual assessment, the system was in Collapse Prevention level as the column suffered major damage.

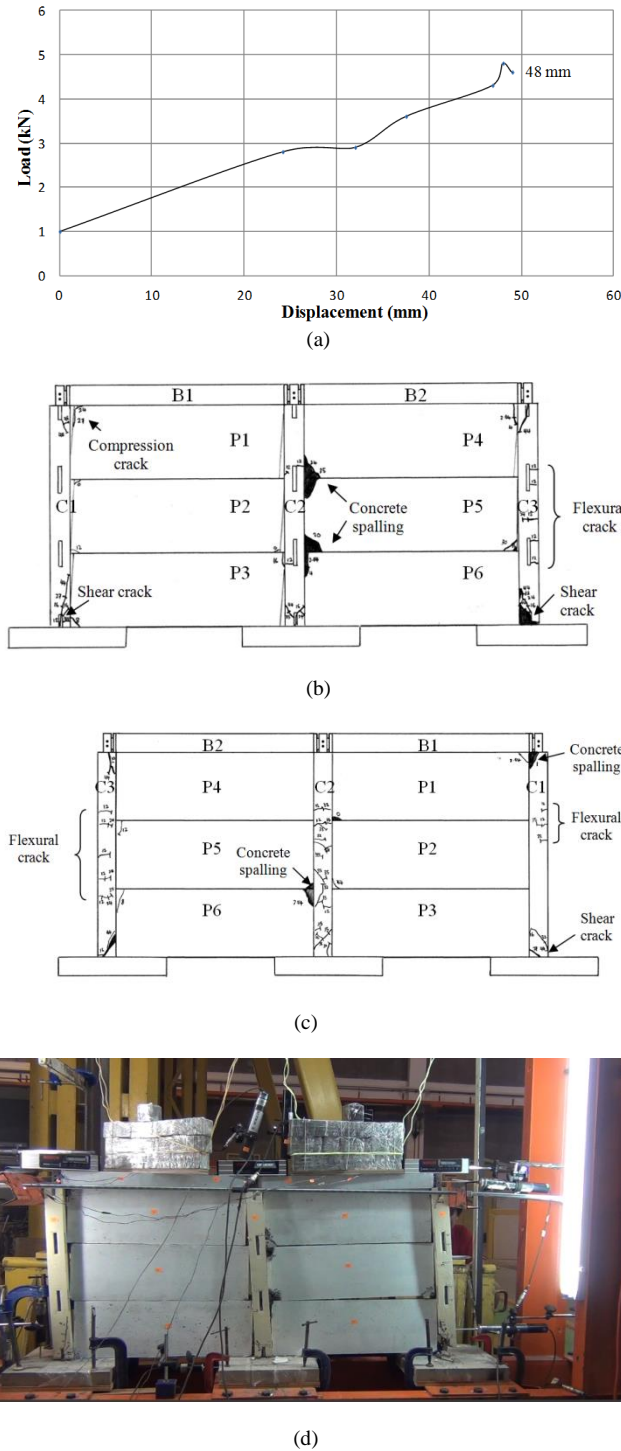
**Figure 10** Cycle 4: (a) load - horizontal displacement relationship; (b) sketch of front view crack pattern; (c) sketch of back view crack pattern; (d) photograph

In the last cycle, the frame was loaded horizontally until a complete failure occurred. As the frame was loaded, the displacement keeps on increasing. The system reached its maximum capacity at lateral displacement of 48 mm with load 4.8 kN before collapse as shown in Figure 10(a).

A sketch of crack pattern of front and back view of frame at the end of cycle 4 are shown in Figures 10(b) and (c). The photograph in Figure 10(d) was taken to conclude all the cracks and deformation of the frame.

In this cycle, wall panels P4, P5 and P6 have an extensive concrete crushing and spalling whereas wall panel P1 has minor concrete spalling. Hence, steel plates of connection of wall panels P4, P5 and P6 were exposed. Large pieces of panel concrete fell off during the experiment. The wall panel P2 was separated from column by 13.17 mm. Wall panels P5 and P6 were separated from each other vertically by 15.12 mm.

Flexural cracks at the mid-span of columns C1, C2 and C3 have propagated and crushing of core of concrete C1 was observed. With further additional load, the core concrete at the bottom of the column has crushes in the compression zone. The crushing of column core concrete causes the separation of RHS

from concrete. This induced the column to become unstable and hence the frame was in critical situation. The system was in earthquake Collapse Prevention level and then collapse without additional load. The experiment was stopped since the system almost collapsed as shown in Figure 10(d).

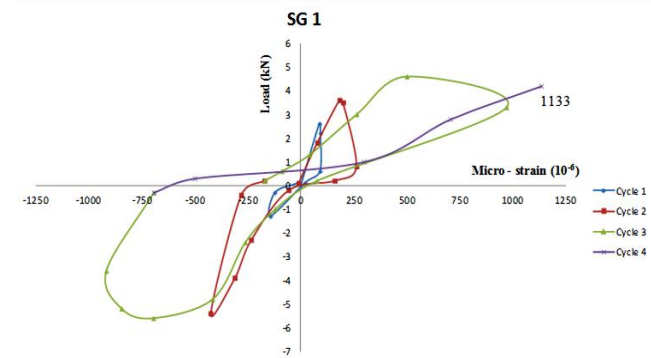
**Figure 11** Load-strain curve of column RHS at connection part

Three steel strain gauges were installed vertically inside RHS of column to detect local deformation of connection during the test. Figure 11 shows the load-strain curve of column RHS at the connection part. The recorded maximum strain of RHS was 1133 micro-strain ( $\mu\epsilon$ ) which was less than yield strain of RHS (0.0031). This shows the RHS of column was not yielding during the test.

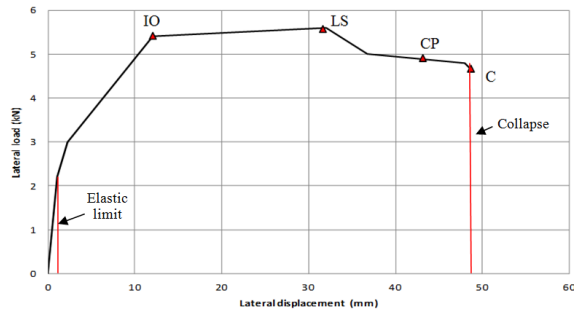
Figure 12 Capacity curve of frame

Capacity curve was obtained by normalising the hysteresis curve in positive and negative direction as shown in Figure 12. This curve represents the system performance in linear and nonlinear state. Three performance levels that are Immediate Occupancy (IO), Life Safety (LS), and Collapse Prevention (CP) were identified in this experiment. The performance level of the system was determined through the damage experienced by the components. In short, it was measured based on damage intensity suffered by the system in compliance with FEMA 356.

In IO level, the structure achieves essentially elastic behaviour by limiting structural damages to light damages. Minor cracks occurred at the corner part of wall panels while columns have minor hairline flexural cracks and no damage occurs in any other components.

In LS level, the overall damage of structure was rated as medium damage. There was some permanent drift occurred in the whole system. The wall panels have extensive concrete crushing and spalling at the corner parts. The columns have minor concrete spalling and extensive of shear cracks.

In CP level, the structure was ensured to have a small risk of partial or complete building collapse by limiting structural deformations and forces to the onset of significant strength and stiffness degradation. In this level, the overall structure has heavy damages. Large permanent drift was found in the system. Wall panels have an extensive concrete crushing and spalling at the corner parts that caused the exposure of steel plate connections. The wall panels were separated from column at connection part by 13.17 mm and separated from the other wall panels by 15.12 mm vertically. Columns have extensive concrete crushing at the

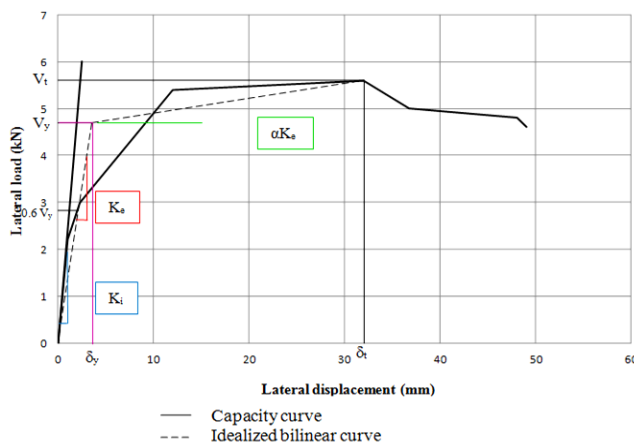
Figure 13 Initial and effective stiffness of frame

The effective lateral stiffness,  $K_e$  was taken as secant stiffness calculated at a base shear force equal to 60% of the effective yield strength of the structure. The effective yield strength of the structure,  $V_y$  was 4.7 kN. The calculated effective lateral stiffness,  $K_e$  and structural post-yield stiffness capacity,  $\alpha K_e$  were 1.34 kN/mm and 0.03 kN/mm respectively. This means the structure has stiffness degradation after it reached its yield state.

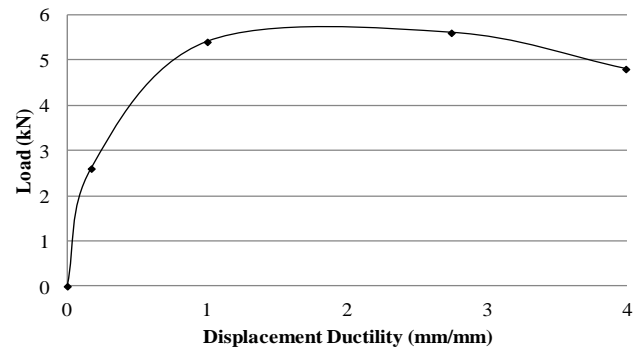
Figure 14 Graph of load versus displacement ductility

Figures 14 and 15 show the system displacement ductility and dissipated energy per cycle of loads respectively. In elastic state, both displacement ductility and dissipated energy were increasing as the load was increasing from load cycle 1 to load cycle 2 as shown in Figures 14 and 15. In load cycle 1 and 2, the frame has displacement ductility of 0.17 mm/mm and 1.0 mm/mm respectively. The frame was also dissipating the energy of 2.875 kN.mm and 26.875 kN.mm in the load cycle 1 and 2 respectively. It was observed that no damage occurred up to the yield displacement (end of load cycle 2).

However, the frame displacement ductility and dissipated energy were observed to increase drastically from load cycle 2 to load cycle 3 without much increment of loads. This was because the frame starts to yield at the end of load cycle 2. In load cycle 3, the nonlinear behaviour of frame starts to control the system and hence the frame continues to show the ductility and dissipate more energy by undergoing higher lateral displacement without much increase in the load. In load cycle 3, the frame has displacement ductility of 2.74 mm/mm and dissipated energy of 118.625 kN.mm.

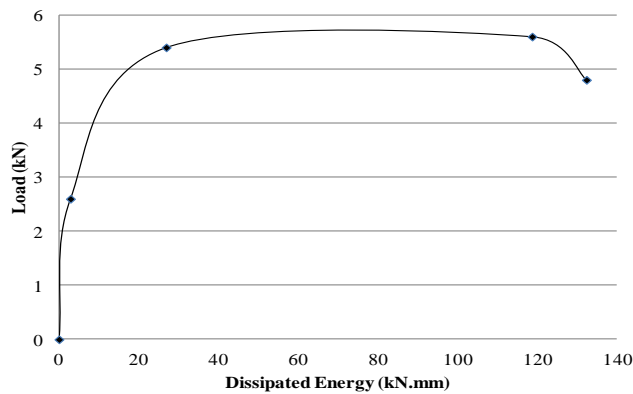
Figure 15 Graph of load versus dissipated energy

In the load cycle 4, the frame starts to degrade with decrement of recorded load but increasing in lateral displacement. This indicates that the frame has lost its internal resistance to resist an additional lateral load. In load cycle 4, the frame has displacement ductility of 3.99 mm/mm and dissipated energy of 132.25 kN.mm. The ultimate displacement ductility of the frame was 3.99 mm/mm. In this state, the frame shows the highest lateral displacement of 48 mm before collapse. The total energy dissipation of the frame was 280.625 kN.mm.
