# Comparison of Sand Patch Test and Multi Laser Profiler in Pavement Surface Measurement

Haryati Yaacob<sup>a</sup>, Norhidayah Abdul Hassan<sup>a</sup>, Mohd Rosli Hainin<sup>b</sup>, Muhammad Fudhail Rosli<sup>c</sup>

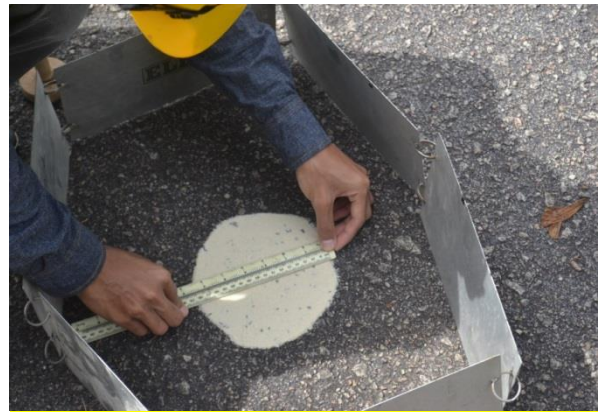
Figure 2 Sand patch test

The sand patch test was conducted based on standard from ASTM E965-06, standard test method for measuring pavement macro texture depth using a volumetric technique. Figure 2 shows sand patch test was being conducted. The multi laser profiler was conducted based on manufacturer's user manual from Soil Centralab Sdn Bhd. Figure 3 shows the multi laser profiler used for the test. This test was carried out under normal operation conditions, on dry weather. The data recorded was used as provided by the operator and possible outlier values were included. Therefore, all possible sources of error are included and will be reflected in the repeatability and the reproducibility of the methods under analysis. Any unusual features and events that have influenced the result were recorded. The test results were then analysed using statistical analysis tools which were SPSS Statistics 20 and Microsoft Excel 2010.

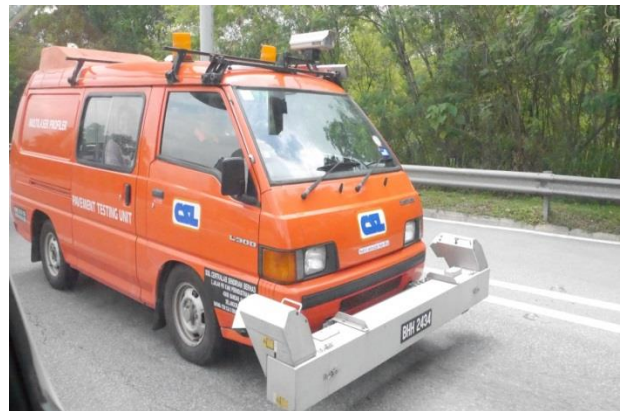
Figure 3 Multi laser profiler

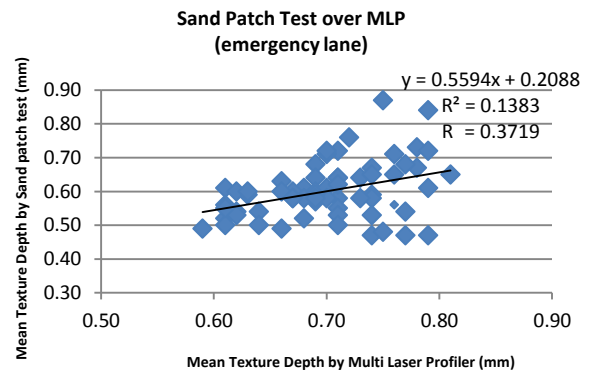
**Figure 4** Correlation between MTD data measured using Sand Patch and MLP for emergency lane

Figure 4 and Figure 5 presents the correlation data of MTD measured using sand patch test and MLP along emergency lane and slow lane respectively. The coefficient of correlation obtained for emergency lane is 0.3719 while coefficient of correlation obtained for slow lane is 0.4579. While the coefficient of determination obtained for emergency lane is 0.1383 while coefficient of determination obtained for slow lane is 0.2096. From the data obtained by emergency lane and slow lane, there does not appear to have a strong correlation between two measurement techniques. This may probably due to the location for each of measurement technique is not really exactly the same

because of the ways the texture depth being measured. Measurement of texture depth by sand patch test was conducted at one small spot to represent the 50m length. While measurement by multi laser profiler is in horizontal line along the pavement surface.

The different time of conducting both of test methods also contribute to the weakness in the correlation between sand patch test and multi laser profiler along emergency lane and slow lane. The measurement by sand patch test was conducted first followed by multi laser profiler about one month later. The change of the surface may occurred during the time interval. During the time interval, the aggregate was polished by the vehicle tires and this will lead to the discrepancy on the texture depth value between both tests.

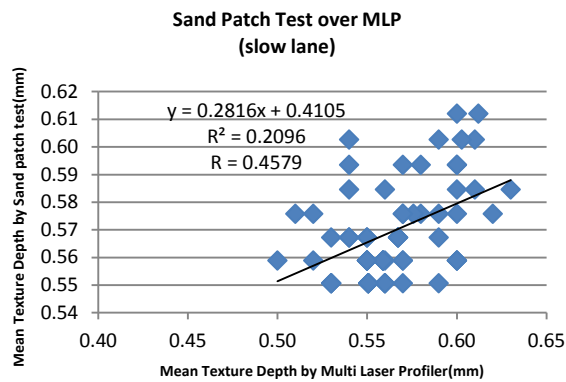
**Figure 5** Correlation between MTD data measured by Sand Patch and MLP for slow lane
