Discrete Element Modelling of Complex Failure Mechanism at Quarry Slope

Keywords: Discrete element method; UDEC; rock slope; block-flexural toppling

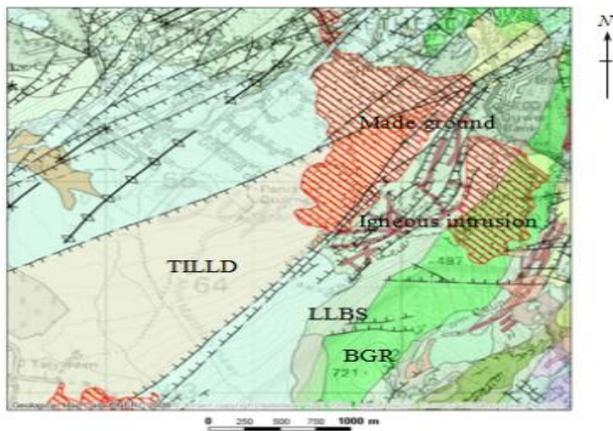
The quarry located near Bethesda in north Wales (Fig. 1). It was once reputed to be the world's largest slate quarry. The slate is known as Llanberis slate of Early Cambrian age (Fig. 2). The development of a slaty cleavage is a direct result of realignment, through orientation and or re-crystallisation. This preferred alignment of platy minerals accounts for cleavage in slate, which gives pronounced anisotropy [27].

Legend:	Rock unit	Age
	Till Devensian (TILLD)	Devensian
	Llanberis Slates Formation (LLBS)	Early Cambrian
	Bronllwyd Grit Formation (BGR)	Late Cambrian

Figure 2 Geology of slate quarry [28]

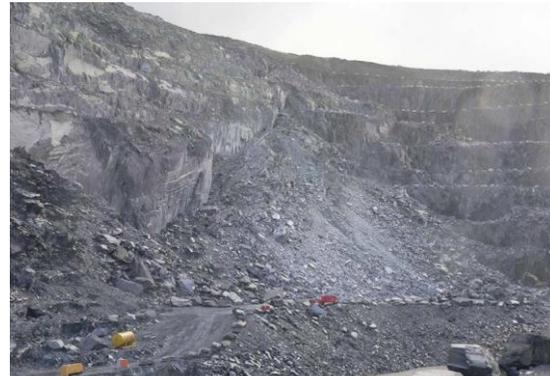
Figure 3 Failure occurred in October, 2008

The south-eastern faces have been the site of a series of large historic slope failures in both the North and South Quarries over the past 100 years. Following a significant failure in the North Quarry in 1989 this area was closed and the workings were then concentrated in the South Quarry. The most recent instability occurred overnight on 2nd October 2008, with a secondary movement reported to have occurred during 5th October 2008, see (Fig. 3-5).

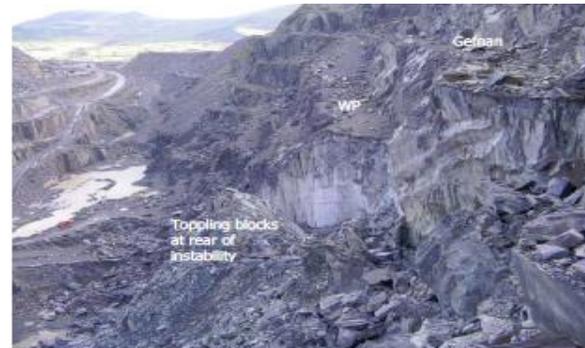
Figure 4 Flexural toppling and overturning at rear of failure

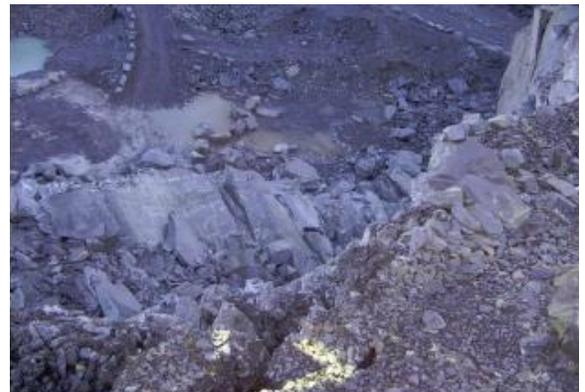
Figure 5 Cracks monitoring point at the rear of instability

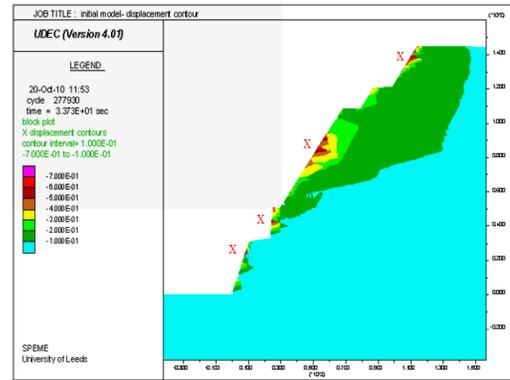
Figure 6 Location (X) of tension crack in slope model

It was found from Figure 6, that the maximum displacement was 0.7m which was located at a few locations at the top, middle and bottom of the slope (marked with X). This gives the slope strain of 0.47%, which reflects the development of a tension crack (Table 2).

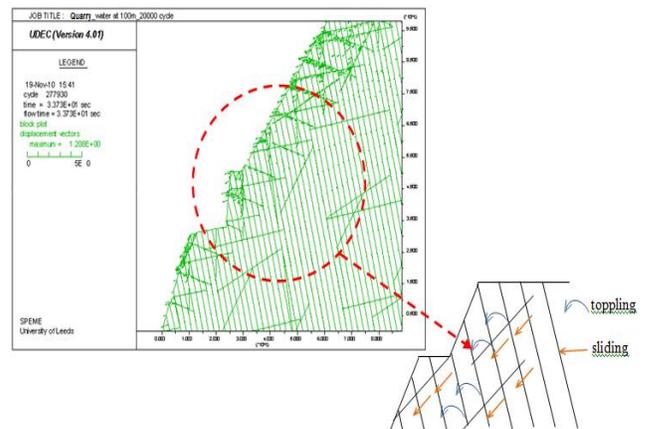
In general, the slope undergoes a complex type of failure. From the displacement vectors, the slope displayed a complex type of failure which consists of toppling between the cleavages and sliding along joints (Fig. 7).

Figure 7 Vectors show the direction of block movement

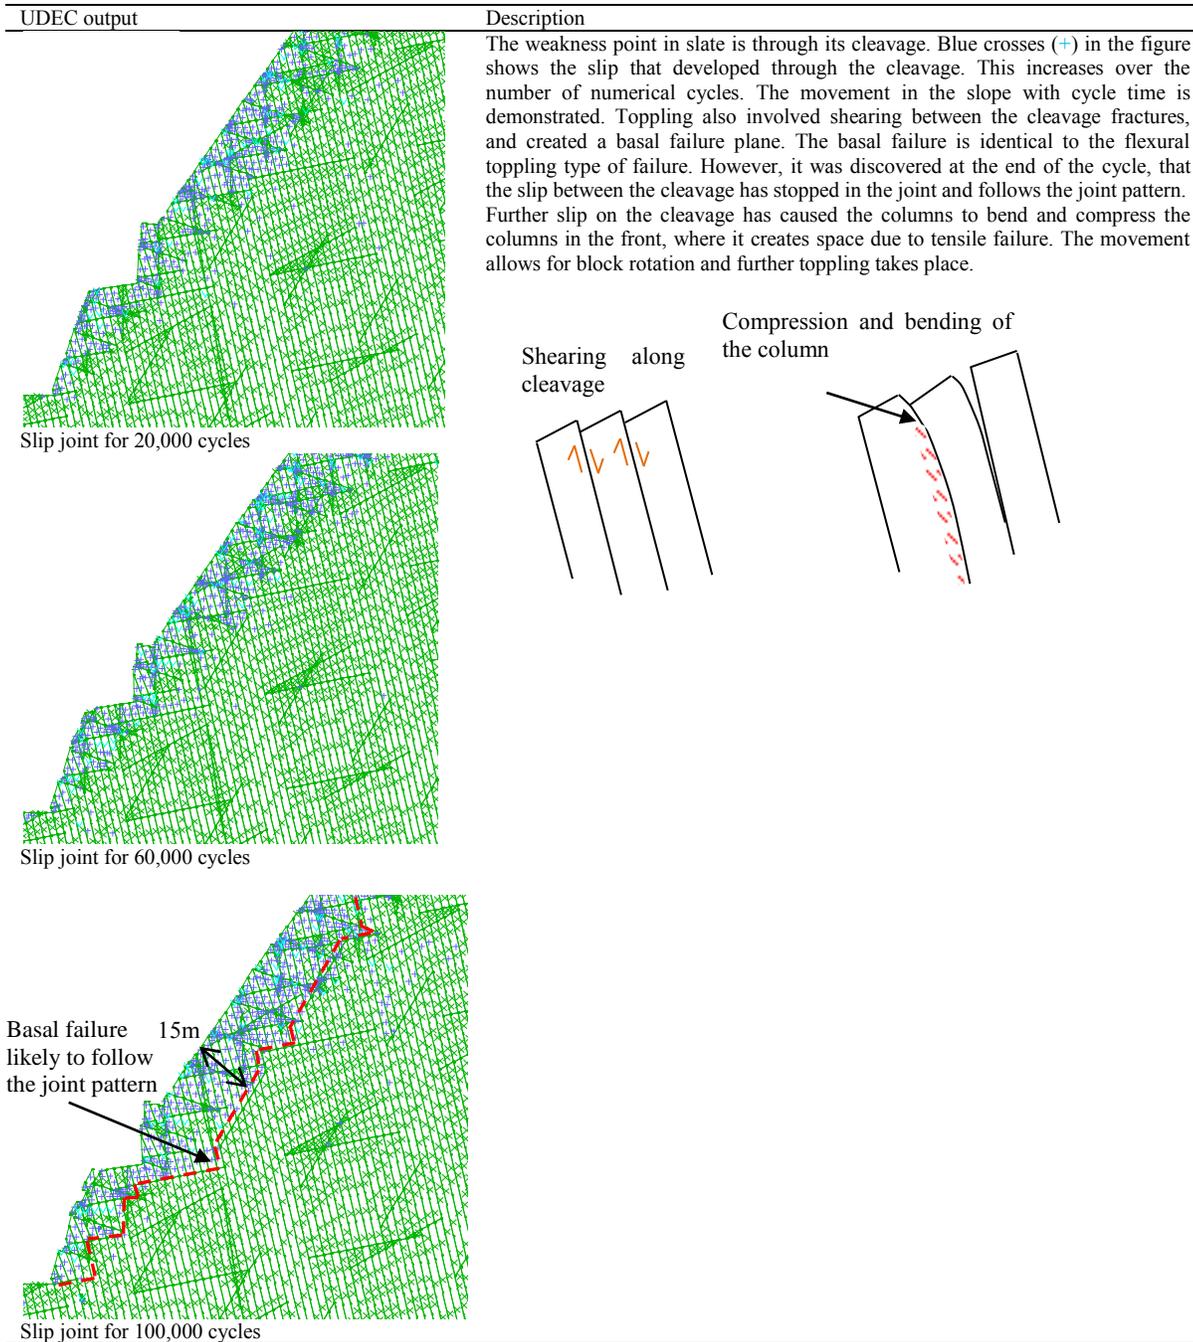
It is believed that block flexural toppling was the mode of failure. Block flexural toppling is bounded by the basal failure plane and the movement is also influenced by displacement on the cross joint. As can be seen in Figure 8, the failure depth is at about 15m. At the toe, joints start to slip and block rotation can also be observed.

Figure 8 Slip along the cleavage creates a basal failure that is identical to flexural toppling failure

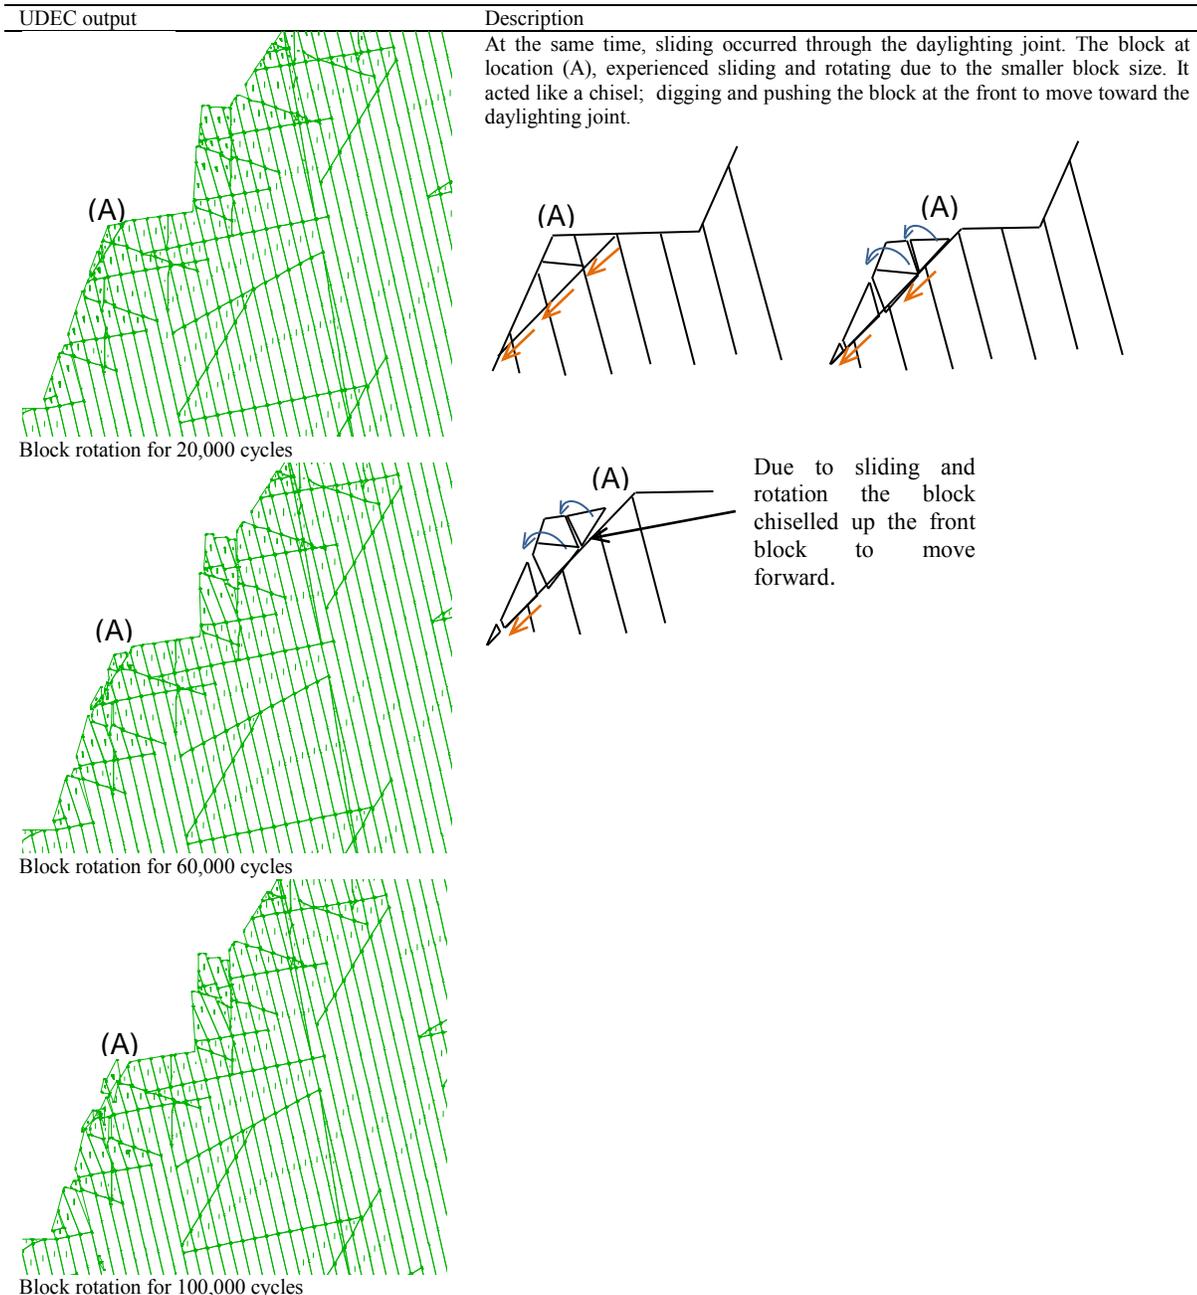
Further movement of the slope takes place when a water table was present at a depth of 100m. The water that filled in the crack pushed the block further and the slope failed with a maximum displacement of 3m. Shearing of blocks which involves the rotation is illustrated in Figure 9. It shows that the larger block at (A) slides and rotated a higher degree thus acts as a chisel causing the block at the front to slide along the daylighting joint. Further toppling also triggers the cleavage to compress and bend. Opening up the cleavage is due to tensile failure.

Figure 9 Shear failure involving block rotation

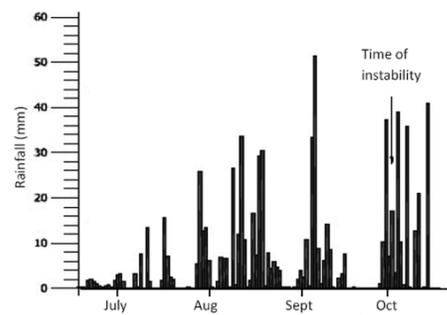
This mechanism was found to explain the pattern of slope movement, which was the objective of the modelling. It also confirms the failure observed on site. There are two main aspects in the instability which are water and tension crack. The collapse of the slope took place after a period of heavy rainfall (Fig. 10). The graph showed that September experienced the heaviest rainfall event without the failure. The implication is that, the slope is generally close to limiting equilibrium, which may be disturbed by heavy rain. This was evidence of movement with the development of tension cracks in the field before the main failure occurred (Fig. 5). Then, the opening of a tension crack being filled with water and triggering the failure at a later date.

Figure 10 Rainfall data event at the quarry slope

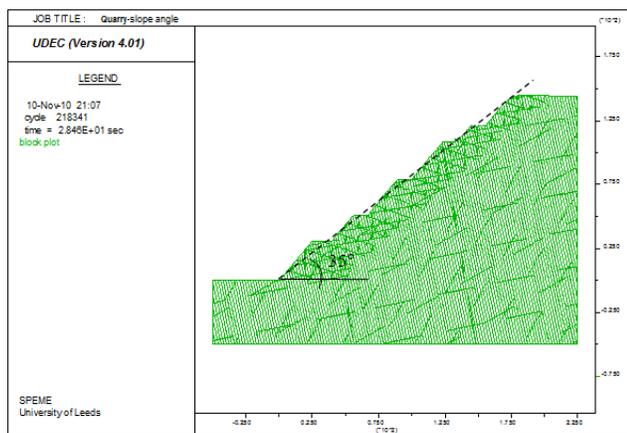
was reduced from 52° to 35° (Fig. 11). This includes flattening the individual slope at about 50° compared to initial individual slope angle that range from 55° – 85°. All the models were tested against four slope condition, i.e. 1) initial model, 2) presence of tension crack, 3) presence of tension crack with water table at 50m and 4) presence of tension crack with water table at 100m.

Figure 11 UDEC model for Slope Angle (SA) analysis with overall slope angle=35°

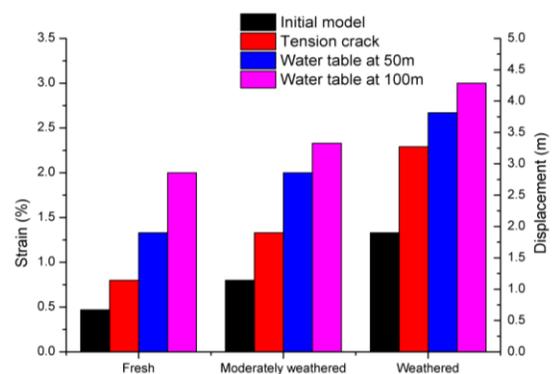
Figures 12 and 13 show the results of the sensitivity analysis carried out on weathering grade and slope angle respectively. It can be seen that, for the initial model, with increasing of weathering grade (fresh to weathered), strain increased steadily from 0.47% (fresh) to 0.80% (moderately weathered) and 1.33% (weathered). This upward pattern of strain is directed to all slope conditions i.e. slope with tension crack and water. In general, the fresh rock slope only collapses once it is modelled with 100m height of water table. Meanwhile, for a moderately weathered rock slope it was observed to collapse once the water table was introduced and for weathered rock slope, it was demonstrated that the slope itself will collapse with only the presence of a tension crack in the slope.

Figure 12 Sensitivity analysis for weathering grade for the slope

It is evident that, the more weathered the rock mass, the more unstable the slope is. This can be explained by changing the discontinuity strength. With lower JCS value, the asperities are more likely to be sheared off and damaged rather than overriding.

With the presence of the tension crack, strain increased to almost double for all weathering states. Opening the tension crack eliminates the rock to rock contact and reduces shear strength between the discontinuities. Strain continues to increase when the water was introduced for 50m of the slope height. Thus, with the presence of water at 100m, it does promote further movements of the slope.

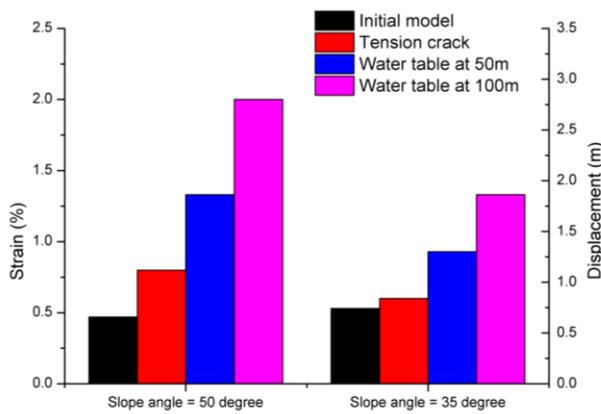
For the analysis of the effect on slope angle, the results show that by flattening the slope, the strain is reduced for all slope conditions. In this case, the slope is found to be stable except that the tension crack was developed for the slope that was modelled with a water table at 100m height.

Figure 13 Sensitivity analysis for the slope angle
