## THE OCCURRENCE OF BUILDING DEFECTS DURING DEFECT LIABILITY PERIOD (DLP)

This study focuses on the defects and causes of defects that occurred during defect liability period. The study began with a literature review to the research topic. Then, site observations were carried out to observe common defects which occurred in Taman Ilmu Indah, Pulau Pinang and Taman Koperat Peradong, Terengganu due to the reason that these sites were still in the defect liability period. The main source of data collection for this study was through questionnaire surveys.

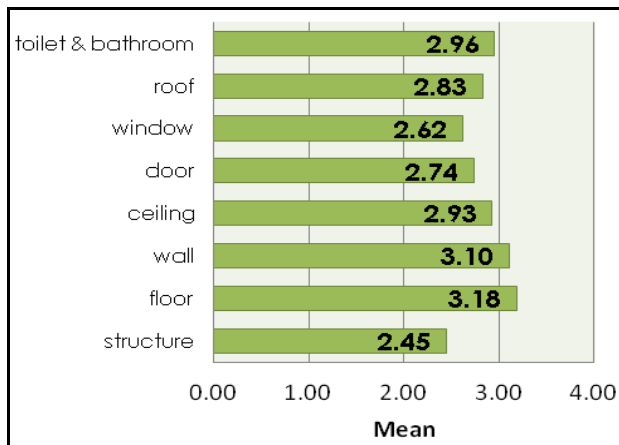
Figure 18 Summary of defects

Figure 18 shows the summary of defects commonly occurred in building element during the defect liability period. It can be concluded that the most defect occurs involving floor which has 3.18 of mean values and wall which has 3.10 of mean values.

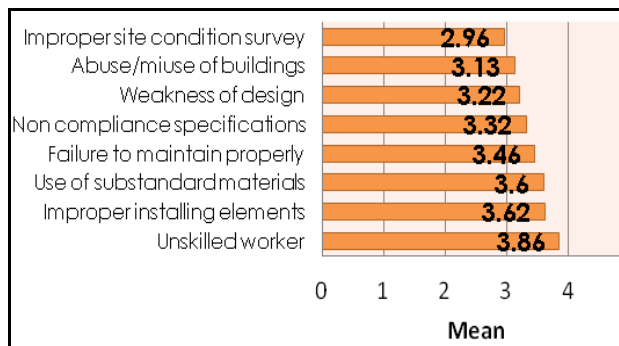
Figure 19 Causes of defect occurs by technical

From Figure 19, it has been found that unskilled worker is the most important factor that contributes to the causes of defects occurred regarding the technical causes. Meanwhile, ineffective planning and scheduling and lack of systematic supervising are the most important causes of defect occurred regarding the management causes as been shown in Figure 20.

The types of defects which commonly occurred during defect liability period were identified, as cracks on wall was the most common defect that can be found on during DLP. From the data collection through questionnaire survey, unskilled worker was ranked as the most significant causes of defect occurred by technical and ineffective planning and scheduling by management factor.
