## ENERGY ANALYSIS FOR LIGHTING AND AIR-CONDITIONING SYSTEM OF AN ACADEMIC BUILDING

Tee Boon Tuan\*, Ahmad Zubair Yahaya, Younus Fahad Breesam, Reduan Mat Dan, Muhammad Zulfattah Zakaria

Centre for Advanced Research on Energy (CARE), Faculty of Mechanical Engineering, Universiti Teknikal Malaysia Melaka, Hang Tuah Jaya, 76100 Durian Tunggal, Melaka, Malaysia

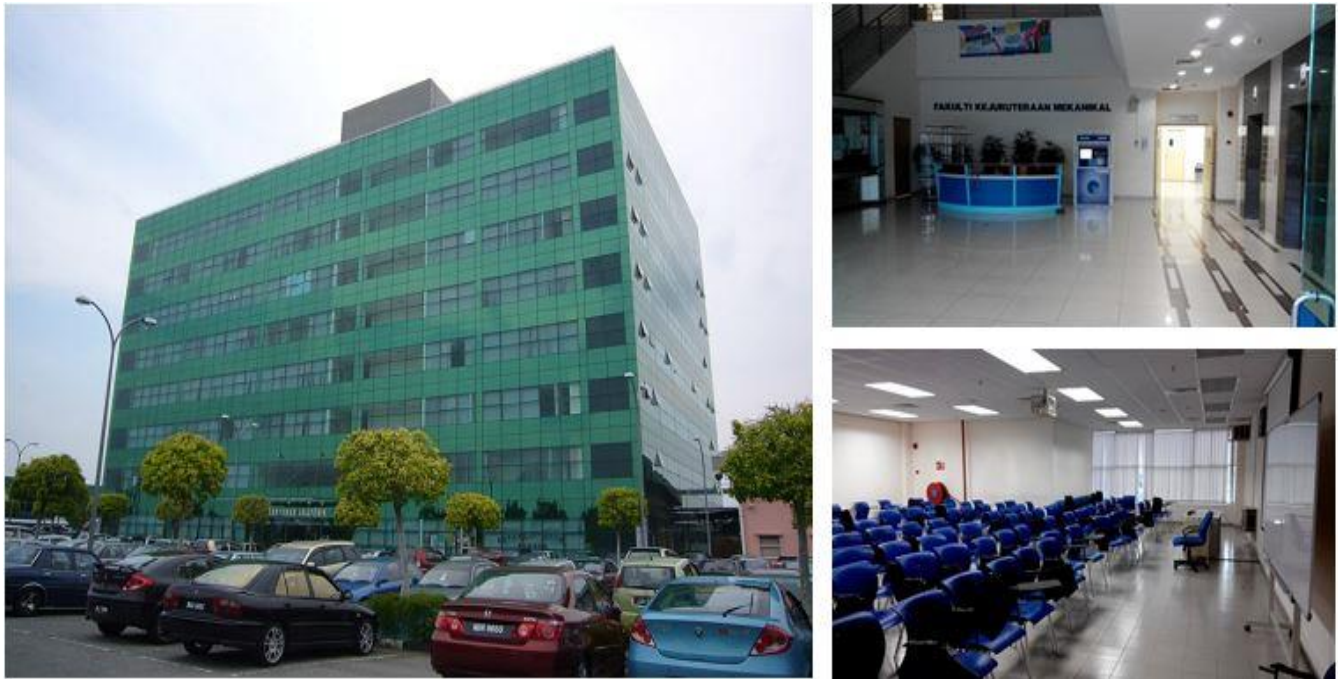
Figure 1 The case study building

The building that is chosen for this study is eight-storey academic building of Mechanical Engineering Faculty (FKM) situated in UTeM's Technology Campus, Ayer Keroh, Melaka as shown in Figure 1. This building accommodates the faculty office, lecturers' office rooms, library, student affairs office and lecture rooms. The building is furnished with central air-conditioning system for all levels. The building floor area is about 3120 m<sup>2</sup> and is equipped with almost 80% of glazed facades.

The interior walls of the building are made from poured concrete and lightweight plaster. Meanwhile for the interior partition wall of the building, a lightweight plaster board is used. Standard glazing is equipped on the building façade which is

constructed from polycarbonate and thermoplastic. This study covered for the whole building floors except on the seventh floor as it was still under renovation during the observation period. The

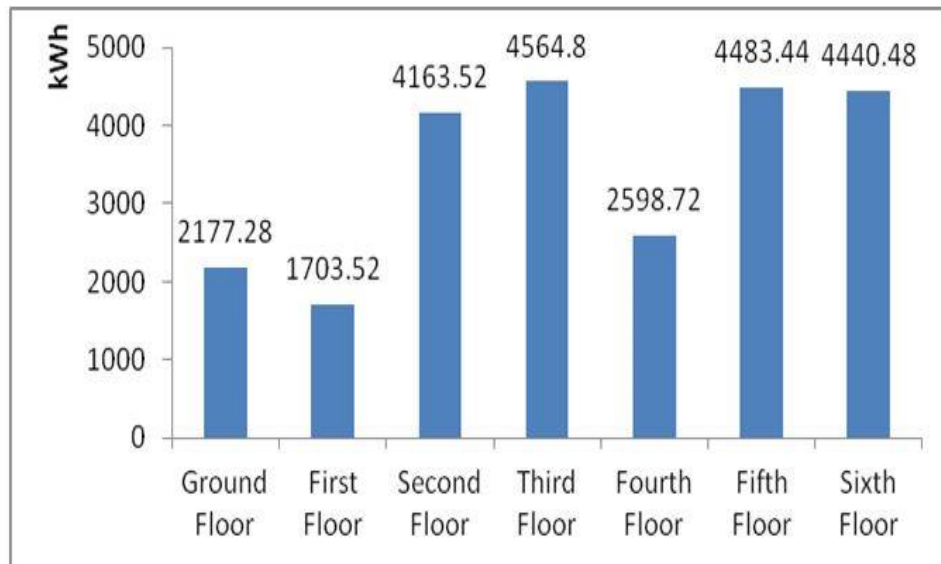
Figure 4 Energy consumption estimation for each floor

Figure 4 shows the energy consumption from the lighting portion of the building. As most of the lecturers' office rooms located in the second, third, fifth and sixth floor, the operational hours were varied and did contribute to the higher energy consumption compare to other floors. The calculations showed that the BEI from the lighting system is 150 kWh/m<sup>2</sup>/year.

Overall, the results from this work indicate that there is a need of retrofit plan from the building management in order to optimize the current usage while reducing the current consumption. Recommended retrofit plan include improving the existing of air-conditioning system with variable frequency drive, 7-day programmable thermostat and using energy efficient lighting and sensors.
