MODELLING THE EFFECT OF WIND FORCES ON LANDSLIDE OCCURRENCE IN BUDUDA DISTRICT, UGANDA

Okello Nelson, Azman Kassim*, Gambo Haruna Yunusa, Zaihasra Abu Talib

Department of Geotechnics and Transportation, Faculty of Civil Engineering, Universiti Teknologi Malaysia, 81310 UTM Johor Bahru, Johor, Malaysia

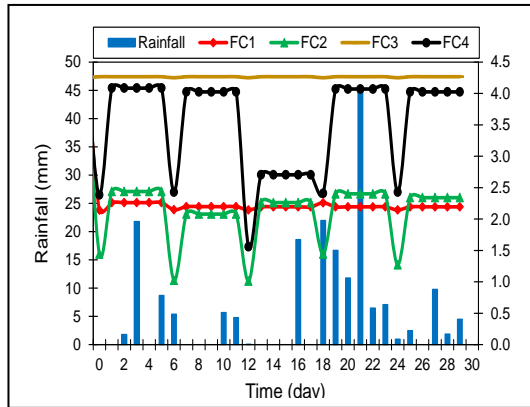
The results obtained from the slope model 1 with eucalyptus trees with *DBH* of 25 cm based on the assumed failure criteria is presented in Figure 1. Tree distribution was pivotal to the realization of the result of the landslide occurrence after running a coupled seepage and limit equilibrium analysis of Seep/W and Slope/W [12,13]. The modelling result from the model slope 1 shows FC2 as the critical failure criteria with a tremendous decline in the factor of safety from the initial value of 4.25 to 1.012, just after the thirteenth day. However, the factor of safety

increases to a value of 2.263 before it decreases to 1.444 again on the eighteenth day and finally to a factor of safety of 2.341 even up to the fateful day. With the tree of *DBH* 25cm, all the failure criteria (FC1, FC2, FC3 and FC4) registered factors of safety greater than 1.0, hence giving the minimum stability condition of the slope to landslide occurrence when subjected to different environmental conditions. Less fluctuation of factor of safety was observed due to FC1, this may be attributed to the distribution of the trees along the slope.

Figure 1 Failure trend of slope model 1 with various FC criteria for DBH of 25 cm

The modeling result from the model slope 1 shows FC2 recorded a tremendous decline in the factor of safety from the initial value of 4.25 up to 1.012, just after the thirteenth day. All other failure criteria registered factors of safety greater than 1.012.

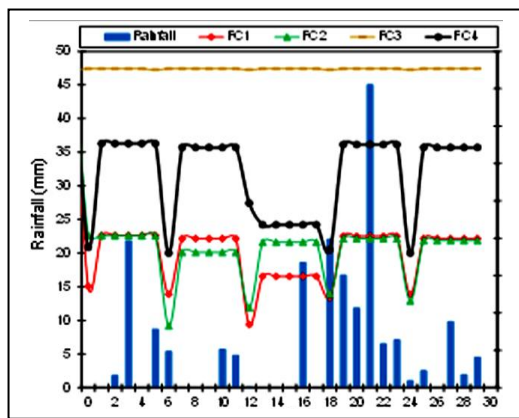
The results obtained from the slope model 2 with eucalyptus trees with *DBH* of 30 cm based on the four failure criteria is presented in Figure 2. These results indicate FC1 and FC2 as the most critical failure criteria, showing the beginning of failure with the minimum factor of safety of 0.826 on the seventh day in FC2. The modelling result from the model slope 2

also shows that FC1 registered a tremendous decline in the factor of safety from the initial value of 4.25 up to 0.845, just after thirteenth day.

Figure 2 Slope model 2, with failure beginning in FC1 and FC2 with DBH of 30 cm

With the tree of DBH 30 cm, the remaining failure criteria (i.e. FC3 and FC4) registered factors of safety greater than 1.0, but since the slope has shown a sign of failure, there is a possibility of landslide occurrence on model slope 2 any time when subjected to different environmental conditions. Lower factor of safety were observed in this slope model compared to slope model 2. This shows that an increase in DBH to 30 cm has resulted in decrease of factor of safety.

From the assumed four failure criteria, the result of the Model slope 2 analysis shows the beginning of failure with the minimum factor of safety of 0.826 (FC2) on the seventh day and also in FC1 on the 13th day.

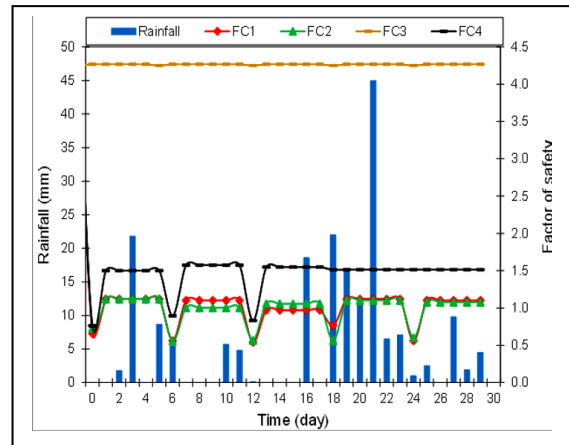
The result of the stability analysis for the model slope 3 is presented in Figure 3. The factor of safety for model slope 1 dropped significantly from the initial condition value of 4.25 to a stable value of 1.012 with FC2. However, the factor of safety for the model slope 3 registered failures in other three failure criteria (i.e. FC1, FC2 and FC4) after including the first rainfall set of day one in the modelling. The model slope

continued to regain strength and at the same time declining in stability at the end of a rainfall set after every six days and the trend of failure is seen even with a minimum factor of safety of 0.562 (FC1) on the 25th day before the landslide eventually happened on the 25th June 2012. This shows signs of total slope failure which triggers the landslide. The slope remained stable only with FC3 (bare slope). It shows that DBH of 60 cm produces very large weight for the over turning moment in the slope stability analysis.

Figure 3 Failure trend of slope model 3 with FC1, FC2 and FC4 showing failure for DBH of 60 cm

The model slope 3 continued to regain strength and at the same time declining in stability at the end of a rainfall set after every six days and the trend of failure was observed even with a minimum factor of safety of 0.562 (FC1) on the 25th day before landslide eventually happened on the 25th June 2012. This shows signs of total slope failure within FC1, FC2 and FC4 to trigger landslides.

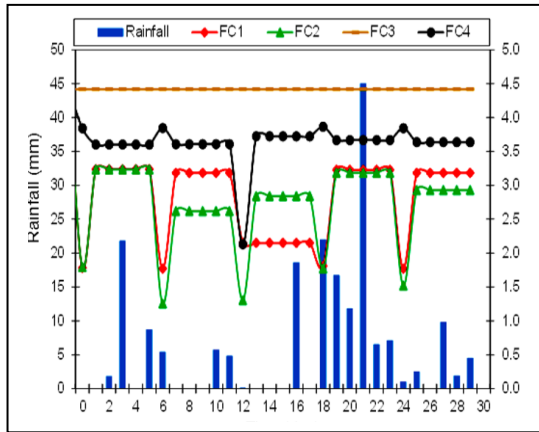
The results obtained from the slope model 4 with eucalyptus trees and DBH of 25 cm based on the assumed failure criteria is presented in Figure 4. From the results of the analysis, the factor of safety increases with failure criteria. FC1 realized a minimum increase in the factor of safety of about 12.99% on the first day of the analysis and the maximum increase in the factor of safety of 106.63% on the 13th day due additional cohesion of 5 kPa on the top layer of silty clay soil. For FC2, the minimum increase in the factor of safety 19.32% (from 1.273 to 1.519) on the 25th day, with a maximum increase in the safety factor being 32.6% obtained from 2nd to the 6th day. The factor of safety of the initial slope condition also increased by 3.98% (from 4.250 to 4.419) as a result of root cohesion on the top layer of the silty clay material and such increase in the factor of safety also manifested in FC3 and FC4 as well. Hence, the slope showed great improvement in the resisting force due to additional cohesion from tree roots.

Figure 4 Increment in the factor of safety of slope model 4 due to increased cohesion for DBH of 25 cm

Slope model 4 had its factor of safety generally increased with all failure criteria and the minimum increase in the factor of safety 12.99% on the first day of the analysis and the maximum increase in the factor of safety of 106.63% on 13th day due additional cohesion of 5kPa on the top layer of silty clay soil.

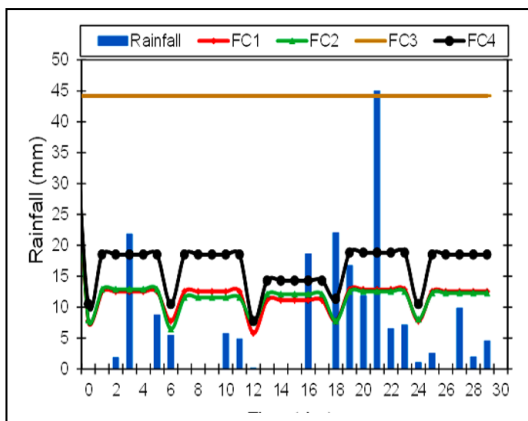
The results obtained from the slope models 5 with eucalyptus trees with DBH of 60 cm based on the assumed failure criteria is presented in Figure 5.

Figure 5 Improvement in the factor of safety for slope model 5 after additional cohesion from the roots DBH of 60 cm

These results also shows that factor of safety increases with failure criteria and the minimum increase in the factor of safety was 0.009% (i.e. from 0.767 to 0.774) on the 19th day and the Maximum was 37.54% between the 2nd to the 6th day which is obtained from FC1. For FC2, the minimum increment in the factor of safety was 8.37% realized on the 1st day (i.e. from 0.729 to 0.790) and the maximum was 37.54%, obtained on the 19th day with all other increments in the factors of safety of more than 13% for FC2. The factor of safety of the initial slope condition also increased by 3.8% (i.e. from 4.250 to 4.419) as a result of root cohesion on the top layer of the silty clay material and such increase in the factor of safety also manifested in FC3 and FC4. Hence, the slope showed great improvement in the resisting force.

The result of the analysis from slope model 5 shows that the factor of safety increases generally with all failure criteria and the minimum increase in the factor of safety was 0.009% (i.e. from 0.767 to 0.774) on 19th day and the maximum was 37.54% between the 2nd to the 6th day, observed from FC1.

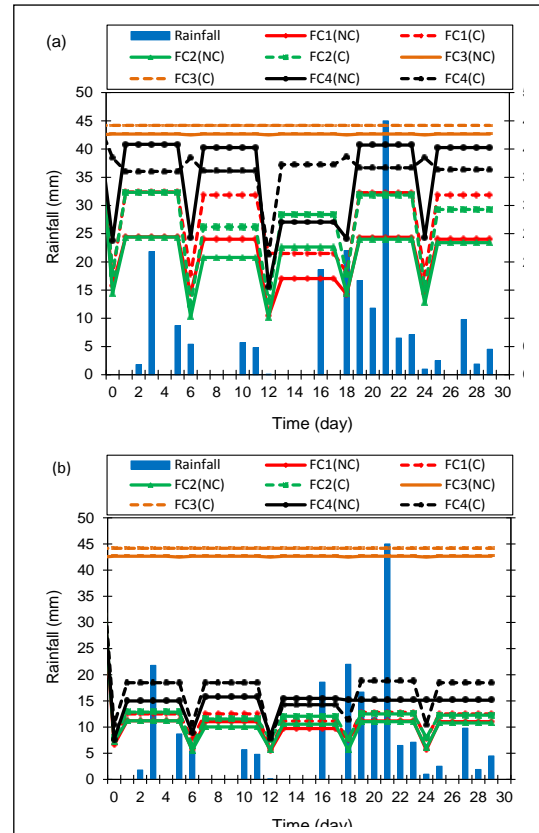
The effect of additional cohesion from tree roots on the factor of safety of the slope due to the four failure criteria is presented in Figure 6. The additional cohesion results in an increase in the factor of safety of the slope due to an increase in the resisting forces along the potential slip surface. The variations in the factor of safety follow similar pattern in both cases.

Figure 6 Comparison of factor of safety due to root cohesion (a) DBH of 25 cm (b) DBH of 60 cm (NC- with no cohesion and C-with cohesion)
