BUILDING DEFECTS AND FAILURE OF MALAY TIMBER HOUSE: CAUSES AND SYMPTOMS

Md Azree Othuman Mydin*

Building Surveying Department, School of Housing Building and
Planning, Universiti Sains Malaysia, Penang, Malaysia

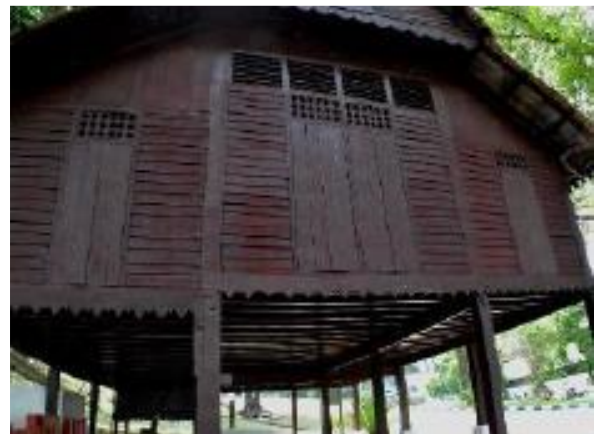
Figure 2 The exterior of Malay House

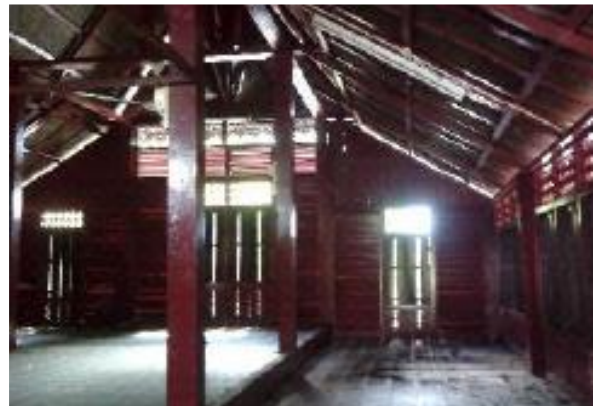
Figure 3 The interior of Malay House

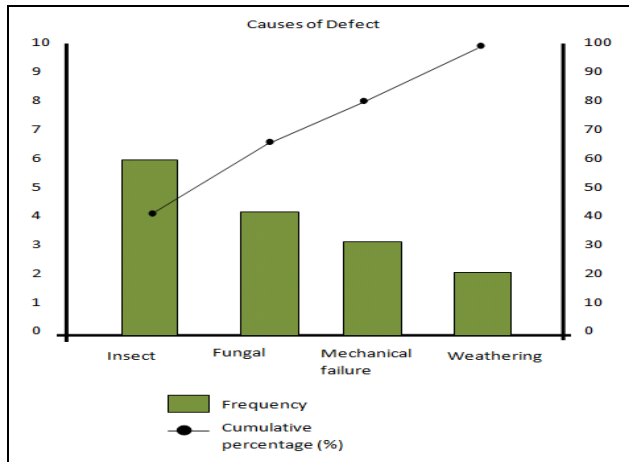
Figure 5 Cumulative percentage of defects

By referring the above Figure 5; it shows the cumulative percentage of the total number causes of defects. In order to lower the causes amount of defect by 87%, it is sufficient to solve the first three causes which are; insects, fungal, and mechanical failure.

Based on pareto analysis technique, it can be conclude that we must give extra focus on the roof, floor and column element. The renovation work that took place in 2009 has given quite numbers of changes to existing building. Even though from the survey it shows that the house is still in good condition and classified as good but for the maintenance purpose; the caretaker are advisable to give priority to replace the roof (attap) as the roof are in worst condition. The survey being conducted to Malay house is the first initiative to determine current state of building. The same exercise should be carried out to other timber related building or structure.

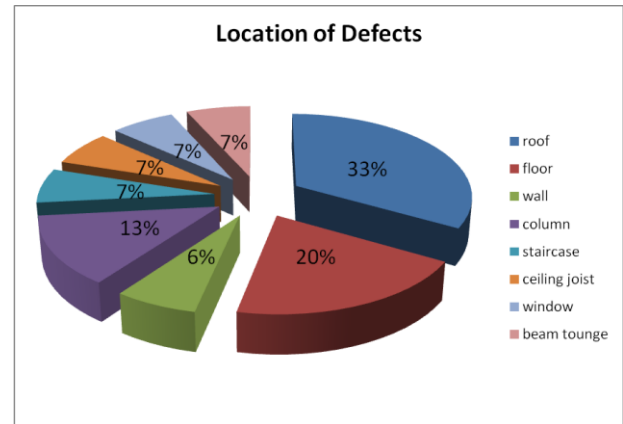
Figure 6 The percentage of Defects (Location)

From the Figure 6, it shows the percentage of location that defects occurred. The roof of the house is recorded as the highest one with 33%. It is followed by floor area with the percentage of 20%. Then, 13% is recorded occurred at the column. The next four locations which are beam tounge, staircase, ceiling joist, and window having the same percentage with 7% and the lowest percentage is walled with 6%.

Building condition survey reveals that the house is still in a good condition and classified as good. For maintenance purpose, the custodian should give priority for replacement of the roof (attap) at the whole area of roof. Malay house form as a pilot project for the ranking system and it is likely to be
