RETROFITTING PERFORMANCE OF REINFORCED CONCRETE ONE WAY SLAB

Norliyati Mohd Amin*, Nur Aqilah Aziz, Ilya Joohari, Anizahyati Alisibramulisi

Institut Infrastructure Engineering and Sustainable Management (IIESM), Faculty of Civil Engineering (FCE), Universiti Teknologi MARA, 40450, Shah Alam, Selangor, Malaysia

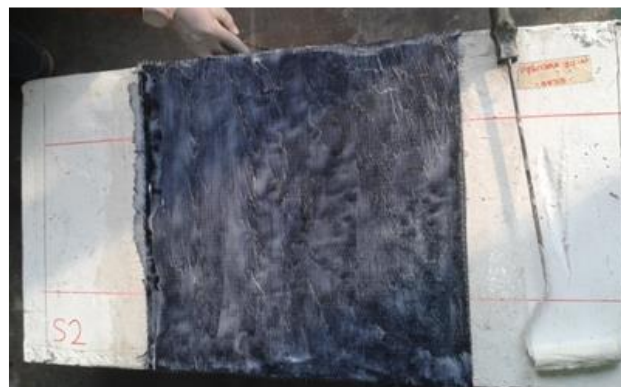
Also, this binder has two parts of component, part A and part B with ratio of 2:1. Before the CFRP was attached on the surface slab, the Epo Bond CF was applied using small roller. The top surface of the CFRP sheet was covered with epoxy bond as shown in Figure 2. The sample that was retrofitted with CFRP laminate was left to be dry for 3 days to achieve good bonding between the concrete and the fiber.

Figure 2 Epoxy bond covered on the top of slab 2

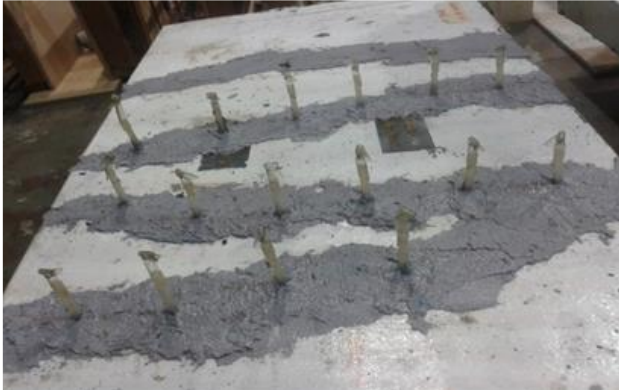
hours so that the epoxy can completely penetrate into the crack line. This is to ensure that the epoxy will fully fills the void of the crack line. Then the nozzle was grinded for a smoother surface of the concrete slab to retest the sample. Figure 3 shows that the installation of the nozzle before the epoxy was injected into the crack lines.

Figure 3 Installation of nozzle

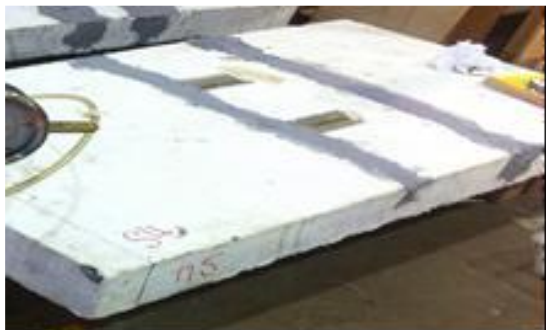
The load was stopped and unloaded after the sample achieved the required crack width of range from 0.5 mm to 0.8 mm opening at approximately 12.69 kN.. The sample was then grinded for a smoother surface and the air compressor was used to clean the dust waste on the surface of concrete slab. The sample is then patched at the bottom surface as shown in Figure 4 of the slab, where Sikadur 31 was used as the patching material. The Sikadur 31 materials are composed with two components of part A and part B. Both components have to be properly mixed with ratio of 3:1 to get a good paste mixture in order to obtain a good bonding between patching material and the surface of the sample. The sample was left to dry for three days.

Figure 4 The crack line was patched

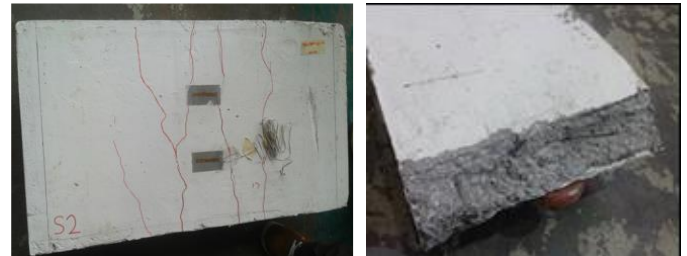
(a) Before retrofit

(b) After retrofit

Figure 5 Retrofitting by lamination of CFRP

The figures above illustrated the concrete cracks behavior where the retrofitting by lamination of CFRP whereby a shear crack that appeared under the line load and failed into the diagonal shape of concrete crack. The crack occurred at the surface without CFRP lamination. The retrofitting of the concrete slabs with epoxy injection and patching techniques depicted a flexural crack as it failed.

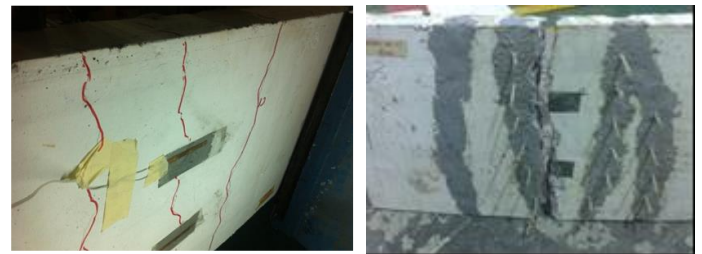
(a) Before retrofit

(b) After retrofit

Figure 6 Retrofitting by epoxy injection

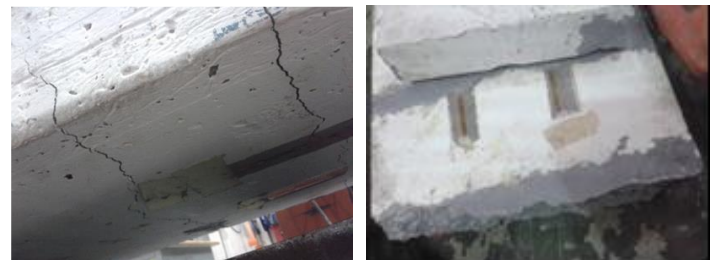
(a) Before retrofit

(b) After retrofit

Figure 7 Retrofitting by patching

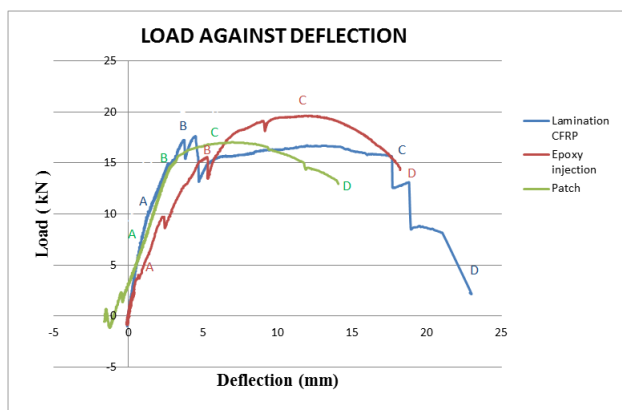
has a good bonding and high durability compared to the methyl methacrylate and polyester resins. Besides that, this resin is low in its viscosity which helps it to penetrate much easier into the hairline crack and filling the void exist. As the cracks formed, the concrete strength, durability and stiffness are reduced significantly. For the slab 4 (S4), the concrete yield faster compared to S2 and S3 where the load is the lowest among the slabs. When the load was applied, the concrete slab reached its yield point much faster when there is a stress imposed towards the slab. This is because of the crack that had already existed when the concrete slab is loaded for the first time before retrofitting. The retrofit method applied on this sample is patching the bottom of the surface crack. The cracks are sealed along the surface crack using the epoxy adhesive that is Sikadur 31 paste. Compared to the others slab sample, S4 has the lowest ultimate load that is slightly below the ultimate load of S2 and S3. Besides the concrete slab for S2 it also experienced brittle fracture as the crack is only sealed on the surface of the slab because of the paste properties of Sikadur 31 that cannot penetrate through the internal crack. Figure 9 shows load against deflection for the different retrofitting method.

Figure 9 Load against deflection for the different retrofitting method

Figure 8 show that the graphs of load against deflection between the three methods of retrofitting slab structures. Figure 8 generalizes that the ultimate load for the each applied methods of the sample. As shown in that table, S2 has 17.64 kN of ultimate load, S3 is 19.606 kN of ultimate load and for the S4 is 17.036 kN of ultimate load capacity. Recognize that ultimate load of the epoxy injection is the highest among the others and the second one highest is lamination of CFRP and the lowest is patching at soffit of the slab. Though, the S3 is the highest one, the percentage different among the S3 and S2 is just 10 percent and for the different percentage among the highest and the lowest ultimate load is about 13 percent. For the different percentage between S2 and S4 is about 3 percent. The deflection values for three of the samples at maximum load are 4.493 mm, 11.631 mm and 6.912 mm for S2, S3 and S4 respectively. The S2 ultimate load occur at an early stage of load compare with the other samples. Though, the strength degradation does not occur as soon as compared to the S3 and S4. Observed that, the lamination of CFRP (S2), epoxy injection (S3) and patch (S4) have similar elastic region. During the elastic state, S2 shows the concrete resist most of the load and started to crack and its give in highest value of load as compared to the S3 and S4.

The load becomes higher because of the modulus of elasticity behaviour of the fiber itself that was laminate at the soffit of the slab. In the plastic region (B-C), the graph interpret that the load seems to increased a little bit and uniformly before its reach the fractured state and fail. The loads failed and descending uniformly due to the behaviour of lamination CFRP caused the transverse crack appear at the side of the slab. The shear cracks are formed and do not indicate any warning before debonding and collapse. The lamination of CFRP influenced the failure mechanism where the slab failed in ductile fracture. Its failure satisfied the characteristic features of the ductile fracture which are large amount of plastic deformation prior to the fracture, shear slips may be present, fracture may appear to be fibrous or have a silky structure and crack growth will be slow. The concrete slab S2 and the S4 reach its yield state a similar point. But both S2 and S4 slab have a lower deflection compare to S3 means that its require more time to reach the yielding point. After the reinforcement steel undergoes the yielding state, the load of the S3 increased until its reach the ultimate load before the degradation of strength takes place at point D.

In the plastic region (B-D), the reinforcement steel experience a strain hardening where the steel become stronger through the plastic deformation as the load increase. In addition, the slab 3 reach the its ultimate load due to the mechanical properties of the epoxy resin used in the retrofitting. S3 having more crack lines compared to S2 and S4. The epoxy is injected to fill the void along the crack lines. The epoxy resin properties of Sikadur 52 itself help the concrete slab to achieve its high load. The epoxy resin
