PRELIMINARY ASSESSMENT OF FIRE DAMAGED REINFORCED CONCRETE STRUCTURE AND STEEL TRUSS

2.0 Case Study: Structural Assessment of a Fire Affected Reinforced Concrete Building

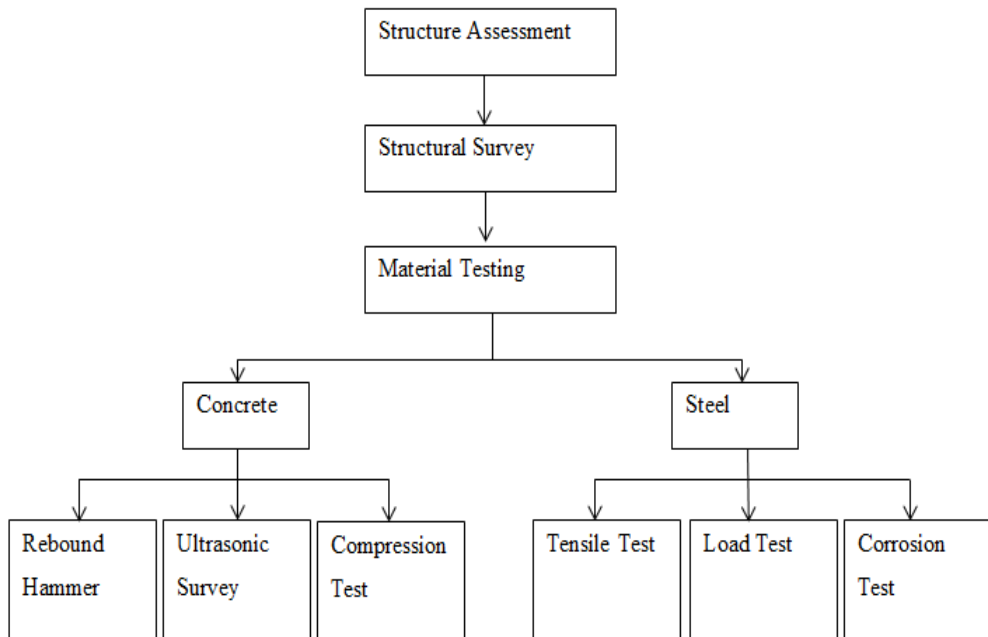
An assessment of structure after a fire happen should to be done to ascertain whether a structure can be repaired or need to demolish (Yüzer *et al.*, 2004). Figure 1 below shows the flowchart for the structural assessment after the building has been damaged by fire.

Figure 1: Flowchart for the structural assessment (Antonio Brancaccio *et al.*, 2012)

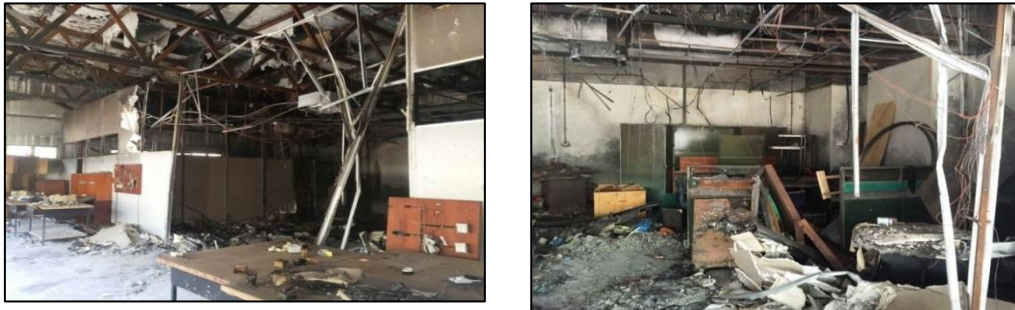
Based on the Malaysian Fire and Rescue Department report, the fire happened on 25 February 2014 at 1900 hrs. The laboratory was believed to be on fire for about one hour, when considering the police report, which stated that the fire had been extinguished at 2001 hrs. From the police report and local witness, the most damaged parts of the structure show to be at the back of the building. It was also reported that the root of the fire was due to the current overload in a middle circuit of the office. From the visual observation, it shows that the mainly damaged consisted in concrete cover spalling over large areas of beam and wall, over-heating of exposed steel truss and overall degradation of materials due to high concentration of dense smoke.

At that place there were a bunch of things that were affected by the fire inside the laboratory such as office partitions, windows, electrical circuit, electrical sockets and insulations. The change in colour of beam, column and wall shows the effect of the fire to building components. Moreover, rusted steel appearance all over the surfaces of the steel truss also shows that steel truss was also affected by fire. The affected conditions can be seen from the pictures illustrated in Figure 2a and Figure 2b.

(a) (b)
Figure 2: Internal views of the laboratory subjected to fire (a) From the side view of the laboratory (b) From the front view of the laboratory

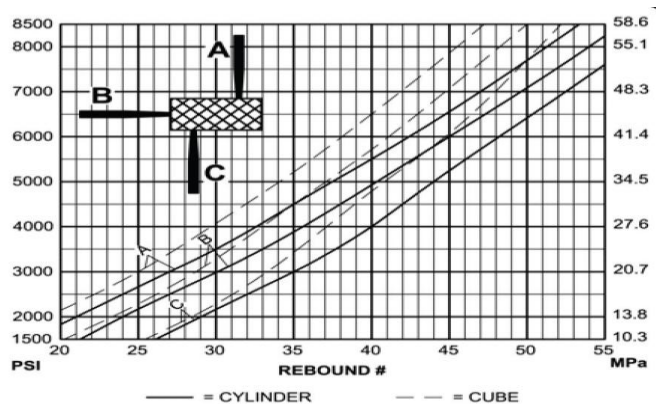
Before the test is conduct the surface of the beam need to be cleaned from any debris or dust. After that, a grid line size 4 x 3 was drawn on the surface of the beam to mark the testing position as shown in Figure 3. Then, press the plunger on the surface of the beam and upon release it. The numbers of rebounds were recorded for each testing position. The concrete strength of the concrete beam was then determined by using the calibration chart using Chart A as shown in Figure 4.

Figure 4: Calibration chart of rebound number and compressive strength

The test results show that the compressive strength for the concrete beams is 40 ± 4 N/mm² based on the Table 2 below. The value is sufficient for design a house.

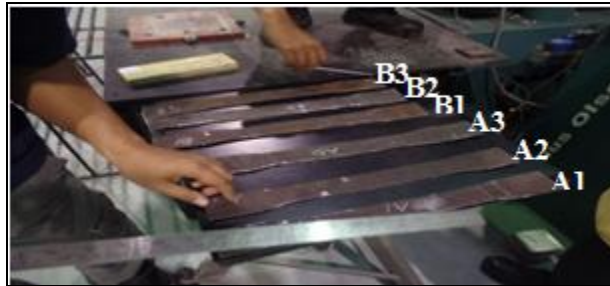
Six samples of coupons steel from the laboratory are used in this test. These samples are from the two purlin truss which are one of the purlin is totally exposed to fire while another one is still in good condition. Figure 5 below shows the six samples of the coupon steel where A is the samples from the least affected area and B is the most affected area due to elevated temperature. This testing follows the procedure of BS EN 10 002: Part 1: 1990 and ISO 6892-1. Figure 6 shows the coupon steel tested using DARTEC machine. The loading was applied incrementally at a rate of 0.2 kN/s until the coupon fails.

Figure 5: Samples of coupon tensile strength test

From the Table 3 below, the ultimate strength is in ranged 395 to 503 N/mm² for samples less affected by fire and for most affected samples by fire is in the ranged 384 to 426 N/mm. For the less affected samples by fire, the average ultimate strength is 434 N/mm² while the average ultimate strength for the most affected samples by fire is 412 N/mm².

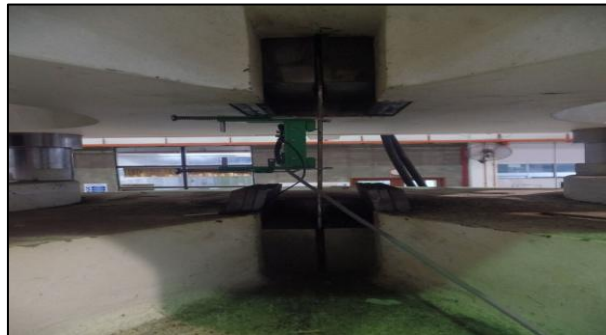
Figure 6: Coupon tensile strength test using DARTEC machine

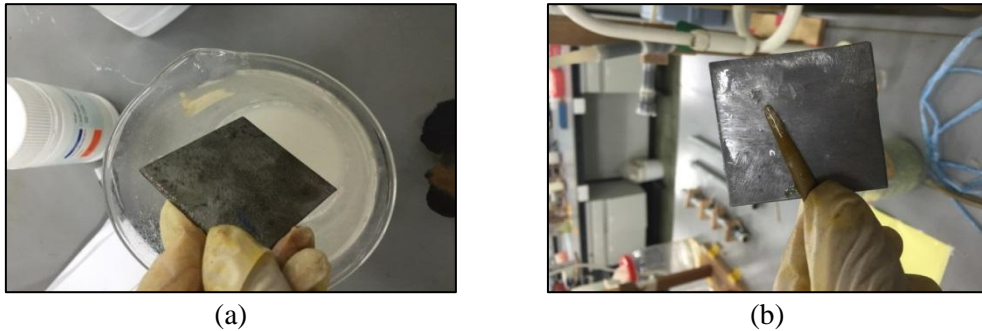
Five samples from the unburned purlin were cleaned it until gets mirror surface with the dimension of the samples is 50 x 50mm. The samples are weighed before the test in the furnace with the temperature of 200 °C, 400 °C, 600 °C, 800 °C and 1000 °C. Then, the samples are clean by using chemical solution and weighing again to find the weight loss. Table 1 shows the preparation of the solution by referring ASTM G1-90 while Figure 7a and Figure 7b shows the sample before and after the cleaning process.

Figure 7(a) Sample before test in the solution (b) Sample after test in the solution

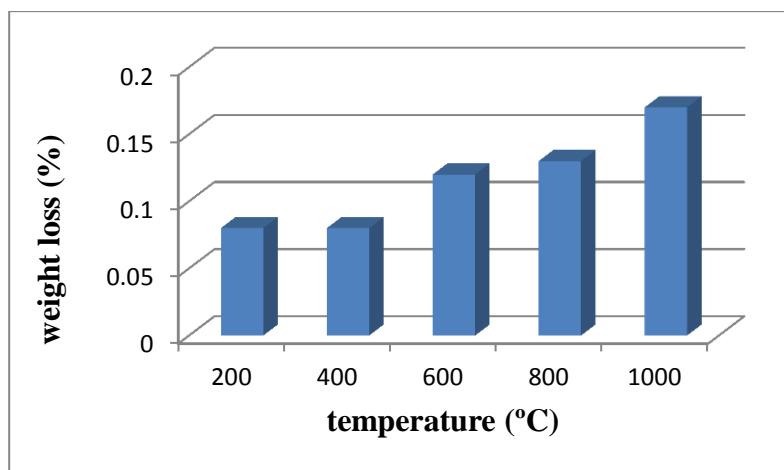
Table 4 below shows the summary results of the chemical test while Figure 8 shows the graph of the weight loss of the coupon steel against temperature.

Figure 8: Weight loss of steel versus temperature
