## STRUCTURAL PERFORMANCE OF SPACE TRUSSES UNDER FIRE

Amr M. Ibrahim, Ahmed A. Elshafey, Boshra A. El-taly\* & Kamel S. Kandil

**Abstract:** An experimental program was designed in the current work to capture the structural behavior of two different space trusses under static loads and under increasing the temperature at the truss nodes up to failure. The results of the two space trusses tested include the central deflection of the truss and the axial forces in truss members under the applied loads and temperature. Also analytical studies based on finite element method for the two tested trusses are introduced in this paper. A comparison between experimental work and analytical study is presented and discussed. The finite element simulation gives good agreement with the experimental results. Also the results of the current work indicate that increasing the temperature causes a local failure due to fusion of the node at which the temperature was applied.

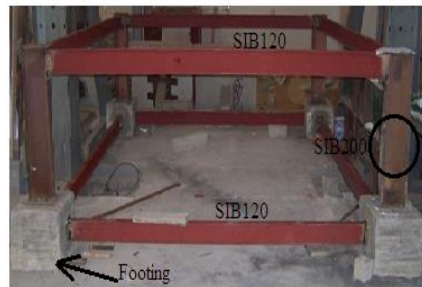
Figure 3: Supporting frame

The supporting frame of the tested trusses consists of four columns with SIB200 and with 800 mm length. These columns are supported on four reinforced concrete (RC) footings with 400 x 400 x 400 mm overall dimensions and each footing was reinforced by 5Φ8 mm in the two directions as shown in Figure 2. The four footings were connected together by SIB120 steel beams in all directions. Also the columns were connected together in all directions by SIB120 beams as shown in Figure 3 to prevent the side sway. The assembling process of the space truss#1 members was carried out through four steps. The first step was the classification process of the truss members to upper, lower and diagonal members and the MERO connections to connections with 3, 4, 5, 6 and 8 holes. The second step was the determination of the location of the lower MERO connections by drawing a layout of these connections on the supporting frame then the lower connections were inserted in their locations. At the third step, the lower chord members were connected to each other through these connections. The fourth step was determining the location of the MERO connections of the upper chord members then the diagonal members were connected to these connections after that the

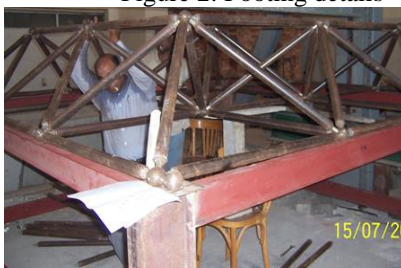
Figure 4: Assembling process of truss#1 members

top members were joined to these connections as shown in Figure 4. Finally, all the connections were well tightened to increase the truss stiffness and to make the truss acts as one unit. The truss was supported on the supporting frame through four connections. Each connection consisted of pipe with 200 mm height. Two plates with 200 x 200 mm dimensions and 10 mm thickness were welded on the two ends of the pipe. Then the top plate was welded to the corner truss connection and the bottom plate was connected with the supporting frame column through four bolts as shown in Figure 5.

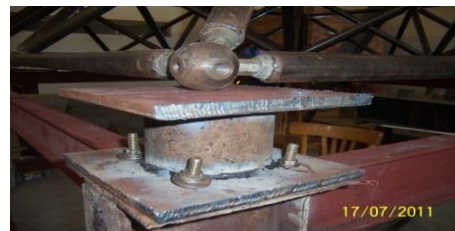
Figure 5: Connection between truss#1 and supporting frame

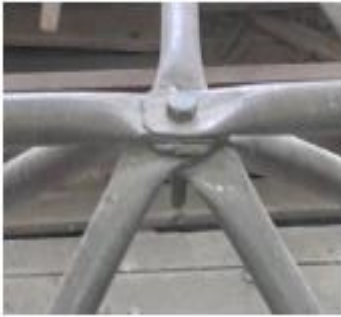
Figure 6: Truss#2 connection

Truss#2 connections were made by flattening the ends of the member and assembling them with one bolt (M17 bolt) as shown in Figure 6. The lower truss members were assembled first, followed by the upper chord members. Then the diagonal members were connected to the upper and lower chord members. Finally the truss placed on the supporting frame see Figure 7.

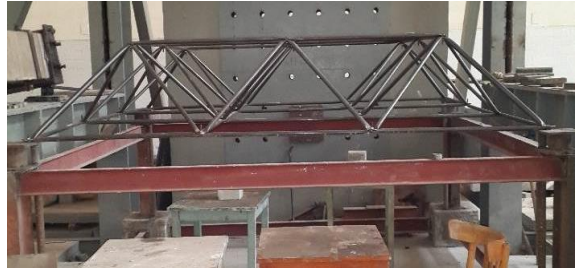
Figure 7: Assembling process of the truss#2 members

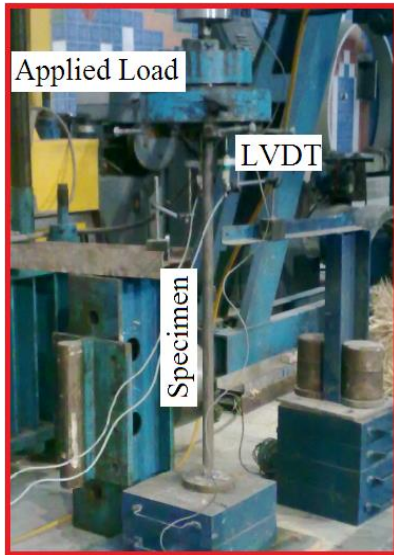
a) Compression

b) Tension

Figure 8: Truss member Tests

Three specimens of each member of the two trusses were tested under compression force to obtain the buckling and post-buckling behavior of the truss members. The members were prepared by welding two stiff circular plates with 100 mm diameter and 30 mm thickness at the two ends. Each member was inserted in the supporting frame as shown in Figure 8. Tensile tests were conducted to determine the stress–strain curve of the truss members. Two specimens; were taken from tubes with 1000 and 866 mm length. The specimens were prepared by adding steel bar with 220 mm length at the two ends of the members. These steel bars were added to avoid flattening of the members ends under the gripping force. The test was carried out on the universal testing machine. The samples were placed in the machine and gripped by the machine ends as shown in Figure 9. Then the test was started by pulling the two ends of the member till its failure.

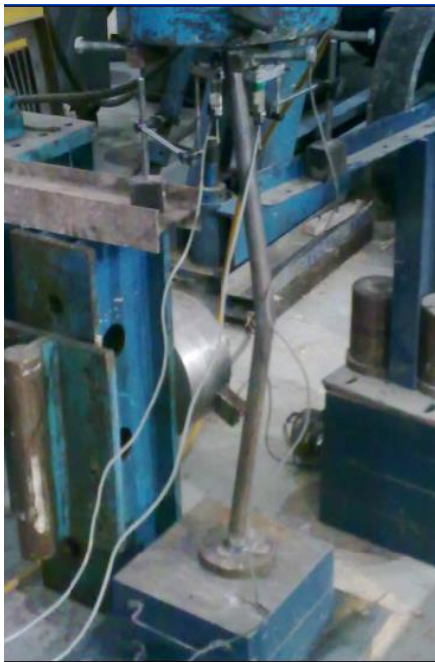
a) Buckling

b) Yielding

Figure 9: Member failure

For truss#1, the upper and lower chord member with 1000 mm length started to buckle at 110 kN axial load, while the diagonal member with 866 mm length started to buckle when the load reached to 250 kN and the member failure is presented in Figure 9. The relation between the load and the axial shortening is represented in Figure 10. The relation between the load and the axial shortening for truss#2 members are represented in Figure 11 and Figure 12. From the two figures, it can be shown that the chord member buckled at 27.08 kN axial load, the diagonal member buckled when the load reached to 23.05 kN load on the other hand the corner member buckled at an axial load of 199.94 kN. The relation between stress and strain curve obtained from the tension test is indicated in Figure 13. From this curve, the modulus of elasticity, yield stress and ultimate strength of the truss were considered as 215 GPa, 380 MPa and 525 MPa, respectively.

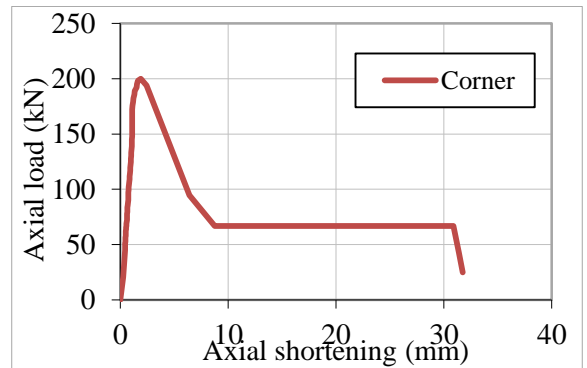
Figure 11: Load-axial shortening curve for corner member of truss#2

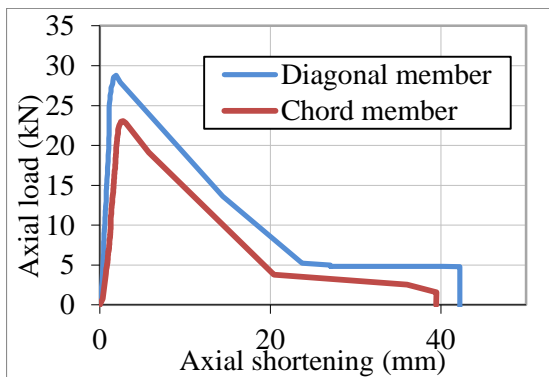
Figure 12: Load-axial shortening curve for chord and diagonal member of truss#2

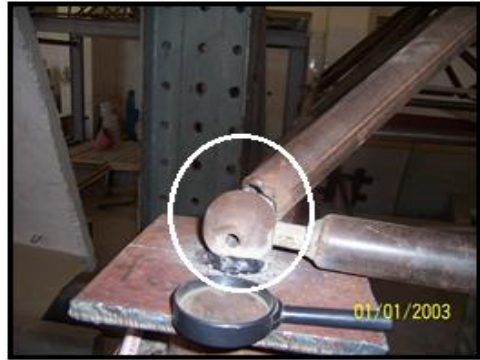
Figure 19: Collapse in the corner member from the first test of truss#1

The results obtained from the finite element simulation for truss#1 were represented as relations between load-displacement, load-axial force, temperature-displacement and temperature-axial force for the selected joints and members (see Figure 15) were compared with the experimental results in the current section. For the first test, the relationship between the applied load and the corresponding mid-span deflection (at point#21) is shown in Figure 18. From this figure, it can be shown that the numerical load-central vertical deflection relationship is linear up to a load of 90 kN with central deflection 3.145 mm. At this load, local failure at a corner joint (at the welding between the tubular member and the cone of the member's end) occurred as shown in Figure 19. The collapse of this connection leads to failure of all the surrounding members and it leads to a large deflection to all surrounding joints. Also from these figures, it can be observed that the failure occurred in the weak point of the member. The strain of tested truss members as the load is applied was measured by means of an extensometer. Knowing the strains, it will be easy to calculate the stresses and the forces in the members for comparison purpose with the numerical model. The relation between load and axial force is presented in Figure 20. This relation is linear till the failure occurred at the location of the applied load. From Figure 18 and Figure 20, the margin of error between the results of FE simulation and experimental work is about 11%, which is considered acceptable.

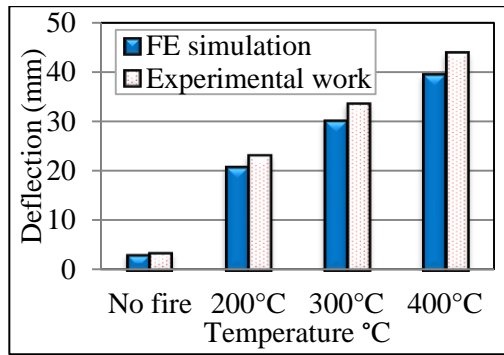
Figure 21: Temperature- deflection curve at joint#7 for the second test of truss#1

Figures 21 to 27 present the results of the tested truss#1 for the second stage of the test as obtained from the experimental program and numerical model. From Figure 21, it can be clearly seen that the displacement was recorded 23.2 mm at temperature 200°C for point#7 from the FE simulation while the displacement of this point at the same temperature was measured as 20.88 mm from the experimental work. At temperature 300°C, the displacement at point#7 is 33.55 mm and 30.19 mm from FE simulation and experimental work; respectively, and at temperature 400°C, the displacement for

point#7 is 43.9 mm and 39.5 mm from FE simulation and experimental work; respectively. From Figure 22 and Figure 23, it can be concluded that the difference between the axial forces in the selected members as obtained from the experimental and FE simulation for the second test stage does not exceed 10%. Figures 24 and 25 showed local failures occurred in the truss joints at the joints subjected to the increase in temperature (at point#7 and 11) from the experimental test and numerical model. Figure 26 shows the variety in deflection at joint#6 and joint#7 as a result of their location from the fire source. The deflection in joint#6 decreases by 77% than that measured for joint#7. Also the axial force in the two selected members (M1&M2) was calculated as presented in Figure 27. From Figure 27, it can be observed that the members near the fire source (M2) are subjected to a high stress than that one far away from the heat source (M1). Also from the results indicated in the two figures (Figures 26 and 27), it can be concluded that the temperature transfers slowly in the truss members when half the truss was subjected to fire.

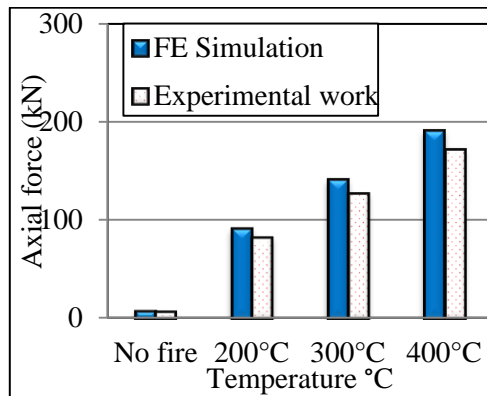
Figure 23: Axial force for M2 from the second test of truss#1

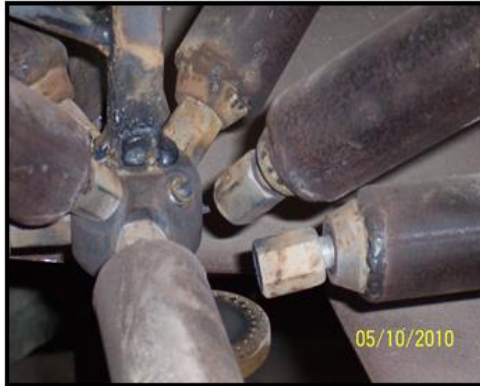
Figure 24: Collapse in connections (7&11) from the second test of truss#1

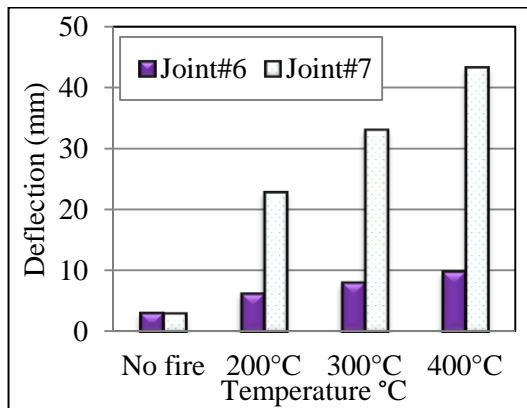
Figure 26: Experimental temperature-deflection curve for joint#6&7 from the second test of truss#1

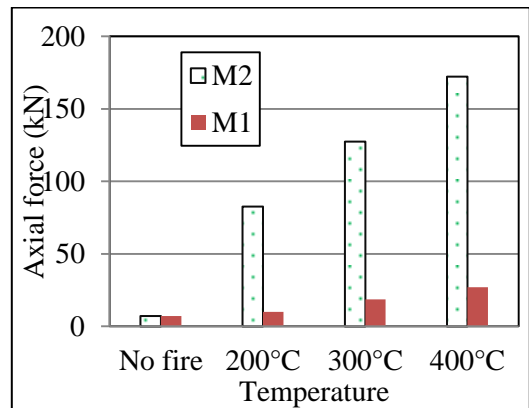
Figure 27: Experimental temperature-axial force curve for M1&M2 from the second test of truss#1

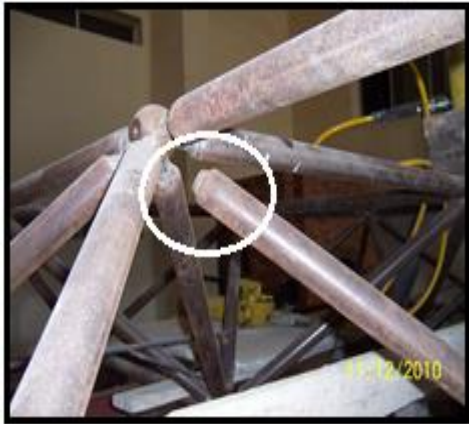
Figure 28: Collapse in connections (20&23) from the third test of truss#1

For the third test stage, the failure in this case occurred at 400 °C temperature as a result of local failure in the truss joints as shown in Figures 28 and 29. The experimental test indicates that the deflection at all recorded joints (6, 7, 10&11) are the same and the axial forces in the two members (M1&M2) are equal. The relation between the displacement and temperature for the third test as obtained from the experimental and numerical results is illustrated in Figure 30. From this figure, it can be observed that the experimental and numerical curves are very close and the difference between their results do not exceed 15%. Figure 31 illustrated that by increasing the temperature to 200°C, the axial force becomes 99.69 kN and 110.77 kN from the experimental and numerical results; respectively, and by increasing the temperature to 300°C, the axial force becomes 153.081 kN and 170.09 kN from the experimental and numerical results; respectively. Additionally, when the temperature was increased to 400°C the axial force in the selected member#1 is 229.4 kN and 206.46 kN as obtained from the numerical and experimental results; respectively. This shows that the structure is more vulnerable at higher temperature as the axial force and deflection increase by about 2000% and by 1500% respectively by applying 400° C.

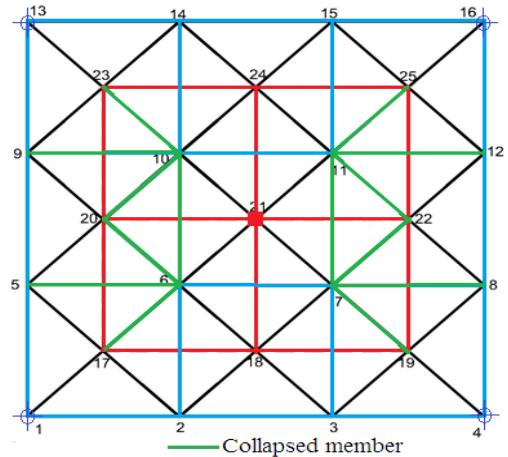
Figure 29: Numerical collapsed members from the third test of truss#1

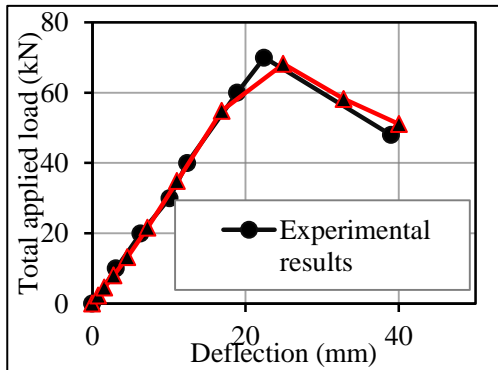
Figure 32: Load-deflection curves from the first test of truss#2

In this section, the experimental results of the tested truss#2 without fire are presented and discussed. Figure 32 presents the load-deflection curves at joint#10. This figure indicated that the relation between load and corresponding deflection are linear till 70 kN total load and 22.43 mm as obtain from the experimental work. At this load, the failure occurred in the truss due to buckling of a top member that attached directly to the joint at which the load was applied (see Figure 33). After that, the truss was not able to carry a more applied load so that the applied load decreases to be 48 kN. Also from Figure 32, it can be seen a good agreement between the results obtained from the experimental and numerical analysis especially in the linear zone. The ANSYS results showed that space truss#2 collapsed at 68.20 kN total load and 25 mm corresponding

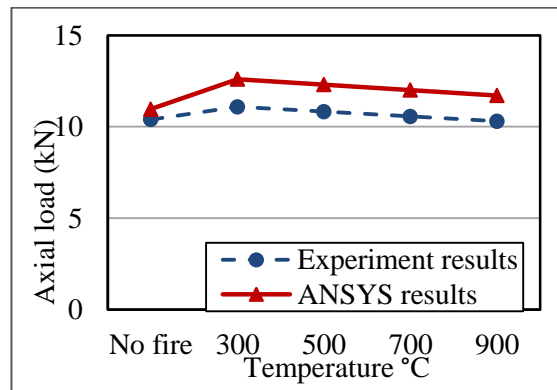
Figure 37: Axial force for M3 form the fire test of truss#2

The results of the studied space truss#2 under the effect of fire are presented in Figures 36 to 38. Figure 36 shows a comparison between the increase in temperatures (from 300°C to 900°C) and the deflection at joint#10 as obtained from the experimental work and numerical model. Figure 37 shows a comparison between the experimental work and numerical model results in term of axial forces in M3 member with different temperatures. From the two figures, it can be concluded that the difference between the experimental and the numerical results do not exceed 10%. From Figure 36, one can observe that the truss deflections increase with increasing the applied temperature. On the other hand, Figure 37 shows that the axial forces in bottom member (M#3) increase by applying 300 °C temperature then the forces decrease by increasing the applied temperature. That is because the collapse in the truss started in appearing at applying 300 °C temperature as a local failure at the four joints at the source of the temperature as illustrated in Figure 38. This failure causes decrease in the truss stiffness with the temperature increase. From these results, it can be concluded that the heat transfer from the joints to the members was very slow that causes buckling or yielding in the truss members.
