# SEM OBSERVATIONS ON WEAR MECHANISM OF TiN-COATED HSS TWIST DRILLS WHEN DRILLING MILD STEEL

R. J. TALIB[1], S. SAAD[2], M. R. M. TOFF[3] & A. H. HASHIM[4]

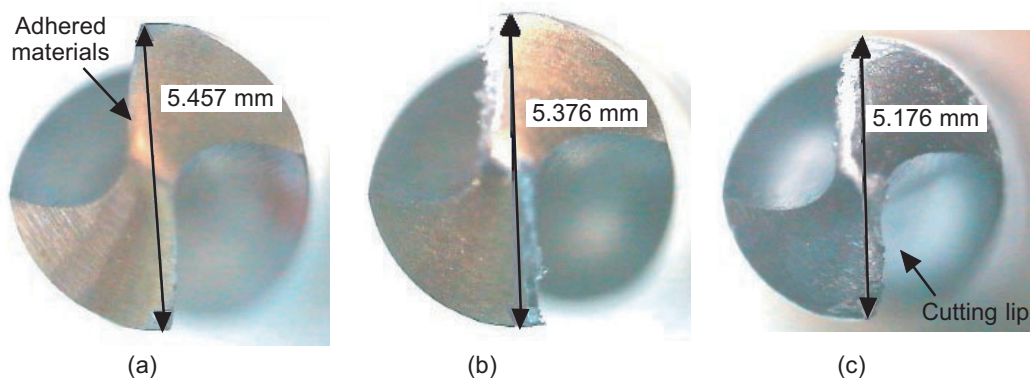
TiN coating is gold in colour and when the drill changes to shiny colour, it indicates that the coating has wear-off. In this study, the appearance of the drill still remained gold in colour even after the $10^{th}$ drilling hole, thus indicating that TiN coating was still intact on the substrate surface. The drilling performance of the coated drill has improved as compared with uncoated drill. The number of a drilling holes produced by a TiN-coated drill was about 25 holes as compared with only 12 holes produced by an uncoated drill. This shows that the tool life of a coated drill was improved by more than 2 times as compared with the uncoated drill. It was revealed that the reduction margin diameter after the $10^{th}$ hole for uncoated drill was 2.49 times more than a coated drill (Table 2). The margin diameter of the drill was measured on a major tool flank with the bigger diameter, as shown in Figure 2. Thus, it could be concluded that the TiN coating did played an important role in improving the tool life of the twist drill. This phenomenon was due to the increase in microhardness, reduction in friction coefficient, and smoother surface roughness. After the $25^{th}$ drilling hole, the colour of the coated drill changed to bluish colour, showing that the TiN coating had wear-off during the drilling processs (Figure 2c). EDAX analysis shows that the worn surface of the coated drill did not composed of titanium and

**Figure 2**   Margin diameter of the coated drill reduces as the number of drilling holes increased (a) before the drilling test, (b) after the $10^{th}$ drilling hole, and (c) after the $25^{th}$ drilling hole

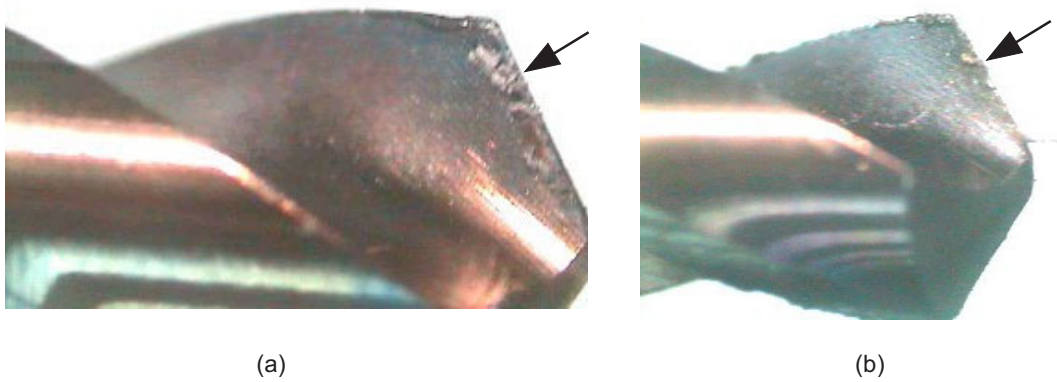
**Figure 3**    Arrow sign showing chip adhered on the cutting lip of the coated drill: (a) after the 10th drilling hole, and (b) after the 16th drilling hole

The optical microscope examinations showed that the transferred material adhered to the cutting lip and chisel edge, as shown in Figures 2 and 3. It was observed that the cutting action only took place at the cutting lip. The microstructure of the uncoated HSS twist drill shows a distribution of granular metallic carbide (MC) in the matrix (Figure 4). EDAX analysis shows that the substrate materials are composed of Fe, C, V, Cr, Mo, and W, and the work piece materials are composed of Fe, C, Mn, P, and S. In the early stage of drilling (5th hole), microstructural examinations revealed that the peak asperities of the coated drill were deformed and had started to form metallic junctions as well as grow (Figure 5). With subsequent drilling, the flaking of materials occurred on the worn surface of the drill tip (Figure 6). Then, the two-way transfer

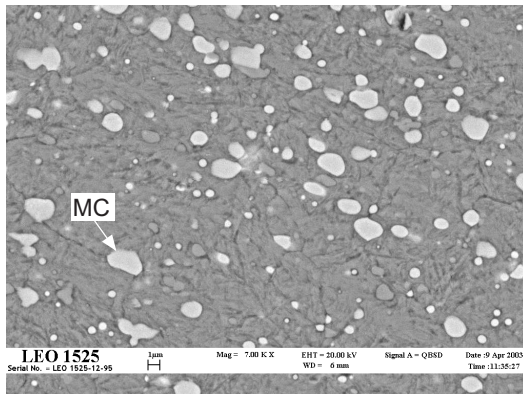
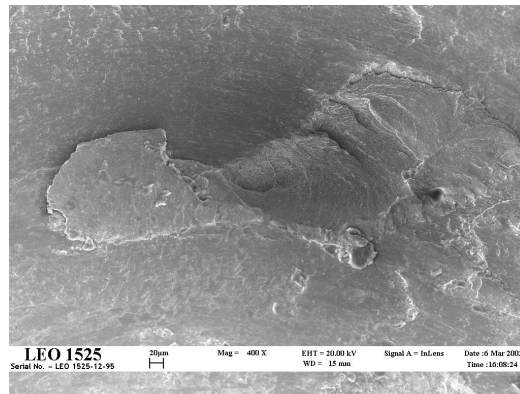
**Figure 4**   Distribution of metallic carbide (MC) in the matrix

**Figure 5**   SEM observation on the chisel edge

**Figure 6**   Flaking of materials

**Figure 7**   Generation of transfer layer on the worn surface

during sliding caused the formation of transfer layers on both sides of the sliding surfaces, as observed elsewhere [15-17]. As drilling process progressed, the transfer materials will be smeared and sheared on the worn surface of the drill (Figure 7).

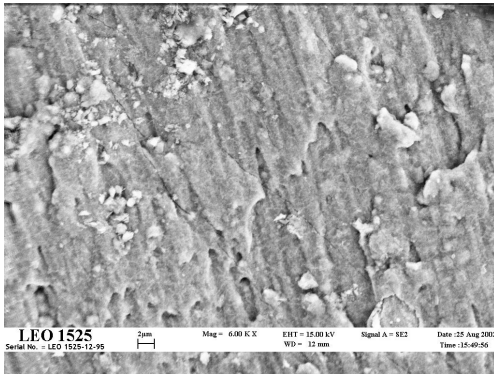
This process was manifestations of adhesion wear mechanisms. The transfer films were continuously smeared and sheared on the sliding surfaces as the drilling progressed, and finally formed multilayers (Figure 8). Energy Dispersive Analysis of X-Ray (EDAX) revealed that the transfer layers generated on the worn surface contain both materials from the coated drill and the workpiece (Table 2). The materials deposited on the worn areas were found to be Ti, W, Mo, Cr, V, C, Fe, Mn, P, and S, which were materials composed in the coated drill and the workpiece. This process was due to the process of mechanical alloying on transfer layers, a phenomenon observed by other researchers such as Chen & Rigney [15,18]. Figure 9 shows that the edge of cutting lip was broken after the 25[th] hole and this was thought as the reason why the coated drill was unable to penetrate further into the workpiece.

**Figure 8**    Micrograph shows transfer layers were smeared and sheared, and finally formed multiple layers

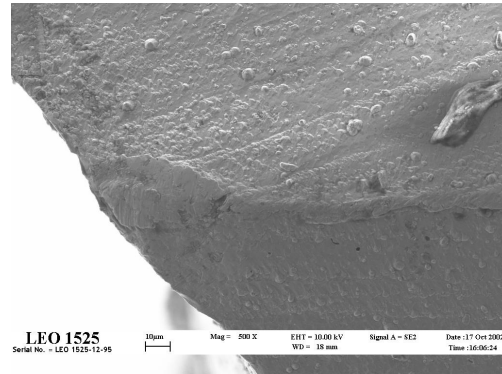
**Figure 9**    Broken edge at the corner of the cutting lip

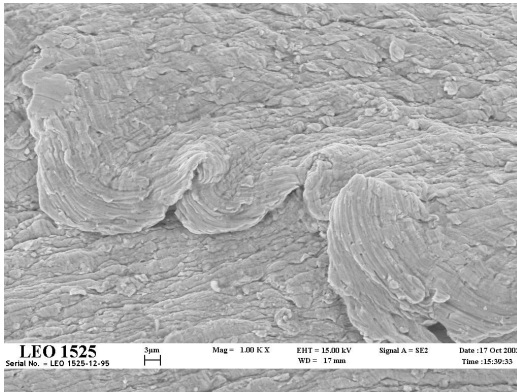
Heat generated in the drilling operation is slightly higher than other machining processes. This is due to difficulty in delivery of cutting fluid through the flutes as the chips are flowing in the opposite direction, thus resulting in high temperature on the contact areas. As the temperature increased, some of the metal elements composed on the drill started to melt, and formed metal droplets on the interface of the sliding surfaces. With subsequent drilling, these metal droplets rolled between the two sliding surfaces and finally formed granule shapes of metal particles. As drilling continued, the granules were compacted and smeared on the worn surface. In the early stage of drilling, it was observed that the melted materials started to flow in a wavy form (Figure 10). At the same time, it was also observed that some droplets of melted

**Figure 10** Material flow due to high temperature generated during dry drilling

Thermomicrocracks were generated due to mechanical thermoinstability, as a result of high temperature. It was observed that the contact areas were located at a higher position on the wear surfaces, and thus became the contact area, as the sliding progressed (Figure 10). As drilling progressed, these contact areas formed the contact area, which would be subjected to high pressures as they have to carry high loads. At the same time, the temperature rise at the contact area introduced thermal stresses, which could superimpose onto the mechanical stresses. This phenomenon resulted in the increase of the total contact stresses. These repeated

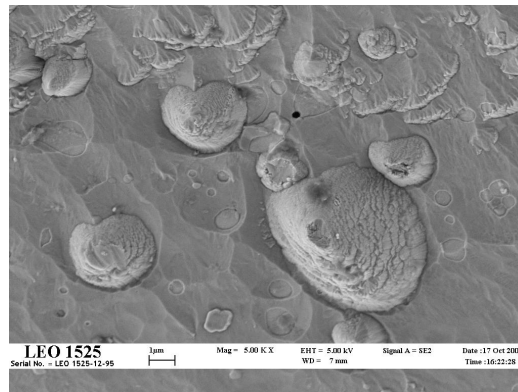
**Figure 11** Formation of melted droplet on the worn surface due to high temperature

material formed on the worn surface (Figure 11). EDAX on this site was composed of elements both from the drill and the workpiece, such as Fe, W, and Ti (Table 3). The materials found in this area are of high melting temperatures, whereas materials of lower melting point were not detected. This shows that the other materials in the composition, which have low melting temperatures such as Mn and P, were melted and vaporised to the atmosphere. Talib *et al*. [8] also observed the same phenomena on the worn surface of the automotive friction materials during braking process.

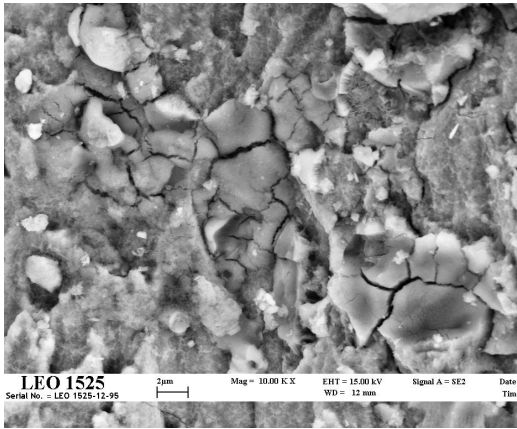
**Figure 12**   Early stage of thermomicrocracks generation on the worn surface of the uncoated drill

phenomena during drilling caused the generation of thermomicrocracks at the contact areas. In the early stage of drilling, thermomicrocracks were generated at a few locations (Figure 12). With subsequent drilling, the microcracks grew, propagated, and finally joined together, forming multiple thermomicrocracks (Figure 13). After reaching a critical length, the wear particles will be disposed through the drill flutes.

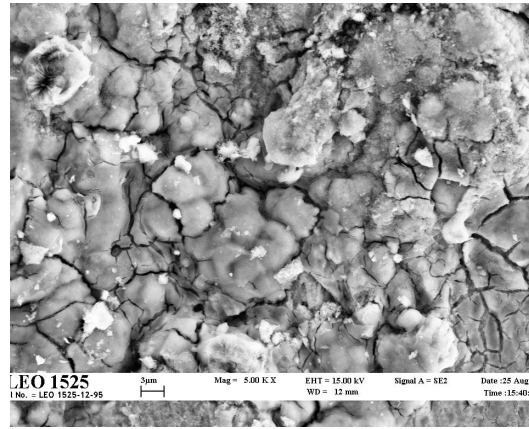
**Figure 13**   Generation of multi thermomicrocracks as the drilling progressed for the uncoated drill

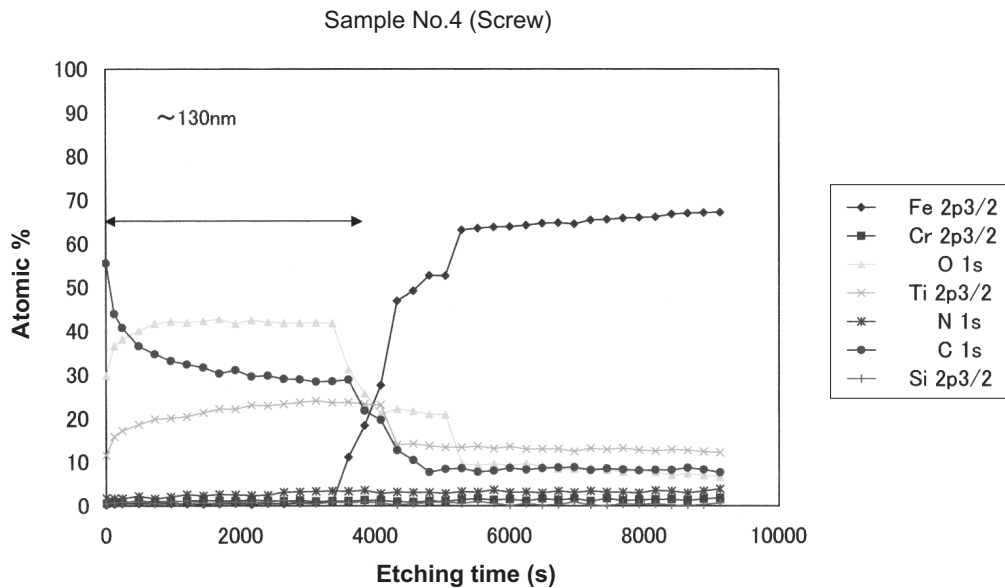
X-ray photoelectron spectroscopy (XPS) analysis on the depth profiling of the coated sample is shown in Figure 14. It shows that the thickness of the coating was about 0.13 μm. This thickness was too thin for the TiN coating to improve significantly the hardness and wear resistance of the coated drill.

**Figure 14** Depth profiling of the coated drill

In this study, microhardness was found to increase from 694 to 995 HV with an increased of 43.3%, as compared with uncoated drill. Good quality coating should have the coating thickness in the range of between 2 to 15 µm [19] with a microhardness of between 2000 to 2500 HV [2], and the tool life of eight times longer [3]. This analysis shows that the developed TiN-coated drill had no significant improvement in mechanical properties as compared with commercially TiN-coated drills. Therefore, some modifications need to be done on this newly developed r.f magnetron sputtering machine, in order to get similar or better results as compared with the commercial drills.
