COMMON BUILDING DEFECTS IN NEW TERRACE HOUSES

Keywords: Building defect, housing, condition assessment, new house, visual inspection

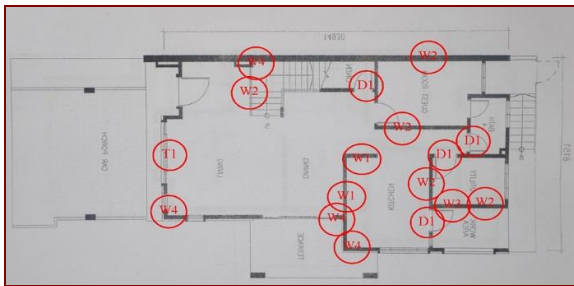
Figure 2 Defects indication plan

All detected defects found were photographed and tagged as evidence in the layout plan. Figure 2 depicts an example of the defect indication plan used in building inspection.
