ROCK SLOPE ASSESSMENT USING KINEMATIC AND NUMERICAL ANALYSES

This paper presents stability assessment of rock slopes at Jalan Kuari, Cheras, Kuala Lumpur. The site is a disused quarry slope where a low cost residential area of Pangsapuri Intan was built very close to it, frequent instability at the rock slope have been reported. A detailed discontinuity assessment was carried at the site, then, the kinematic and numerical analyses were performed in order to determine the stability of the rock slope. The kinematic analysis was carried out using DIPS 5.0 software and the results showed that about 19% is the percentage of the wedge failure that is encountered for the rock slope. Meanwhile, the finite element method of analysis in Phase² showed that the slope is in stable condition, with the Strength Reduction Factor (SRF) of 2.0. The difference between the results of the kinematic and the finite element analyses is because, the kinematic analysis considered the discontinuities volume and orientations with regards to the slope face, while the finite element, analysed the slope with respect to strength properties. Since the slope is a disused quarry, where previous blasting work had pr

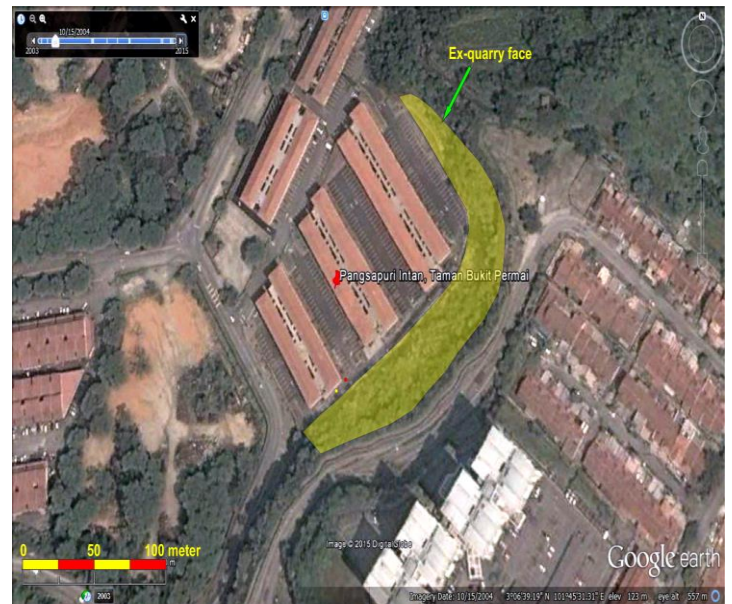
Figure 2 Disuse quarry face layout at Apartment Intan, Taman Bukit Permai, Cheras, Selangor [3]

The geological map of Jalan Kuari shows that this area is a granite formation, Figure 1 [2]. The study slope is a disused granite quarry, previous blasting and quarry works that took place in that area had caused fracture to the rock forming the slope (Figure 2) [3]. Fractured and jointed rock slope may fail at any time, causing major damages to properties and loss of lives. As a result of the lack of awareness, i.e. by assuming that the rock is safe and strong, residential units were built near to the steep slope with only on 8 m the buffer zone (Figure 3). From conversations with the residents at Pangsapuri Intan, a frequent instability have been occurring at this slope, yet it is not documented. The worst situation was reported in the news, when there was a big boulders that hit a taxi that park under the slope [4,5].
