DEGRADATION ASSESSMENT OF NUCLEAR POWER PLANT EXTRACTION STEAM PIPING AFTER LONG TERM SERVICE

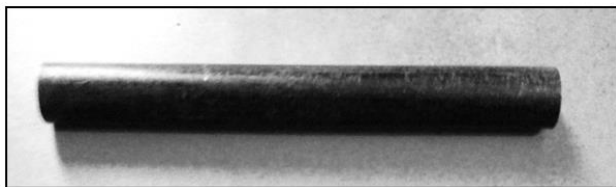
Visual examination shows no disturbance in the uniformity of as received pipe (Figure 2). Whereas, aged pipe shows marked surface corrosion (Figure 3), confirming the long term service in sea shore environment. Corrosion has the potential to reduce a product's design life by premature degradation [23]. Examination of corroded surface under metallurgical microscope (Figure 4) revealed formation of 0.07 mm deep corrosion pits.

Figure 2 SA 106-B Seamless Pipe (As received)
