CORROSION PROCESSES ON WEATHERING STEEL RAILWAY BRIDGE IN PRAGUE

Viktor Urban*, Vit Krivy, Vojtech Buchta

VSB – Technical University of Ostrava, Faculty of Civil Engineering, Department of Building Structures, 17. listopadu 15/2172, Ostrava Poruba 708 33, Czech Republic

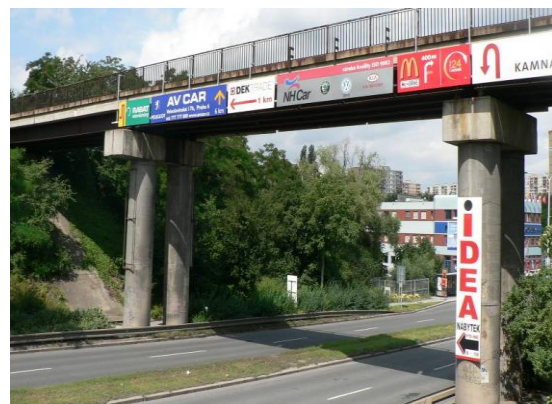
Figure 1 Side view on the railway bridge in Prague

This paper deals with experimental corrosion test on the 3-span composite weathering steel and concrete bridge in Prague. The girder bridge is situated in the capital city of the Czech Republic in corrosion aggressiveness C2. The average annual air temperature achieves 9.8 °C in observed area. The bridge was built in 1981 and the assembling completed in 1983. The steel construction is designed from low-alloy weathering steel Corten B. The supporting construction is created by four main girders designed as welded I-sections. The girders in each of the three spans are designed as 20 m long simply supported beams, see Figure 1. The main girders are connected to each other by crossbeams. The railway track is stored in a gravel railroad bed. Total weight of the steel structure is 155 tons.

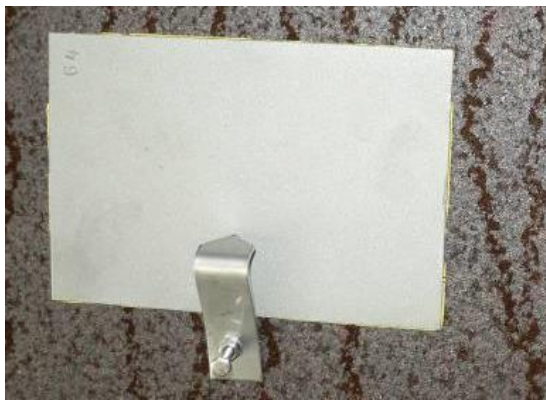
Figure 2 Specimens attached by anchoring device

The protective patina layer slows down the corrosion rate [5, 6]. The effects of the expected corrosion losses are typically eliminated by corrosion allowances which are added to the thickness of the structural element calculated in static analyses [7, 8]. The quantity of corrosion losses depends on the position and location of the surface in the structure [9]. The specimens are installed on typical surfaces of the structure. The specimens are flat panels made of steel S355J2WP with a nominal size 150x100 mm and with thickness 1.5 mm [10]. The specimens are attached to the structure with a special anchoring device [11], see Figure 2. Three specimens are installed on typical surfaces of the structure. The specimens will be withdrawn after one, three and ten years of exposition.
