## **EROSIVE WEAR OF NATURAL GAS PIPES DUE TO HIGH VELOCITY JET IMPACT: PHYSICAL EXAMINATION AND EXPERIMENTAL STUDY**

**Abstract.** A sequential failure of API 5L X42 (NPS8) carbon steel and SDR 17 medium density polyethylene (MDPE) pipes towards the high pressure water pipe was studied. Pipe's failed specimen was physically examined and experimental testing was conducted by using high speed water jetting facility towards a similar NPS8 pipe specimen. High pressure water jet impact from leaked water pipe forms highly erosive water-soil slurry, causing severely damaged on NPS8 carbon steel pipe surface. Thus, it causing substantial losses of pipe coating materials and subsequent rapid thinning of pipe body occurred. Furthermore, weaker ground support causes instability to the MDPE pipe and leads to vertical descend towards high speed gas jet region exerted from failed NPS8 pipe. High impact gas jet physically hit the MDPE pipe at its opposite direction causing its rapid erosion.

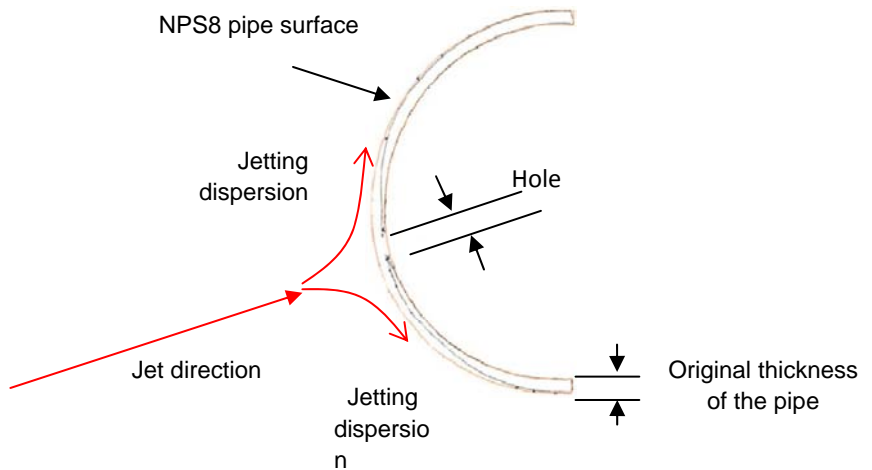
**Figure 10** Jet dispersion around pipe wall

Assessment of this results revealed that the thickness of the pipe decreased substantially only at area against to the jetting orifice position. Pipe metal loss has occurred on the area facing directly to the water pipe orifice jet resulting in a hole which increased in its dimensional size with severed metal losses (Figures 2 and 6b). This indicates that the hole was caused by drastic erosion from the failed water pipe buried in the vicinity of the gas pipe. This phenomenon is further explained in Figure 11. By considering the estimated jetting of  $20^\circ$ , it is found that the jetting direction is directly hit the area that had severely experiencing the thickness reduction. The surface pattern was similar with the finding made by H. McL. Clark [12] on cylindrical specimen using slurry pot erosion tester as shown in Figure 12 [32]. There are two peculiar areas that had experienced two different types of wear mechanism. The centre part which is directly hit by the water jetting at high angle where the water is the dominant erosive medium will erode according the deformation wear mechanism. The surrounding areas in the other will erode following cutting wear mechanism. These two types of wear mechanism was proposed by Finnie [13-14], Bitter [15-16], and Neilson *et al.* [33].

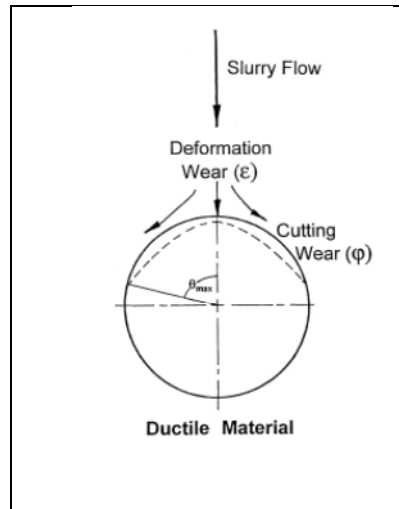
**Figure 12** Schematic diagram of slurry flow and distribution of deformation wear and cutting wear on a ductile material

Rapid thickness reduction is also clearly illustrated in Figure 13. Thickness reduction show significant reduction toward the leaked hole. The reduction pattern found to be similar with the wear depth reported by Clark *et al.* [34-35]. As the pipe behaved as a ductile material, it will be eroded through cutting wear mechanism. The estimated jetting angle of  $20^\circ$  which is at low angle just suitable to performed that type of mechanism. This finding is in agreement with study reported by Neilson *et al.* [33].

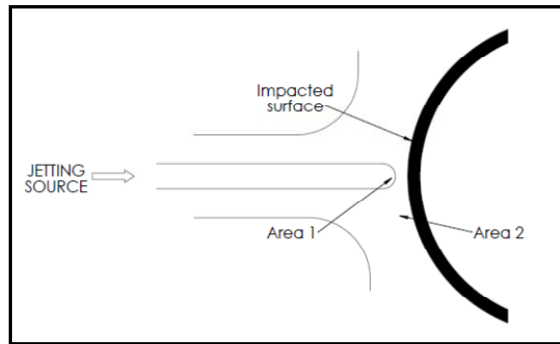
**Figure 19** Orifice jetting profiling

Two distinct impact patterns could be seen clearly on the impact surface. Impact pattern upon these two areas could be characterized by mode of impact medium either water or sand as the major contributor in the erosion media. *Area 1* has a smoother surface compared to the *Area 2* and this can be explained by Figure 19.

Due to water velocity differences between *Area 1* and *Area 2*, different erosion rate had been experienced by these two areas. It may had resulted to the differences of sand carrying ability (ability of the jet stream to induce and carrying the erosive media (sand particles)) of the water jet stream. In this particular case, various velocities of several impact areas in the water jet stream had resulting differences in the erosion rate. As such, velocity of the orifice outlet in *Area 1* was found higher compared to its subsequent *Area 2* (deformation wear) [32]. Therefore its ability to carry sand particles is subsequently reduced. The acting weight of sand particles reduce the ability of sand particles' to move with higher velocity in Area 1, thus causing a cutting wear. Similar finding had been reported by H. McL. Clark [32]. The erosion mechanism for ductile material suggested by Finnie [13, 14], Bitter [15, 16], and Neilson *et al.* [33] which postulated that the 'erosion by cutting' will act upon low angle direction whilst 'erosion by deformation' implied for high angle direction, both applied in these two peculiar areas.

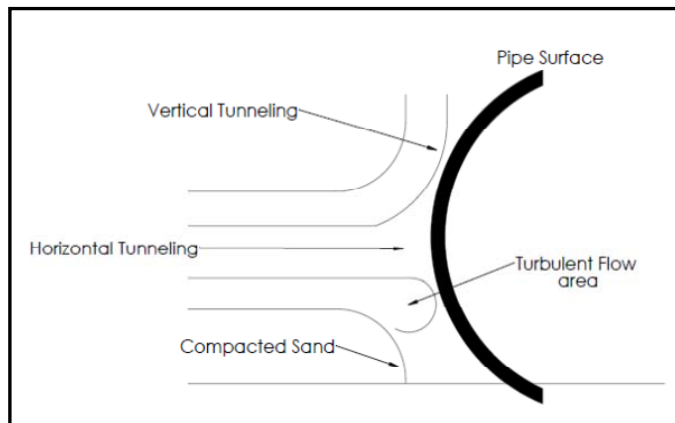
**Figure 24** Tunnel profiling

The average thinning rate of each point was obtained by dividing the thickness loss to the total period of experiment. Table 4 denotes each point's average thinning rate of the specified point due to water jetting. Points indicated in the Table 4 were based on the marking points rendered by the designated template design shown in Figure 16. Data shown in Table 4 indicates that the highest thinning rate is running across line E while the lowest thinning rate is evident in the line A. This could be explained by the existence of vertical tunneling near Line A and turbulent flow area near line E as shown in Figure 24.
