## **EROSIVE WEAR OF NATURAL GAS PIPES DUE TO HIGH VELOCITY JET IMPACT: COMPUTER SIMULATION STUDY**

**Abstract.** A sequential failures of underground API 5L X42 carbon steel and the SDR 17, 125 mm polyethylene pipes placed side-by-side to a water pipe was studied. Previous study shown that high pressure water jet from leaked water pipe that had mixed with surrounding soil formed water soil slurry with high erosive properties had severely impacted on the pipe surface causing the loss of pipe coating materials. This phenomenon eventually causes rapid thinning of the steel pipe body which later led to its failure. In this study Computational Fluid Dynamics (CFD) and structural analysis were performed to simulate numerically the chronological event of pipeline failure, in comparison with the findings made in the previous study. The structural and CFD simulation results proved that the location, rate and the extent of erosion failures on the pipe surfaces can be well predicted, as compared with actual instances.

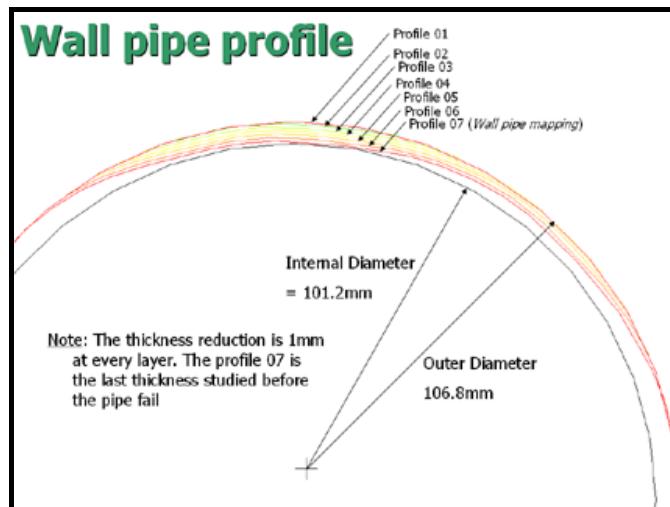
**Figure 16** Steel pipe wall profile

In the simulation, 1800 kPa internal pressure was applied from inside the pipe. Using the pipe dimension analysis (*thickness mapping*) the pipe thickness is modeled and simulated for different cases. The pipe thickness dimension model base is on the initial size which is 5.6 mm. The simulations were run for every 1mm reduction of pipe thickness as shown in Figure 16.

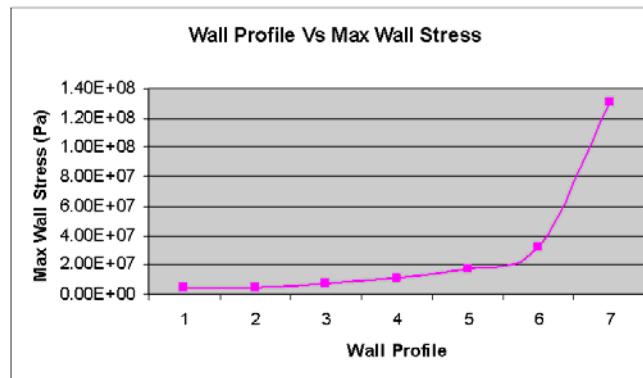
**Figure 18** Maximum stress profile

maximum stress profile and maximum displacement are shown in Figures 18 and 19 respectively. These figures show that maximum stress a displacement increase in the similar pattern as the pipe become thinner.
