# A SIMULATION STUDY OF SLOPE STABILITY AFFECTED BY CONSTRUCTION OF NEW BUILDINGS AT UNIVERSITI TEKNOLOGI MALAYSIA, SKUDAI.

Azman Kassim<sup>1</sup>, Fauziah Kasim<sup>1</sup>

<sup>1</sup>Faculty of Civil Engineering, Universiti Teknologi Malaysia, Skudai, 81310 Johor Bahru, Malaysia

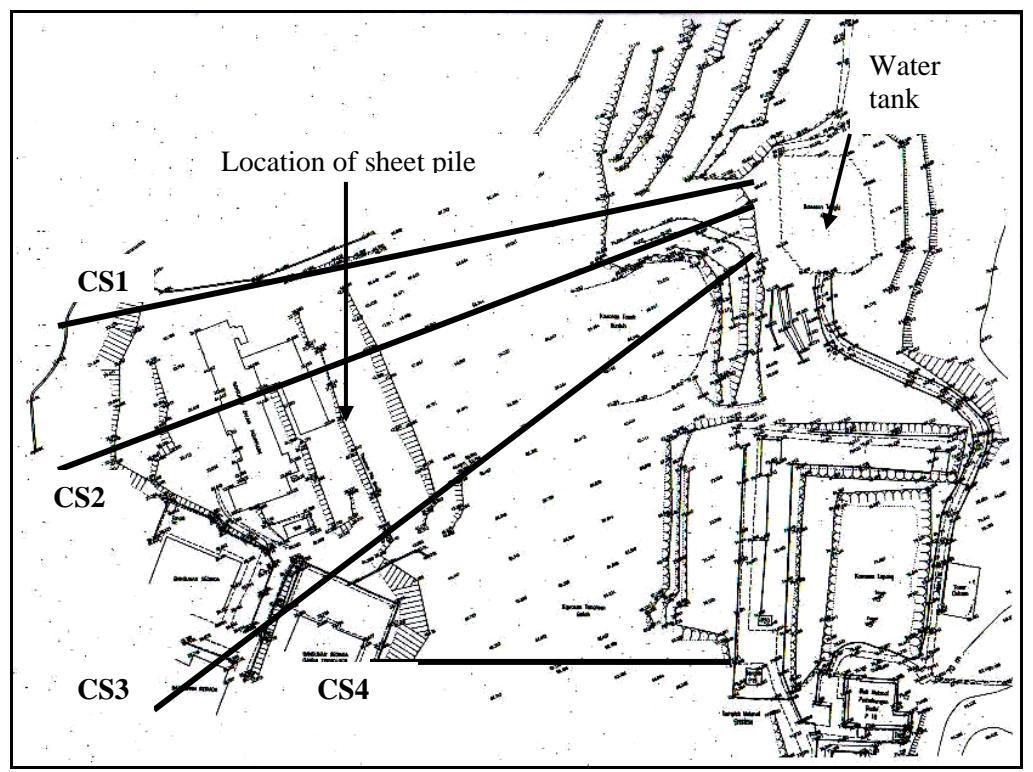
The mechanism of failure observed on site was simulated analytically with respect to deep-seated slip movement initially with combination of lateral pressure of adjacent slice in soil mass and shear mobilized along the slip surface and later followed by the movement of soil mass along the slope surface due to localised tension crack slip failures. The slope stability analysis was divided into two categories, i.e., global slope stability and localized slope stability. There were four cross sections considered, namely CS1, CS2, CS3 and CS4 (Figure 2).

Figure 2: Layout of cross sections CS1, CS2, CS3 and CS4.
