DAMAGE ASSESSMENT BASED ON MODAL ANALYSIS OF PIPE STRUCTURE

Sakhiah Abdul Kudus*, Yasuo Suzuki, Masahide Matsumura, Kunitomo Sugiura

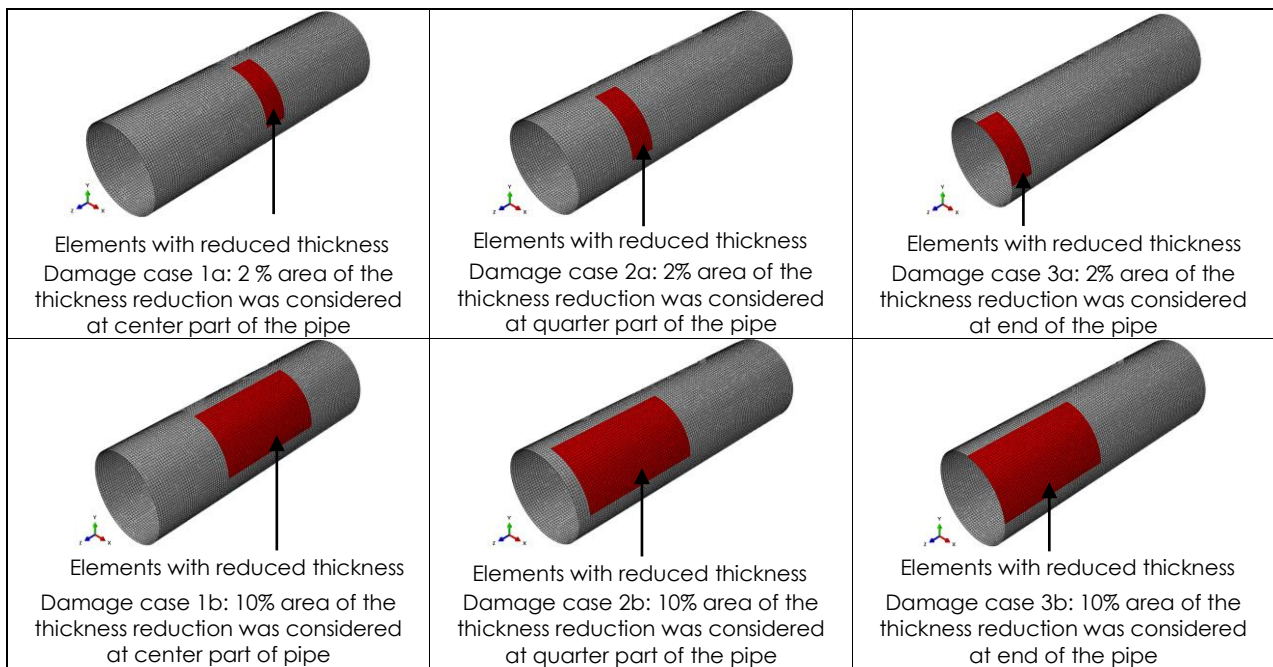
Figure 2 Details of damage case scenario in pipe structure

The size of damage is another parameter that was varied in the artificial damage model. The size of the damage was categorised as small and large. Small damage represented localised damage and was set as 2% of the total area of the structure. On the other hand, the large damage was set as 10% of the total area. Figure 2 represents the artificial damage case scenario in the pipe model with a designated area of reduced stiffness. In each size and position of damage, three stages of thickness reduction were applied which are 25%, 50% and 75% reduction.

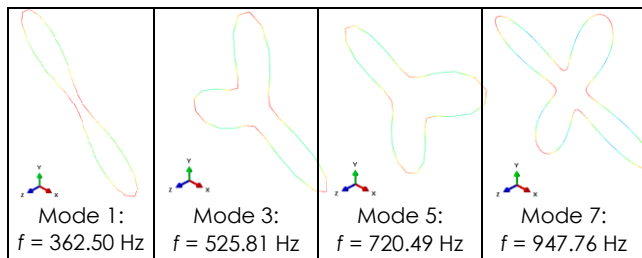
Figure 3 Circular cross section of steel pipe during vibration

Figure 3 represents the circular cross section of the steel pipe during the vibration for mode 1, mode 3, mode 5 and mode 7. In the breathing mode, the pipe extends radially around its circumference. There are two lobe shapes in mode 1, three lobe shapes in mode 3 and mode 5, and four lobe shapes in mode 7, as per the results of the cross section figure. Mode 3 and mode 7 have the same vibration pattern, but mode 7 showed two independent regions of vibration in the axial direction. Mode 7 has a higher independent region of vibration compared to mode 3.

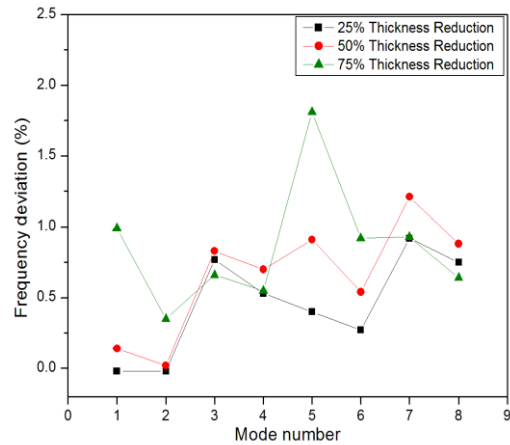
Figure 4 Deviation of natural frequency in the first eight mode of steel pipe tube for damage case 1 of 2% designated area

The change in natural frequency is one of the indicators of the existence of damage in the structure. With 2% of designated damage area in the pipe model, the reduction in natural frequency can be observed. Figure 4 presents the graph of frequency change in the 2% size of damage case 1. In damage case 1, the damage was located in the middle part of the pipe. The higher deviation of natural frequency was observed in mode 5 with 75% of thickness reduction. Overall, the deviation of natural frequency was small around 1% for all three levels of cut off depth.

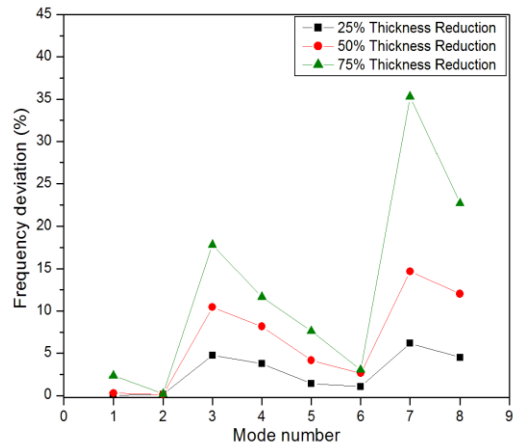
Figure 6 Deviation of natural frequency in the first eight mode of steel pipe tube for damage case 1 of 10% designated area

Figure 6 shows the graph of deviation of natural frequency in 10% damage area for damage case 1. The results show that the deviation in natural frequency increases with increases in the level cut of depth in the damaged region. The pipe with 75% thickness reduction showed the highest deviation of frequency as compared to 50% and 25% thickness reduction. Mode 7 shows the higher deviation of natural frequency

followed by mode 3. On the other hand, mode 2 shows the lowest deviation of natural frequency indicating that this mode is less sensitive towards the presence of damage case 1.

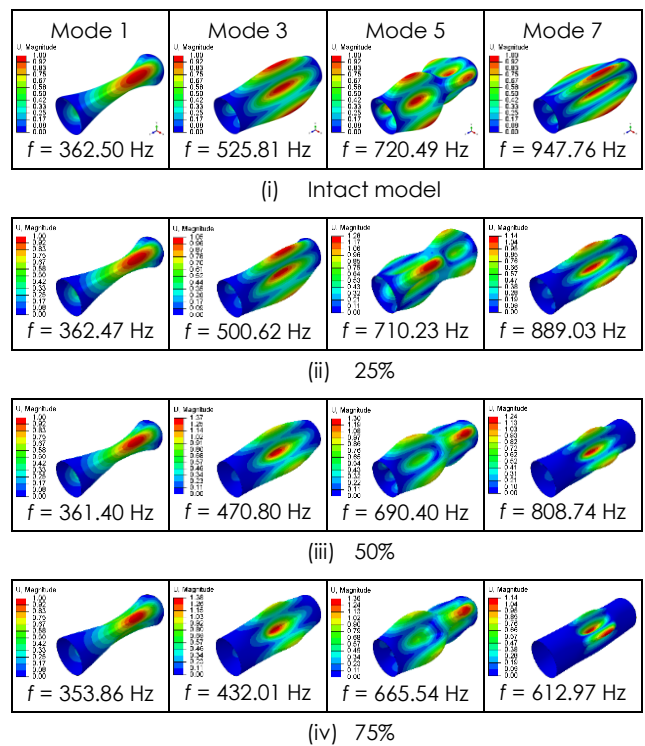
Figure 7 Pattern switch in mode shape due to 10% designated area of damage case 1 in steel pipe

Additional assessment based on mode shape results was conducted as shown in Figure 7. The large switch in mode shape has been expected to occur around the damaged region, which is invaluable for the prediction of the location of damage in the structure for further investigation. At first, when small damage of 25% thickness reduction was introduced to the pipe model, there was no distinct change between the damaged model and reference model. With an increase in the level cut off depth to half of the thickness, there was clear localisation in local mode 7. Mode 7 represents the more localised mode of vibration among others modes which possessed a higher number of independent vibrations in the region. The mode shape localisation in this particular mode due to damage was more apparent compared to mode 1, mode 3 and mode 5. Further, as the level cut off depth increased to 75% thickness reduction, more localisation occurred in local mode 7. There was almost zero vibration in surrounding damaged regions, and the vibration was dominant only in the damaged region.

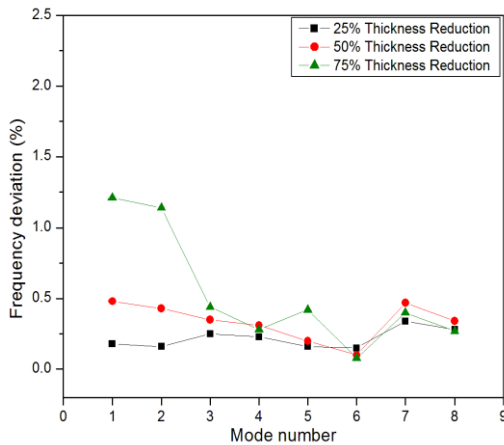
Figure 8 Deviation of natural frequency in the first eight mode of steel pipe tube for damage case 2 of 2% designated area

In damage case 2, the position of damage was switched to the quarter end of the pipe. A clear pattern switch of frequency deviation cannot be obtained when only small damage was introduced to the system as 2% of damage in damage case 2. This is illustrated in the graph of frequency deviation in Figure 8. It was supposed that with increases in damage severity, there would be an increase in the reduction of natural frequency. In this case, the highest frequency deviation occurred in mode 1 for 75% of thickness reduction with a value of 1.41%. The average value of frequency deviation was around 0.5% and below.

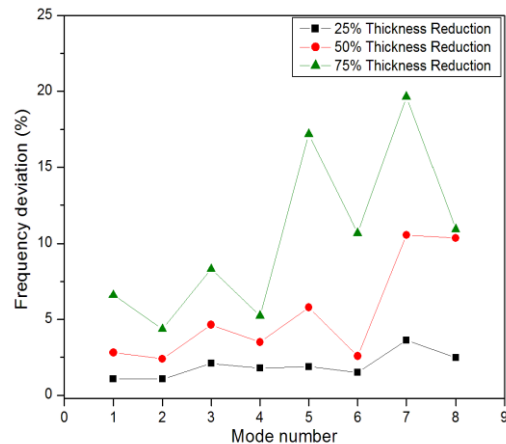
Figure 10 Deviation of natural frequency in the first eight mode of steel pipe tube for damage case 2 of 10% designated area

In this stage, the damage size increased from 2% to 10% to study the effect of the size of damage in case 2. Figure 10 displays the results of frequency change in three level cuts of depth. In large damage case simulations, it was clear that increased levels of damage increased the frequency deviation. Mode 7 and mode 5 show the higher sensitivity based on the higher deviation of frequency.

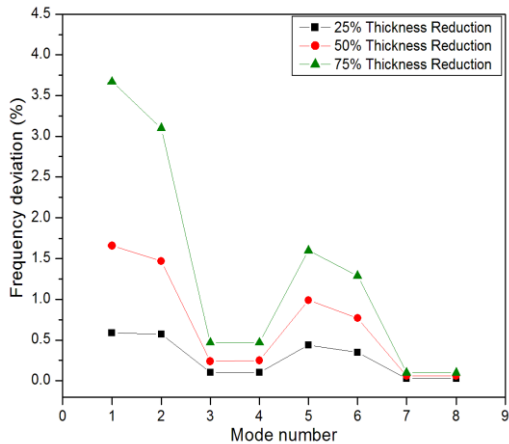
Figure 12 Deviation of natural frequency in the first eight mode of steel pipe tube for damage case 3 of 2% designated area

The damage was located at the end of the pipe in damage case 3. The effect of the position, size and level cut of depth towards the modal parameter was further assessed in this damage case simulation. Figure 12 shows the deviation of natural frequency for small size of damage case 3. With the increase in thickness reduction, the frequency deviation also increased. Couple mode 1 and mode 2 shows higher deviation in natural frequency compared to others modes followed by couple mode 5 and mode 6. Couple mode 7 and mode 8 shows less frequency deviation indicating that this mode is less sensitive to the presence of damage case 3.

The pattern of frequency change was not the same between small damage and large damage sizes. Figure 14 shows the deviation in natural frequency when the damage areas increased to 10%. In this case, mode 7 followed by mode 5 show higher deviations in frequency which is different from the lower state of damage observed in Figure 12. In 25% of thickness reduction, the frequency deviation between each mode extracted was minimal.

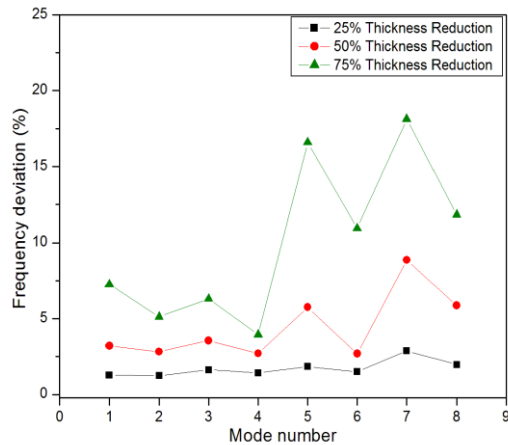
Figure 14 Deviation of natural frequency in the first eight mode of steel pipe tube for damage case 3 of 10% designated area

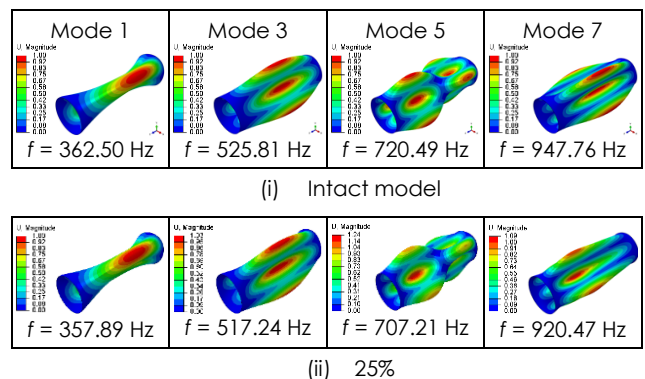
Figure 15 Pattern switch in mode shape due to 10% designated area of damage case 3 in steel pipe

Figure 15 summarises the effect of damage case 3 in a 10% damage area in terms of mode shape. Mode 7 shows the higher localisation of mode shape in the damaged region whereas mode 1 and mode 3 only slightly deviate from the intact case.
