# DAMAGE PROPAGATION AND THERMOGRAPHY IN DISCONTINUOUS CARBON FIBER COMPOSITE (DCFC) UNDER TENSILE (FATIGUE) LOADING

The discontinuous carbon fiber composite (DCFC) has a different damage behaviour due to non homogenous sub structure. Consequently, monitoring and diagnosis of DCFC damage mechanisms require the application of a contactless method in real-time operation, i.e., non destructive method of thermography. The aim of this study is to investigate the damage propagation of DCFC material under tensile (fatigue) condition with non destructive testing (NDT) thermography method. Under fatigue testing, temperature evolutions were monitored by an Infra-Red (IR) camera. The results show that damage propagation and thermal response indicated the similar behaviour which consists of three stages. At the beginning, low temperature increased until  $\approx 10\%$  of fatigue life due to the initial damage. The initial damage propagated and the temperature reached the stable thermal state due to the saturation in the damage appearance of micro cracking of matrix and chip until  $\approx 80\%$  of fatigue life. At the last  $\approx 20\%$  of fatigue life, damage continued to propagate an

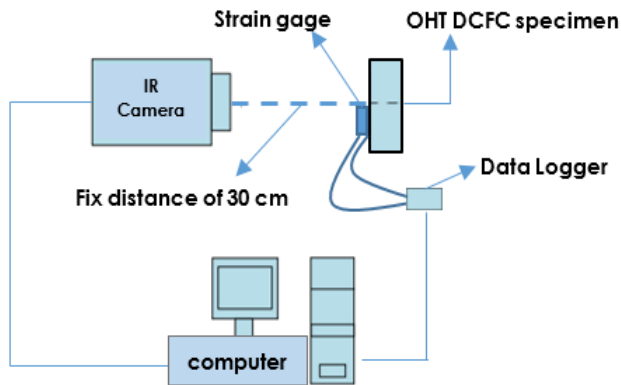
The open hole tension (OHT) specimen test is 60 % of random discontinuous (chip form) carbon fiber volume as the reinforcement and epoxy matrix. Chip dimensions are 50 mm length and 8 mm width where fabricated into composite material under compression molding. The test was carried out on INSTRON Machine 8501 100 kN, equipped with mechanic grips of 20 kN max capacity. Local strain was measured using single strain gage with a gage length of 5 mm. Temperature evolutions during the cyclic tests were monitored by an Infra-Red (IR) camera. Figure 1 below shows the schematic diagram of experimental set up.

Figure 1 Schematic diagram of experimental set up

The fatigue tests were performed under load control, at a stress ratio, *R*, equal to 0.1, i.e., tension tension loading and constant 3 Hz of frequency. An IR camera was placed in front of the specimen with fix distance, i.e., 30 cm. The test specimen is rectangular shape with an open hole condition, as seen in Figure 2.

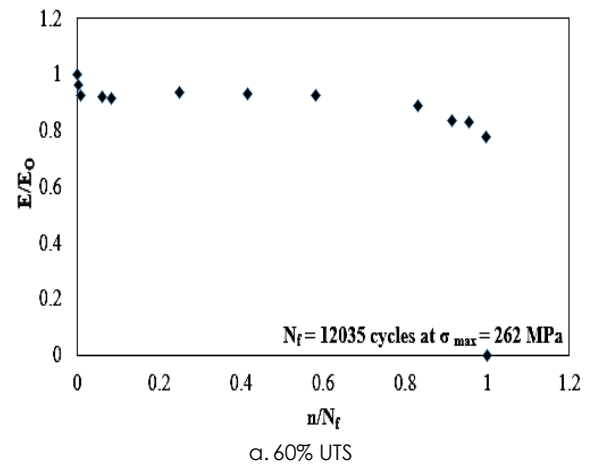
The fatigue tests conducted with different of load level, i.e., 60 % of ultimate tensile strength (UTS) and 75 % UTS. Figure 3 shows the stiffness degradation ( $E/E_o$ ) as a function of fatigue life ( $N_f$ ). The stiffness degradation were in the range between 1 and 0.

Figure 3 Stiffness degradation of DCFC

From Figure 3, under different load level, specimens failed at different number of fatigue life (Nf) where 60% of UTS generates Nf of 12035 cycles and load level of 75 % of UTS has a shorter fatigue life of 1033 cycles. it is noted that DCFC specimens experience the change in modulus or stiffness as a function of fatigue cycles. The Stiffness degradation curve or the decrease trend in material modulus has been commonly used to express the state of cumulative damage D in polymer composite material as a function of loading cycles [14], where defined as:

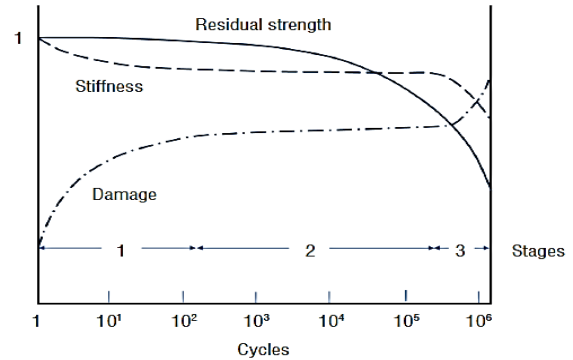
In general, under fatigue loading, the first small drop of stiffness is associated with the presence of initial micro matrix cracking damage mechanism in micro scale. Then, the stiffness propagates into gradual decrease as also the damage seems to increase and develop into others mechanisms, such as interfacial matrix/fiber debonding and delamination. The final stage of damage propagation

leads to a decline of stiffness with an increasing amount of damage mechanisms, such as fiber breakage and delamination growth [22-24]. The illustration of stiffness degradation and damage propagation of fiber composite can be seen in Figure 5.

**Figure 5** The three characteristic stages of fatigue damage in composites [25]

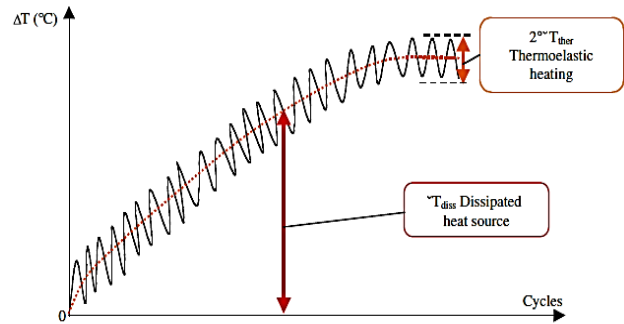
It is well known that, thermography can fulfill the need of a non contact technique and real time inspection of damage detection under dynamic loading conditions [28-34] due to the transformation of damage in an irreversible way into heat [35]. An illustration of thermal evolution during a fatigue test can be seen in Figure 8.

Figure 8 Thermal evolution during a fatigue test [15]

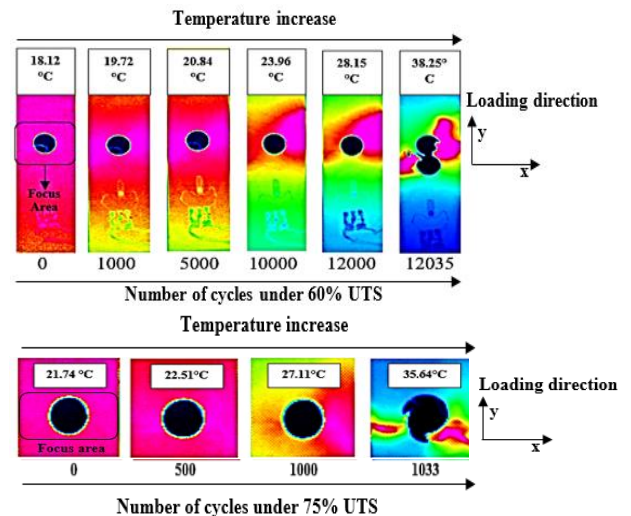
The aim of this study is to have a relationship between temperature evolution and damage propagation. Figure 9 shows the temperature change for certain cycles until failure, respectively. The focus area is localised around the hole.

Figure 9 Temperature images of DCFC under fatigue loading

The focus area, which the damage area at the edge of the hole, is shown in Figure 9 for the 60% UTS and 75% UTS specimen. The temperature shows a similar slow increase until it reaches at  $N_f$  around 10000 cycles for 60% UTS and 1000 cycles for 75% UTS. A significant increase of temperature occurs at the end of fatigue life for both specimens and reaches  $\Delta T \approx 20^\circ\text{C}$  for 60% UTS and  $\Delta T \approx 14^\circ\text{C}$  for 75% UTS. All temperature formation during the fatigue test can be seen in Figure 10

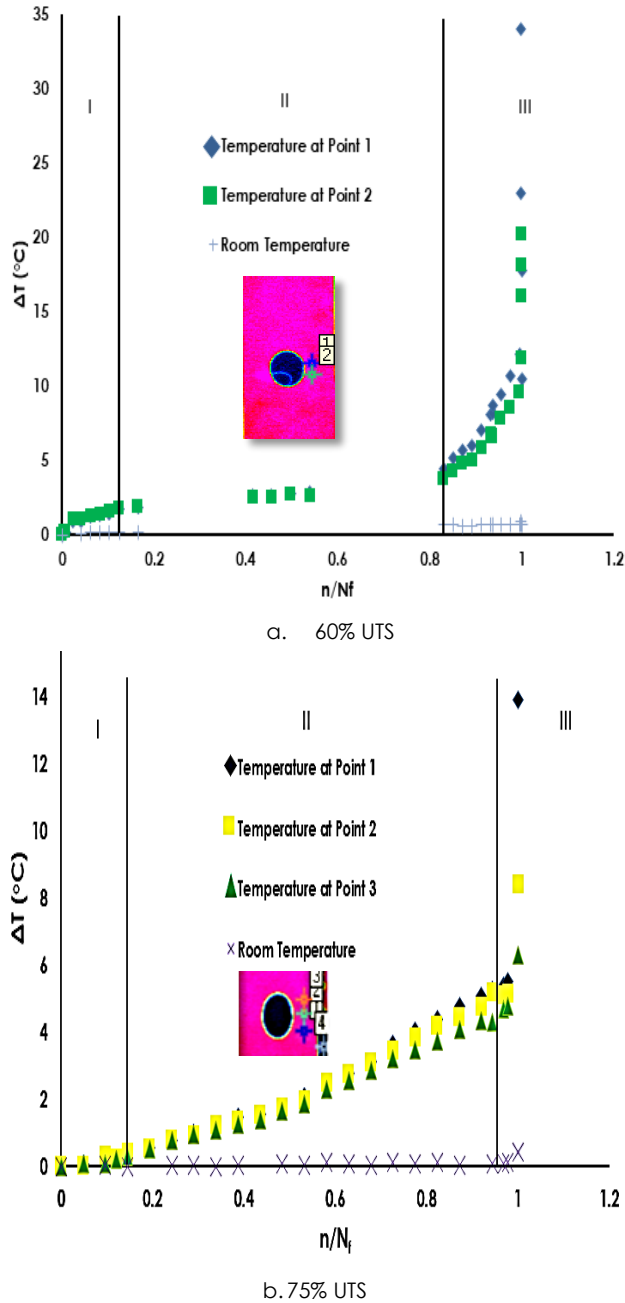
Figure 10 Thermal evolution of DCFC under fatigue loading

When damage occurs, it represents the energy which gradually released. The energy that has been absorbed is sufficient to create micro-crack, enlarging the pre-existent ones, and create new inner and interfacial debonding and chip cracks then leads to final failure. The heat generated from the energy release then detected by the IR camera that showed an increase in temperature in the area of damage. It shows temperature increase behaviour at  $\Delta T \approx 1-3\text{ }^\circ\text{C}$  until  $\approx 10\%$  of fatigue life due to the initial damage. The initial damage propagates and the temperature reaches the stable thermal state (an example of a

slope of  $0.0004^\circ\text{C}/\text{cycle}$  from 1200 to around 10000 cycles for 60% UTS) due to the saturation in the damage [15]. Each peak of temperature indicates different type of damage mechanisms. We found that temperature reaches at  $\Delta T \approx 1-5\text{ }^\circ\text{C}$  is directly associate with the appearance of micro cracking of matrix and chip. After that, damage continues to propagate and temperature starts to show a higher increase until reaches at  $\Delta T \approx 12^\circ\text{C}$ . The  $\Delta T \approx 6-8^\circ\text{C}$  for 60% UTS and  $\Delta T \approx 4-5^\circ\text{C}$  for 75% UTS is related with the appearance of interfacial damage. The higher temperature of interfacial damage is in fact due to absorb more energy of damage. From the temperature evolution during test, the presence of macro damage indicate the area of final failure which is exist and concentrate in the region of focus area around the hole. In sum, initial macro damage provokes the occurrence of catastrophic or final failure of the specimen that induce the highest peak of temperature at  $\Delta T \approx 20-34\text{ }^\circ\text{C}$  for 60% UTS and  $\Delta T \approx 13-14\text{ }^\circ\text{C}$  for 75% UTS suddenly. Based on the temperature evolution of DCFC above under fatigue test, an approximate of temperature behaviour of DCFC until fatigue limit can be approached in a form of an empirical relationship, which is expressed as:

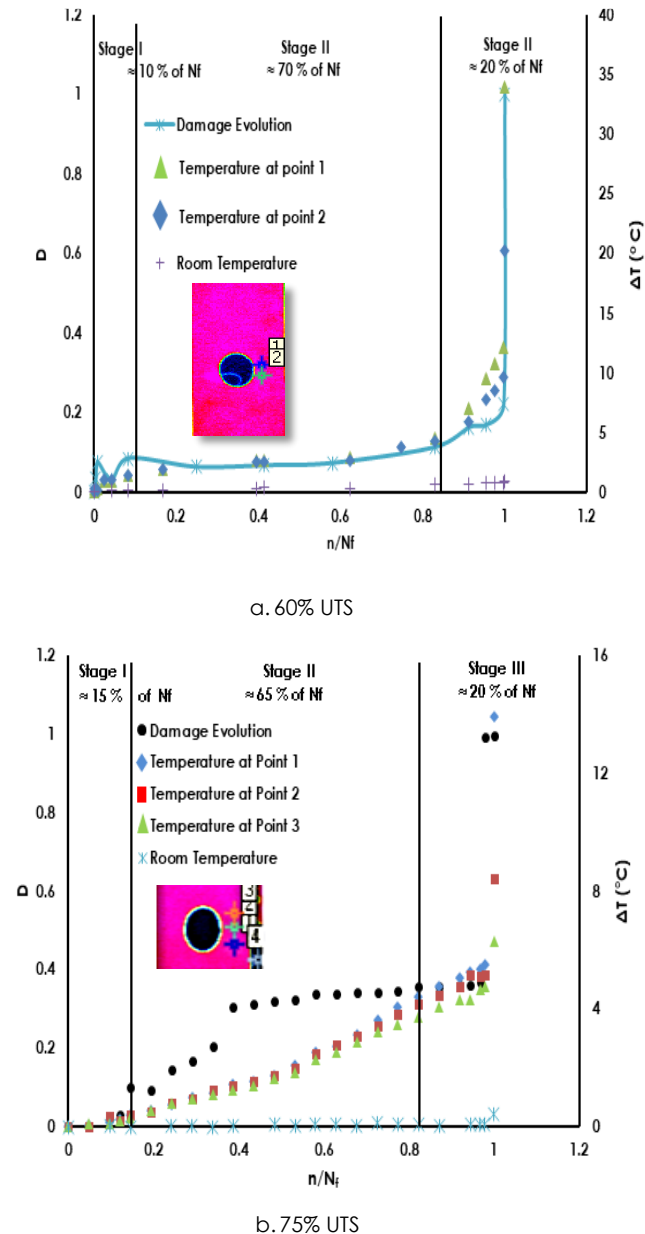
The comparison between the thermal evolution and the damage propagation can be seen in Figure 11.

**Figure 11** Comparison between the temperature evolution and the damage propagation of DCFC under fatigue loading

From Figure 11, temperature evolution and damage propagation show the same 3 (three) increase phases characterised by low phase, slow-gradual phase, and high-sudden phase. Therefore, it can be noted that the temperature behaviour ( $\Delta T$  response) of DCFC under fatigue loading can be used as one of damage parameter and not only stiffness degradation which has been used in conventional method. This confirms the results from previous studies [15, 18-19, 21], which conclude that thermal dissipation relates to the damage evolution and can effectively estimates the damage behaviour of carbon fiber composite material.
