Post-Impact Investigation of CFRP Laminated Plate

This paper deals with low-velocity impact and quasi-static indentation tests on carbon fibre reinforced plastic (CFRP) laminates that classically used in aeronautical applications. The aim is to carry out post-impact analysis using Vic 3-D digital image correlation to investigate the behaviour of permanent indentation which is an important condition for the damage tolerance justification in composite. Result shows the indentation depth decreased with the time due to relaxation of the specimen until at certain position. The microscopic observations were carried out to understand the phenomenon. Besides that, the post-mortem analyses on the impacted plate were also carried out through microscopic observation to determine the delamination area at each interface which is normally difficult to extract from the C-Scan result. The observations were made at three different sections cut (0° , 90° and 45°). The results of delamination area obtained from both microscopic and C-scan analysis is compared and there are rather satisfying to each other.

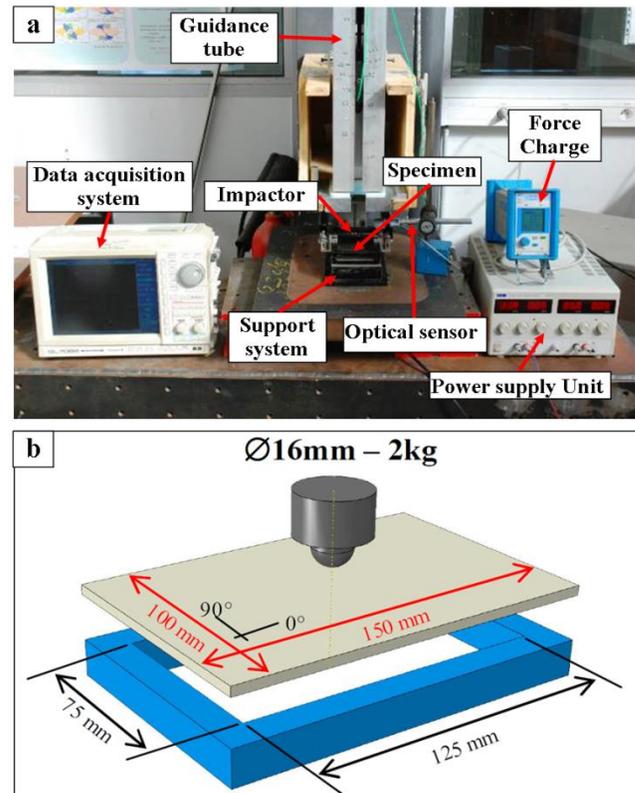
Figure 1 (a) The arrangement of the impact test (b) Boundary condition of the impact test

Impact tests were performed using a drop tower system with an impactor with 8 mm radius and 2 kg mass as shown in Figure 1a. The test is according to the guidelines from the standards ASTM D7136/D7136M [14]. The specimen was placed under the drop tower with simply supported on a of 75 mm x 125 mm frame, as shown in Figure 1b. The test was performed at impact energy of 25 J. This energy provides sufficiently different damage mechanisms around the BVID threshold and does not reach the perforation level [2,12]. During the test, the optical sensor, accelerometer and force sensor were installed to measure the impact forces, accelerations and optical signal for plate deflection. All the data were recorded using Yokogawa DL708 digital oscilloscope and acquired at the maximum rate of 200 kHz because the impact test is very dynamic that gives a wide range of frequencies.

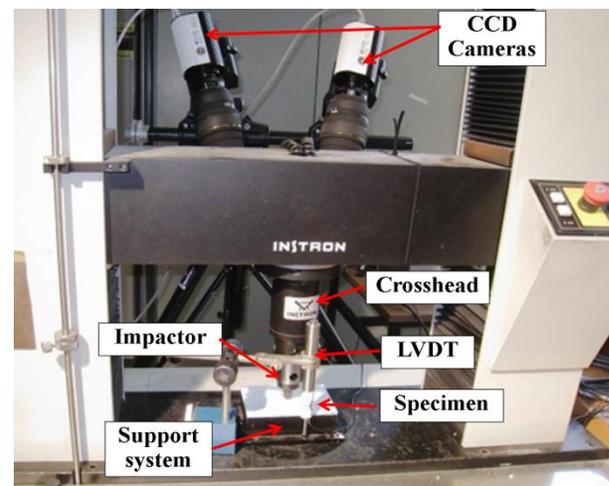
Figure 2 The indentation test arrangement on the test machine

The indentation test was done by using the Instron 4206 test machine. The set-up of the test can be seen in the Figure 2. The impactor is the same used in the impact tests. Similarly, the specimen was placed on a simple rectangular frame support as in impact test. The displacement of the impactor was controlled by the feed of the test machine's crosshead and the loading speed was set at 2 mm/min. The displacement was measured using Linear Variable Differential Transformer (LVDT) as this instrument allows more accurate values than the displacement measured by the test machine. The LVDT was installed parallel to

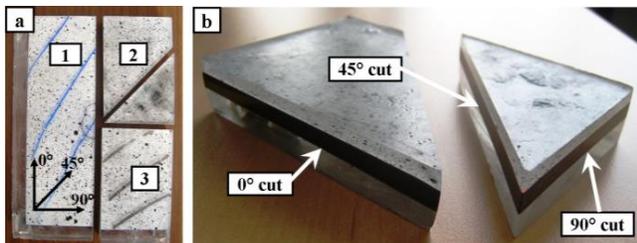
Figure 3 Specimen preparations for microscopic observation (a) the plate after being cut (b) The areas that were polished and observed (section no.2)

The microscopic analysis was done by using an optical microscope on both impacted specimens, T-dyna and T-static. First, the specimens were cut along the 0° and 90° through the impacted area as shown in Figure 3. After the microscopic observations have been done at both sections, only then the 45° section was cut. However, before cutting, the specimens are immersed in resin together with chemical hardener (catalyse polyester peroxide) to make sure the debris will not be removed during the cutting and polish processes as demonstrated in [15]. These microscopic observations were made to study the debris behaviour inside the crack areas and also to measure the crack length between the interfaces that occurred after the plate being impacted. The measurement of the crack length can be used to

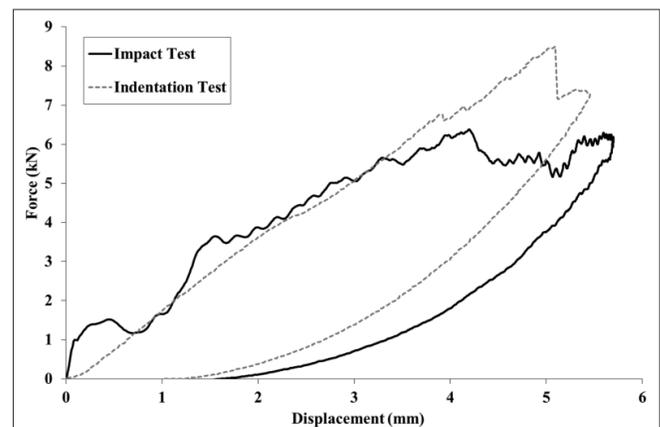
Figure 4 The comparison of force-displacement curves between impact and indentation tests

Between the impact and the indentation test, there is one parameter in common, namely the maximal displacement of the impactor. Therefore, a good possibility is given to compare the results of these two different tests. Although the maximal displacement of 5.7 mm was shown by the LVDT machine, however Figure 4 shows that the maximal displacement is only achieved by 5.4 mm. This is probably caused by error in setting LVDT machine at the beginning of the test. This difference is neglected for further analysis. Besides that, the force curve increased linearly longer in the indentation test than in the impact test. Moreover, the force at the same respective displacement is larger in the case of the impact test than the indentation test. From previous studies [11], this phenomenon is explained due to the inertia effect that occurs during the impact test because of the

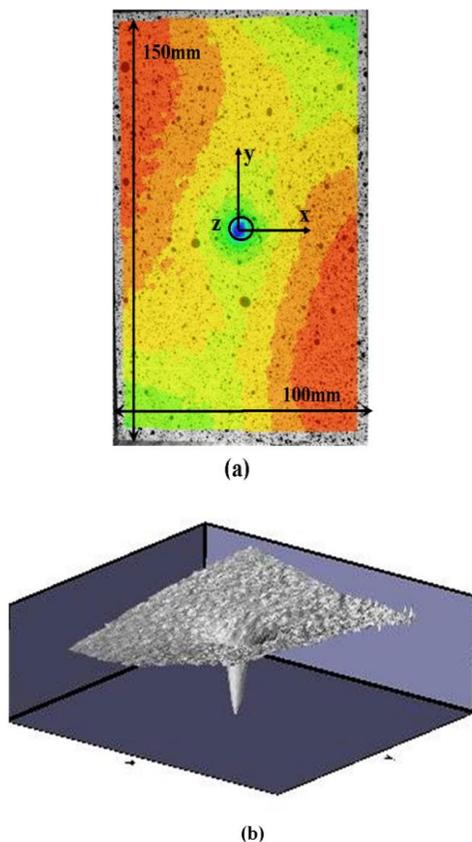
Figure 5 The Image from Vic 3-D Digital Image Correlation (a) Coordinate system and size (b) The twisted shape of specimen after being damage

A further criterion to assess the damage caused by an impact test or static test is the indentation depth of the plate at where the impactor has knocked. The characteristics of the permanent indentation after certain relaxation are one of the main interests in this study. Therefore, the indentation depth of both specimens; T-dyna of impact test and T-static of static test were measured. A series of 3D images of the damaged specimen has been taken for a few days after the tests to measure the plate's indentation by using the CCD-cameras. The indentation was observed directly after the test. From the CCD-camera systems, it gave the contour plot images of the specimen by using Vic Snap and Vic 3-D Digital Image Correlation as shown in Figure 5a. These contour plot images were used for the determination of the indentation. The indentation can be seen in the middle of the plates as shown in Figure 5b. Besides that, a global deformation of the specimens can be marked. The specimen has a twisted shape after being damaged because of the plasticity of the resin (Figure 5b) even though the resin's characteristic is brittle. However, the plasticity can occur in this case.

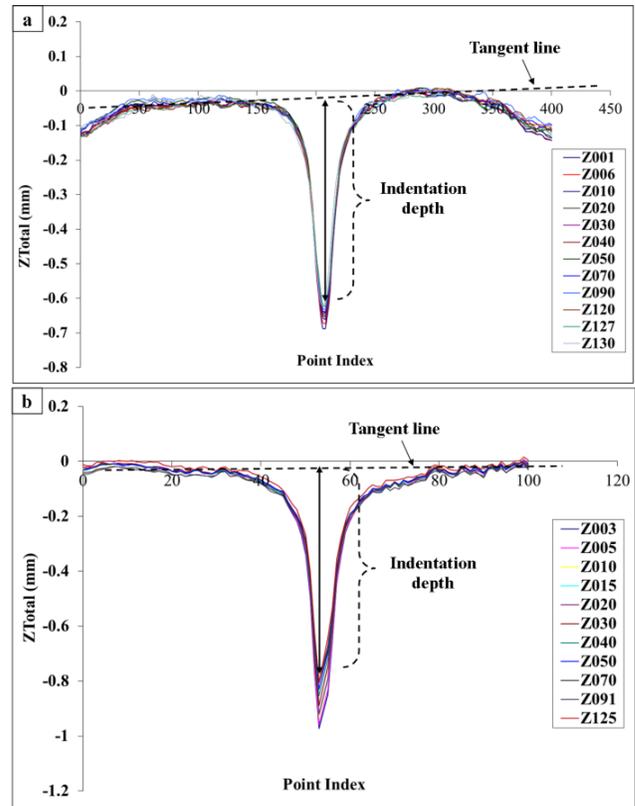
Figure 6 The indentation depth measurements (a) impact test (b) indentation test

sixth image taken by the CCD camera and Z is representing the displacement in Z-direction. One tangent line was drawn approximately in the middle between the curves. The indentation depths were measured from the point on the tangent line to the lowest peaks of each curve as in the Figure 6.

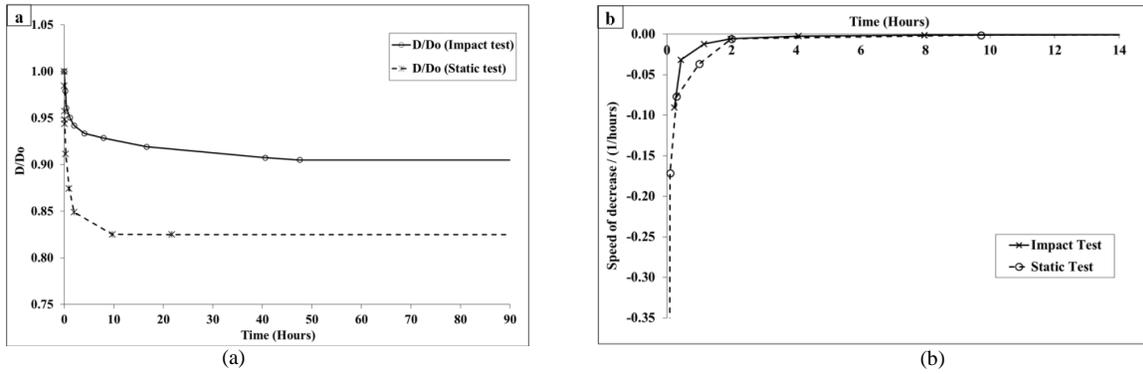
Figure 7 (a) The percentage of evolution indentation depth of each test (b) The comparison of speed of decrease for both tests

Thus, by knowing these data the curve of relaxation of the indentation depth were plotted as shown in the Figure 7a. As a result, the characteristics of indentation depth after certain period of time were as expected, the depth will decrease due to relaxation of the specimen. The difference between temporary and permanent indentation depth for impact test is $\approx 10\%$ and $\approx 18\%$ for the static test. In reality, the initial indentation depth (D_0) for both cases is difficult to obtain, especially for the impact test. Hence, in this study the D_0 value is assumed as the indentation depth of the first picture which was taken just after either the impact or the static test. Therefore, there is always a gap between the original D_0 and the assumed D_0 depending on how fast the first picture was taken. For both tests, when the plate gets unloaded, the deformation which occurred on the plate tries to back its initial location due to the elasticity of the material that is called the plate relaxation. The debris can prevent that relaxation, the better it is distributed the higher is that effect. It is obvious a better distribution can occur during a static test because the debris has more time to fill the free space of the cracks [4,9].

Referring the speed of decrease for both tests, during the first 5 hours the indentation decreased dramatically but after that it started to decrease steadily. It is almost constant after 45 hours of the tests. Figure 7b has shown that the indentation depth of the plate performed under static test has greater decrease of speed than the impact test. The reason for this phenomenon was not yet found. The counting of fragment or debris of each plate through the microscopic observation could give some idea of this behaviour.

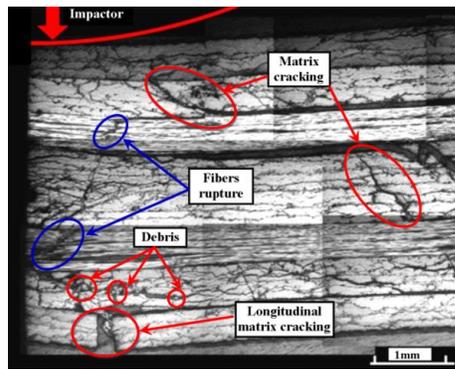
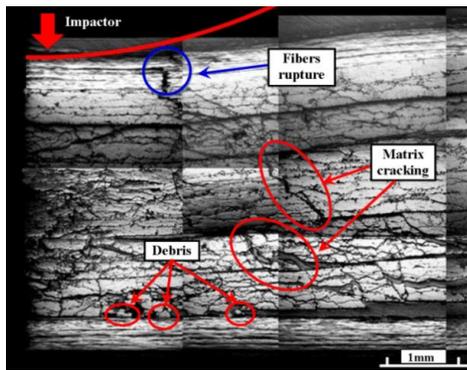
Figure 8 Some example of debris in the delamination areas and the matrices cracking for (a) Near to the impact of 90° cut and (b) Near to the impact of 0° cut

The microscopic observations on the 90° and 0° sections cut have shown that there are plentiful of debris exists in the delaminated areas in both sections. Besides the delamination between the interfaces, matrix cracking and fibres rupture are also exists in many areas as shown in Figure 8. Similarly, for the 45° section cut, there are also a lot of debris exists in the delaminated area. Therefore, it seems difficult to count the debris with the naked eyes. Hence, it can be concluded that the existing of these debris will tend to block the fibres and matrices of the specimen being impacted to return to its initial location. It will affect the relaxation of indentation. This could give the general explanation why in previous section the indentation depth became constant after certain period of times. When the crack areas became

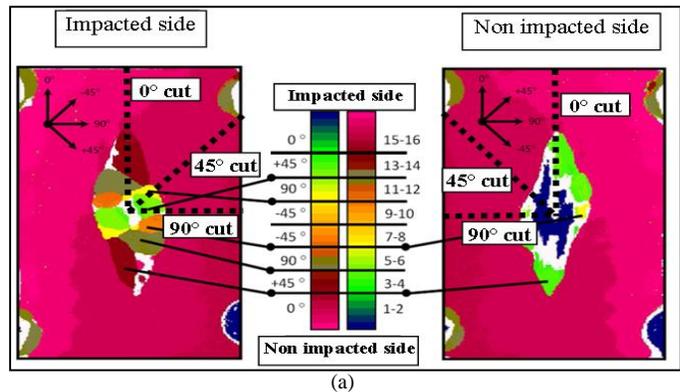
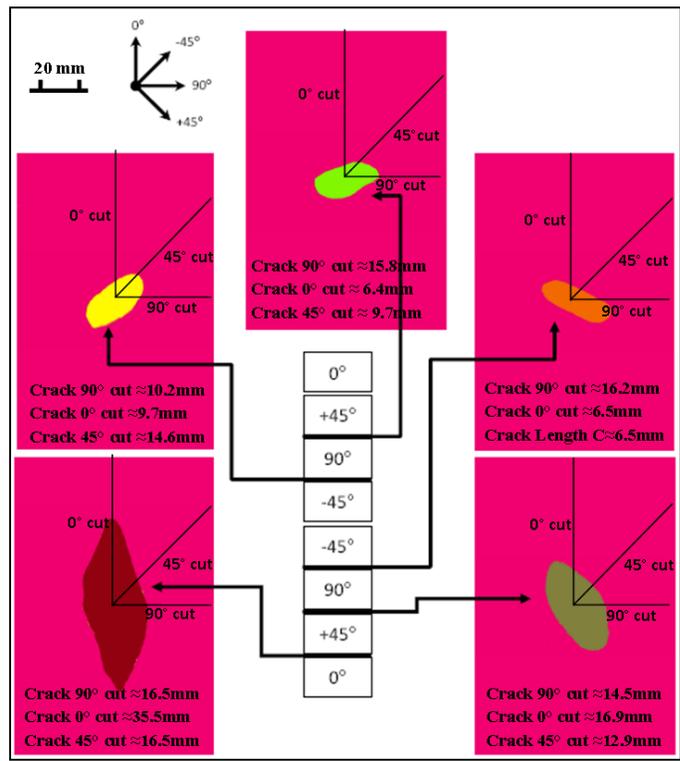
Figure 9 (a) General results from C-Scan (b) Approximation of delamination area for each interface

Delamination area of impacted plate taken from the C-scan analysis was measured for each interface as shown in Figure 9. The delaminated area of each interface presents in Figure 9b was approximately extracted from the Figure 9a. From the color bar (Figure 9a), the delamination area in each layer can be distinguished. Moreover, the C-scan result on the non-impacted side (Figure 9a) is necessary to make sure the areas of delamination were properly extracted. There was no delamination if the plies were in the same orientation such as four plies of -45° in the middle of the laminates.

For both microscopic observations on the 90° and 0° sections cut, the results obtained were rather satisfying compared to the C-scan result. However, for 45° section cut the results obtained by microscopic observation has shown that there are significant differences with the C-scan result. Referring to Figure 10c and Figure 11c, the longest crack occurred at $90^\circ/45^\circ$ interface with the length of 22.3 mm while for C-scan, the longest crack occurred at $0^\circ/45^\circ$ interface with length 16.5 mm. Besides that, the second longest crack is also different in both results where for the microscopic observation is 15.7 mm at $-45^\circ/90^\circ$ interface while for C-scan at the same interface, the approximation made are only 6.5 mm. Another important point to discuss is there was a short crack at $0^\circ/45^\circ$ interface in the microscopic observation. These major differences may be caused by the difficulties to see exactly the delaminated area on each interface from the general result of C-scan (Figure 9a).

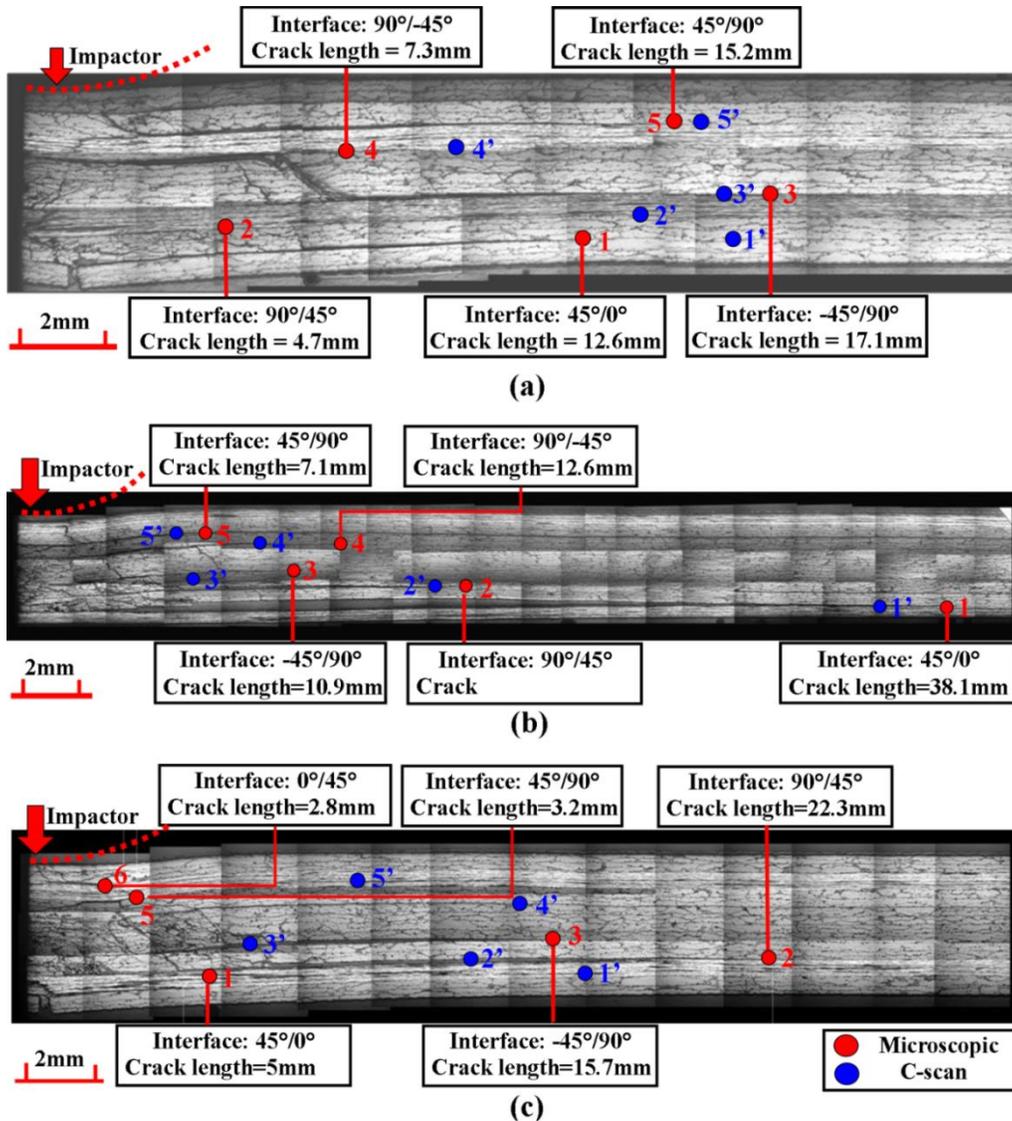
Figure 10 Results of delamination length by microscopic observation (a) 90° section cut (b) 0° section cut (c) 45° section cut

After that, the measurements of delamination length for each interface of C-scan result were compared with the delamination length calculated from the microscopic observation as presented in Figure 10.

Generally, the delamination length measured from both microscopic and C-scan analyses have some differences. For a better comparison, the measurements from these analyses were plotted in Figure 11. As can be seen in Figure 10 and Figure 11a, the longest crack measured through the microscopic image along the 90° section cut was between the $-45^\circ/90^\circ$ interface which is around 17.1 mm. Meanwhile for the C-scan, three different interfaces have almost the same longest crack around 16.2 mm. This is may be due to the minor error of the approximation process of delaminated area from the Figure 9a. Moreover, the C-scan results have shown that there are five interfaces encountered with delamination but from the microscopic observation, only four interfaces where the delamination can be clearly seen. The $45^\circ/90^\circ$ interface has only small delamination near to the impacted area.

The microscopic observation on 0° section cut has shown that the longest crack occurred at $45^\circ/0^\circ$ interface (38.1 mm) which is close to the C-scan result (35.5 mm) as presented in Figure 10b and Figure 11b. Besides that, the number of interfaces having delamination in both analyses is also similar with the delamination length of the other interfaces are compatible to each other.

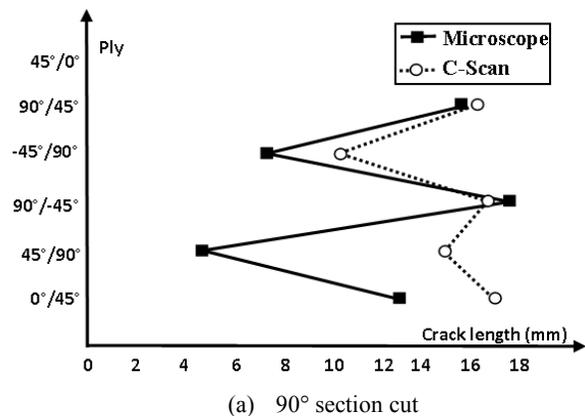
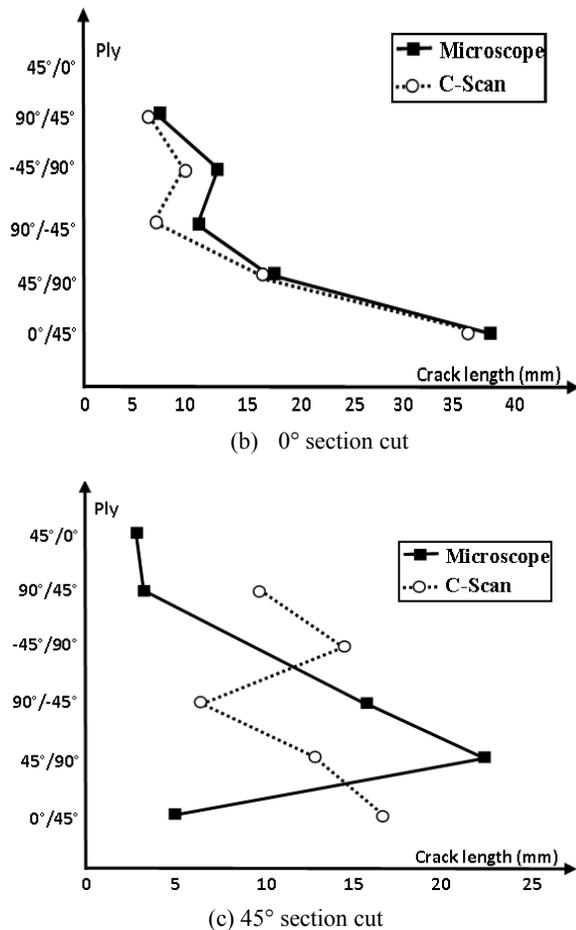
Figure 11 The results comparison of microscopic observation and C-scan
