EVALUATION OF RAIL HEAD SURFACE REPAIR USING SMAW PROCESS WITH PRE HEATING CONDITION

Muhd Faiz Mat^{a*}, Azwan Fadzli Musah^b, Abdul Ghalib Tham^a, Syidatul Akma Sulaiman^a

^aFaculty of Mechanical Engineering, Universiti Teknologi MARA, 40450 Shah Alam, Selangor Darul Ehsan, Malaysia

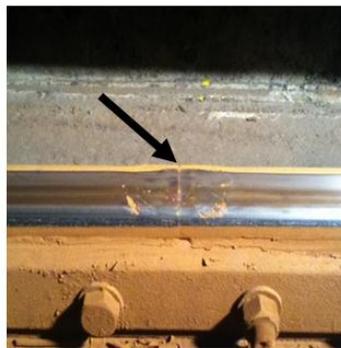
Figure 1(b) Embedded rail

and train components. Track component replacement job, especially the running rail requires costly skilled manpower and special machineries [9]. As an alternative, build-up welding can be performed in order to restore worn out and damaged rail. Nevertheless damaged rail always repeat at the previous welded area. It may be caused by improper use of consumable during the repairing process. This study was conducted in order to evaluate the quality of welding repair on running rail RE115 using Magna 488-Rail consumable welding rods currently used at Track Network Maintenance Department of RapidKL Kelana Jaya Line. Figure 1(a), Figure 1(b) and Figure 1(c) shows common running rail damage that occurs at RapidKL Kelana Jaya Line.

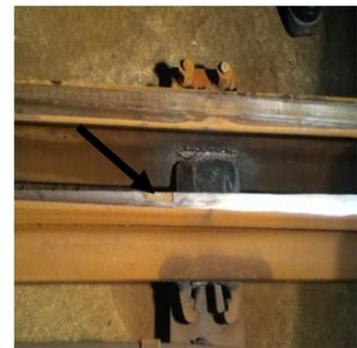
Figure 1(c) Surface crack

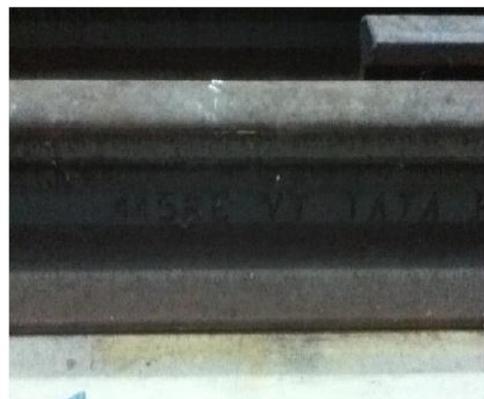
Figure 2 RE115 Rail sample

Running rail samples for this study were obtained from Track Network Maintenance Department of RapidKL Kelana Jaya Line, in order to evaluate the quality of welding repair on running rail RE115 using Magna 488-Rail consumable welding rods (Figure 2). Running rails are made from very high quality steel alloy and subject to very high stresses. In order to have the required qualities of strength, wear and corrosion resistance and fatigue endurance, running rails was specifically rolled.

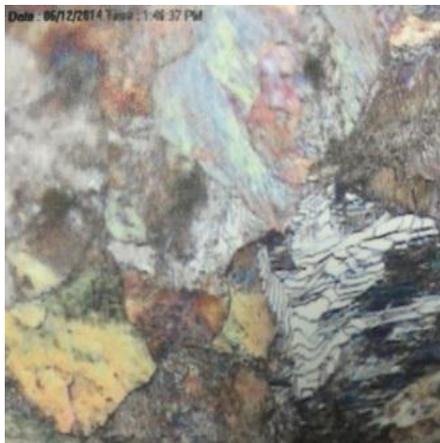
Figure 3 (b) shows the microstructure of base metal which is RE115 rail consist of pearlitic microstructure. Since pearlite consists of soft ferrite and hard cementite, therefore RE115 rail, presumably achieves a high resistance to wear because of hard cementite. Lamellar structure also appeared in Figure 3(b) it explains the high value of hardness property of the rail [12].

Figure 3 (b) Optical Microstructure of Rail Base Metal (500x)

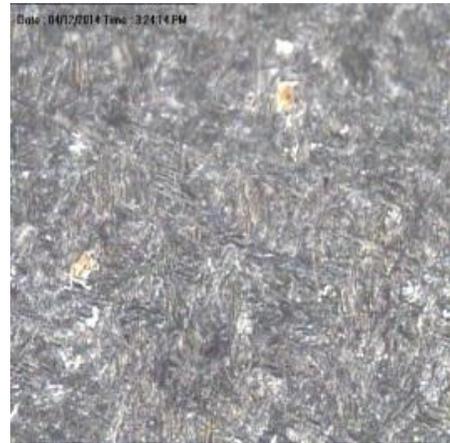
Figure 3 (c) shows the microstructure of heat affected zone (HAZ) area. Microstructure of HAZ area also has pearlitic structure but with finer grain as compared to the base metal. This result occurred due to the thermo mechanical treatment of HAZ area during the welding process.

Figure 3 (c) Optical Microstructure of HAZ (500x)

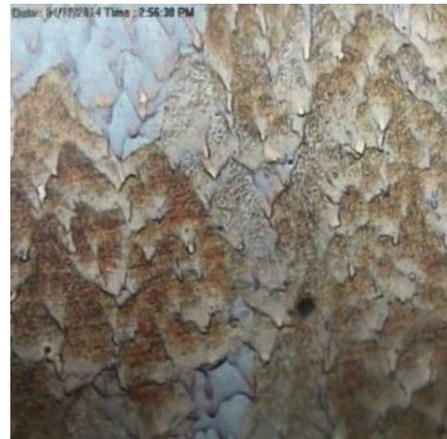
Figure 3 (d) indicates that the welded layer consists of delta ferrite microstructures. This delta ferrite microstructure may occur from slow cooling rate after the welding process has completed in effect, of the preheating process and also the post heat weld process after the rail is cooled using room temperature [12].

Figure 3 (d) Microstructure of welded layer
