EROSION CHARACTERISTICS OF A MEDIUM SAND BREACHED EMBANKMENT

Zainab Mohamed Yusof*, Syura Fazreen Hamzah¹ & Shahabuddin Amerudin²

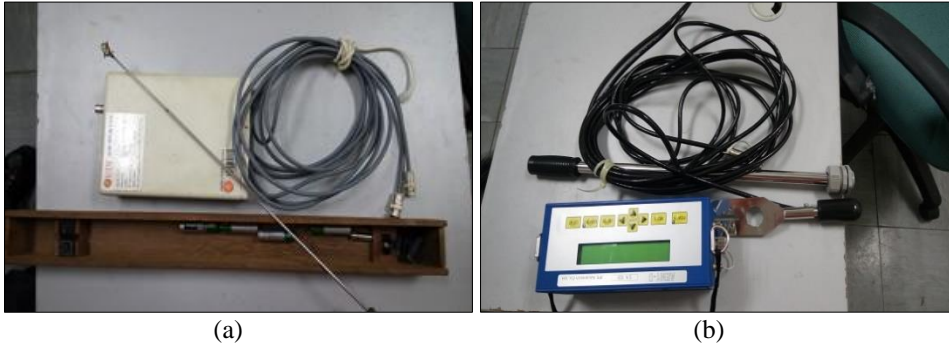
Figure 6: Flow calibration; (a) a miniature velocity, and (b) an Electromagnetic Flow Meter (EFM).

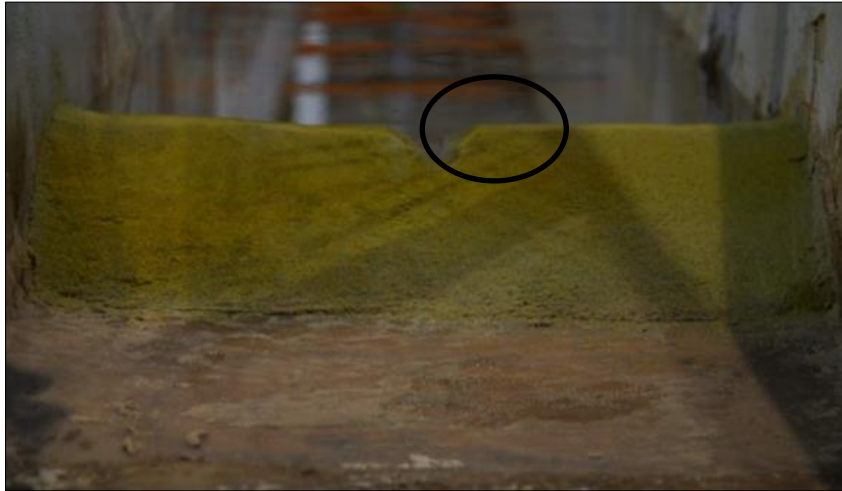
Figure 9: A notch; acting as a weak point of the embankment dam, is located at the middle of the embankment filled.

The test was carried out in a flume of 11 m long, 0.6 m deep and 0.61 m wide. The wall of the flume is installed transparent at one side for observation and recording work during the tests. Figure 9 shows the embankment setup when the compaction work has completed. At the center on embankment crest, a notch was produced which is marked as a circled. It functioned as a weak point of the embankment dam. The notch size was 1.7 cm height and 6.5 cm width. The details study of the experiment as follows,
